“Bridge Creek Landslip Remediation”

Final Report & Acquittal (Sunshine Coast Council Minor Grant)

(July 2011)

PROJECT TITLE: Bridge Creek Landslip Remediation (LBCCG Project No. 1011-010)

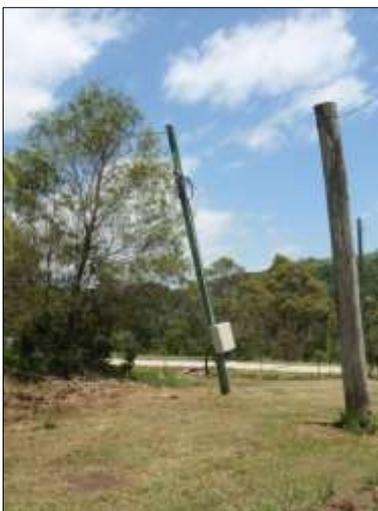
Since the assessment by Fraser in 2009 there has been further movement in the immediate area. The recently constructed concrete driveway to the McLauchlan dwelling above the identified slip has been shifting. In 2011, following the extreme wet conditions experienced over the summer period there was significant movement on the Ward property (RP227535, Lot 5) further up-slope. This indicates the entire slope spanning the three properties is subject to mass movement.

Figure 6: The most recent landslide in the area has affected the Ward property, which is up-slope from the McLauchlan & Bull properties. Note the electricity pole in the centre of the photo.

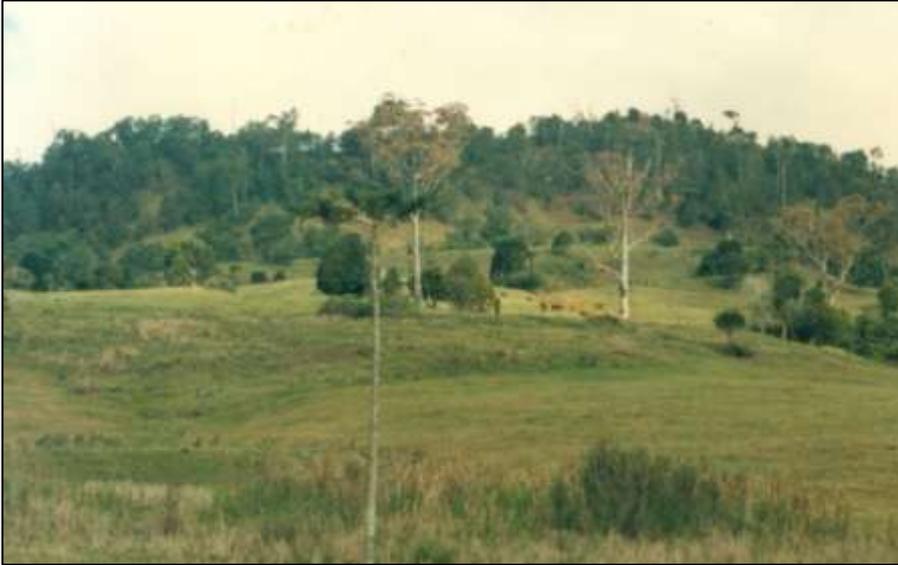
Figure 7: The project site in 1988. The properties had better pasture coverage however the instability of the area can be seen. Note the change in slope

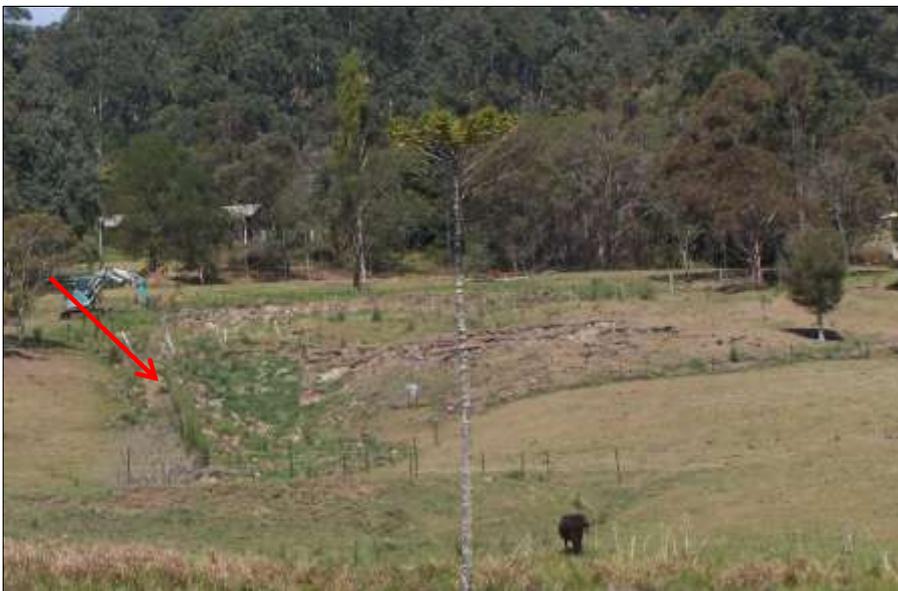
Figure 8: The project site in June 2009. The willow tree in the slip (red arrow) was originally planted above the fence on top of the rise. The areas on and adjacent to the slip require vegetation to help stabilise the site. Note the revegetation and regeneration in the background that has occurred since the removal of stock in these areas.

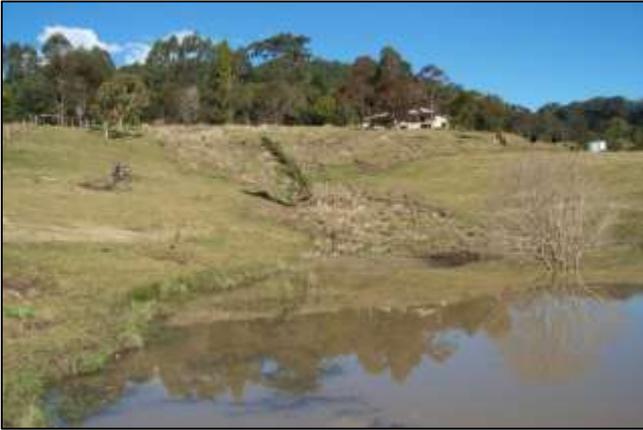
Figure 9: The landslide from down-slope. The two willows (green willow in centre of photo and dead willow in the dam) in the centre of the photo were originally growing above the boundary fence on top of the rise.

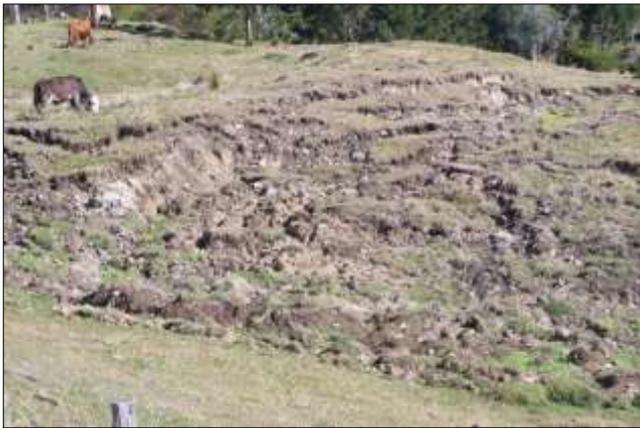
Figure 10: Typical of landslips in Kikuyu dominated pasture – the ground cracks and shears but retains some structure from the grass roots and tends to 'fold' rather than slide. This usually results in a 'bulbous toe' at the leading edge of the slip.

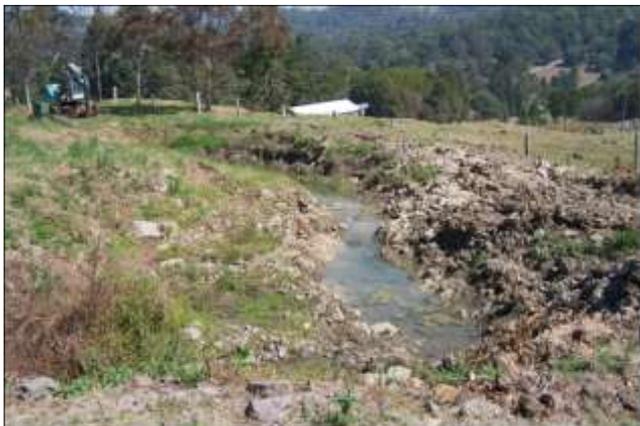
Figure 11: The small dam at the top of the landslide. This dam was roughly circular in shape – note the encroach of material into the dam from up-slope (to the left of the photo). The debris slide associated with the landslide was caused by the failure of the dam wall (bank).

The site was profiled to remove the small dam at the head of the slip and to reinstate a gradual slope to facilitate water run-off. To prevent rilling from heavy rainfall, David Bull constructed diversion banks across the slope on his property to slow run-off and direct it to a stable point.

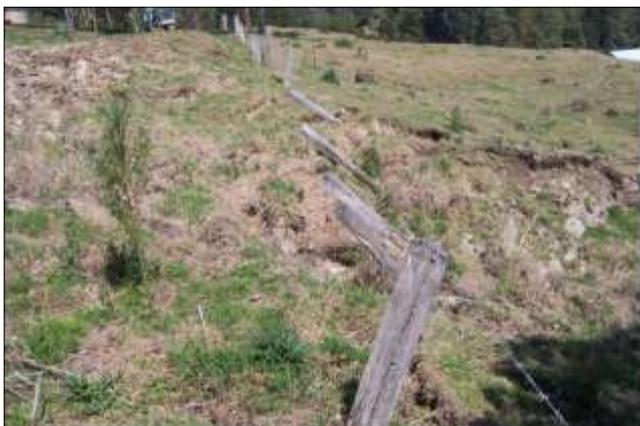
Figure 12: Boundary fence between the McLauchlan and Bull properties damaged from the landslide.

Permanent fencing was placed around the bottom of the slip and the boundary fence separating the two properties was reinstated. This replaced the temporary electric fencing erected 12 months previously.

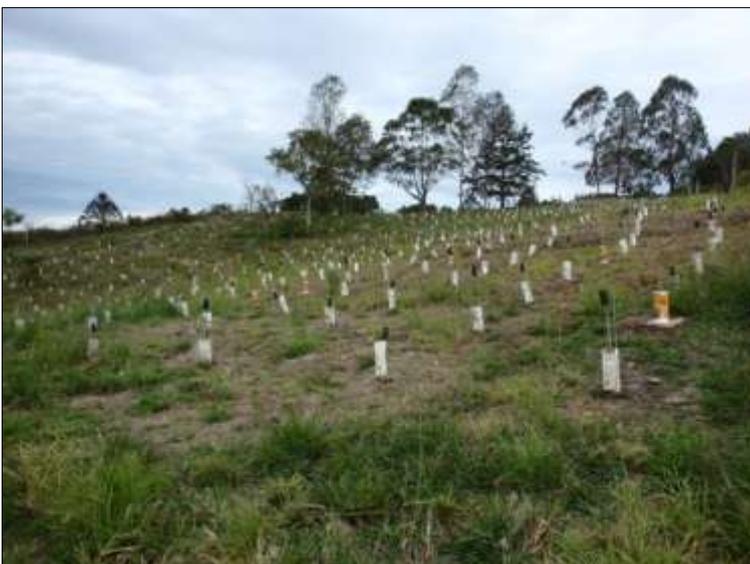
Between March and June the site was replanted to replace dead stock. Although the species initially chosen were selected for their hardiness, the extremely wet summer resulted in moderate losses (approximately 15%) due to waterlogging. Wallaby predation also contributed to losses although the wallabies tend to 'nip' the tops out of the tubestock.

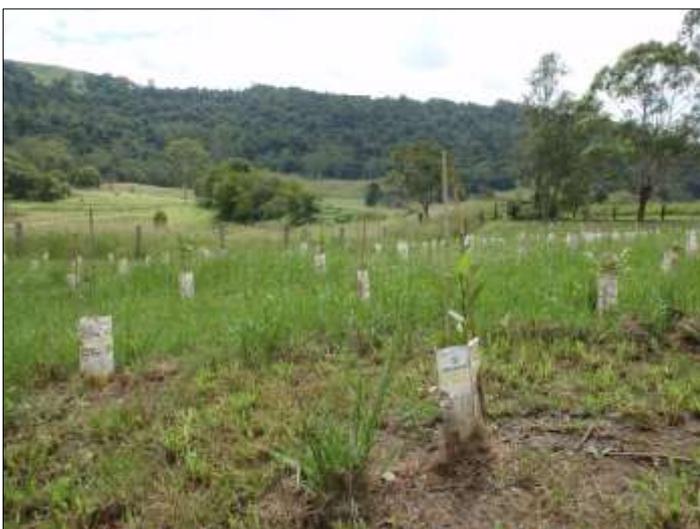
Figure 14: Grass has been retained and encouraged between the rows to provide surface stability. Grass is kept clear immediately around each individual plant to reduce competition. There does not appear to be any need to keep the inter-row grass short as lack of moisture is not a major concern on the site – indeed most plant losses have been from waterlogging.

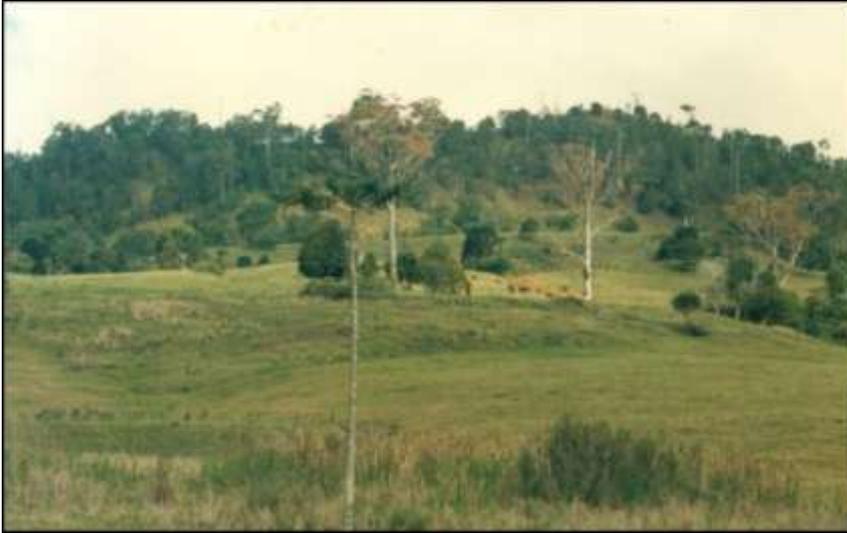
Figure 15: circa 1988.

Although relatively stable, the area displays the unmistakable 'hummocky' appearance of a landslip. The colluvium present would have resulted from tree-clearing activities and lack of ground cover in the past.

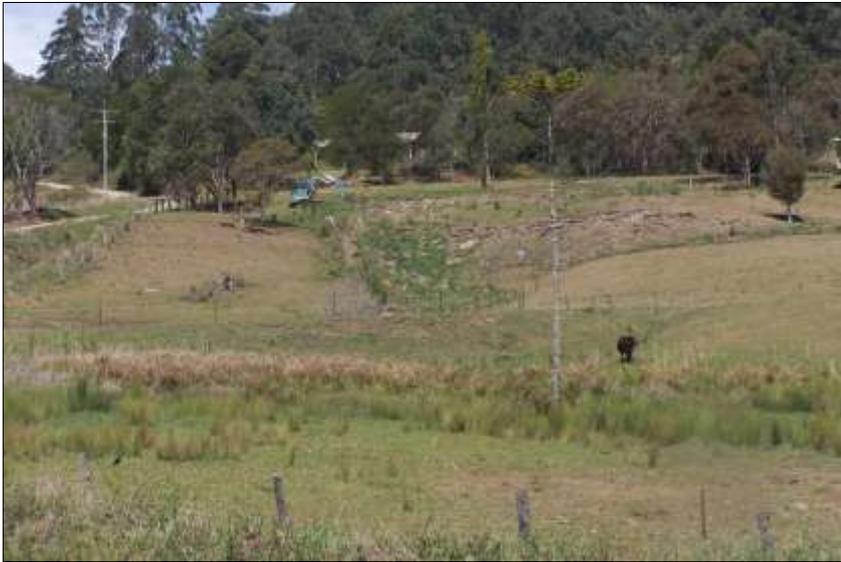
Figure 16: September 2009.

The landslip that occurred in the summer of 2009 largely resulted from high rainfall, the small dam at the head of the slip, and the lack of soil binding vegetation on the site.

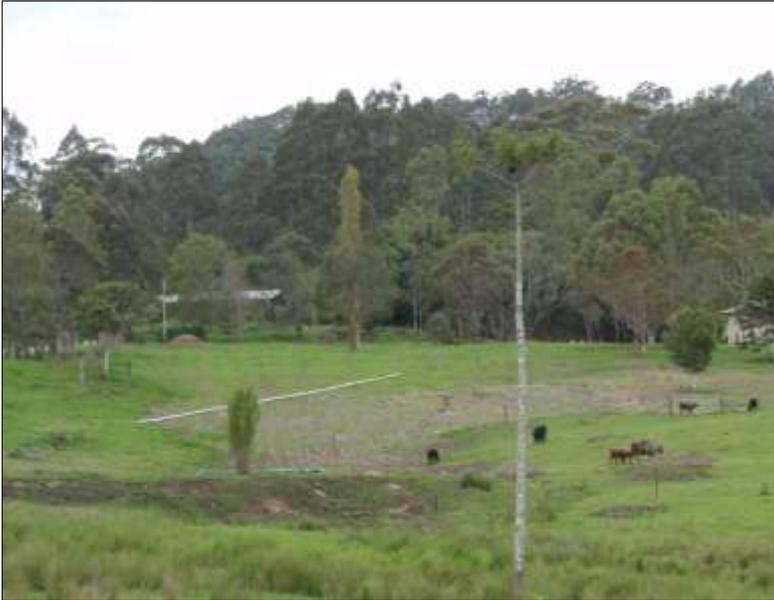
Figure 18: October 2010.

Pasture grass establishment was slow as the soil surface was predominantly clay and stone.

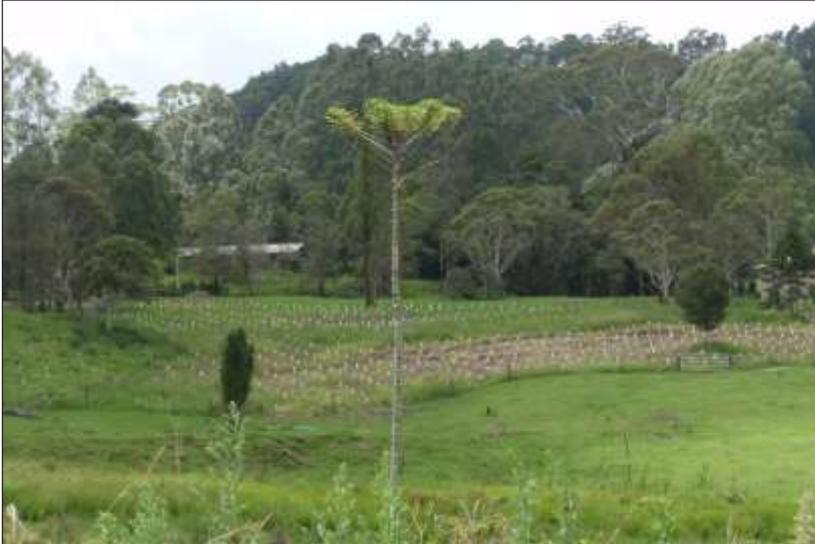
Figure 21: January 2011.

Grass still very slow to establish on the heavier clay soils.

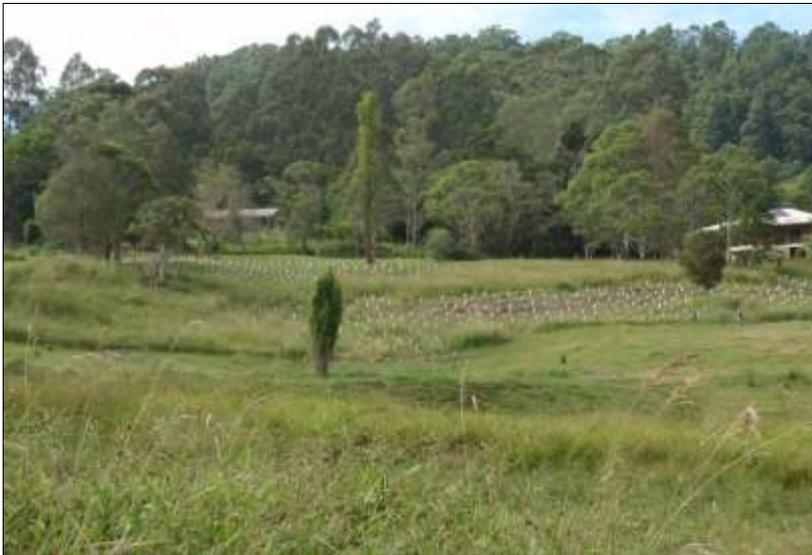
Figure 22: March 2011.

Better quality soil has excellent grass growth and in these areas tree growth has been good. growth on the undisturbed area on the left (adjacent to Wells Road) has been excellent. Grass growth on heavy clay soil still virtually non-existent.
