Cork Dairies Obi Obi Creek Laneways Rehabilitation

ON MAINTENANCE REPORT

Project No. 1011-009

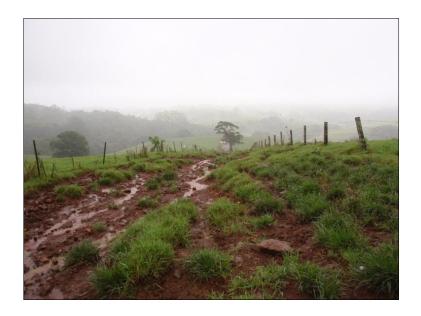
Left: The northern laneway at the dairy before works. Note the severe erosion and the formation of rilling which directs run-off down the laneway further exacerbating erosion and results in run-off directly to the properties watercourses.

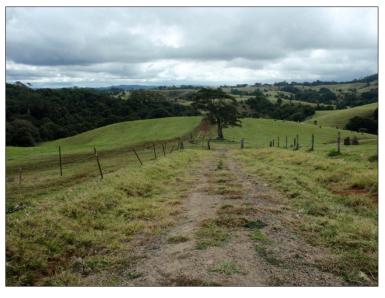
Left: The northern laneway following rehabilitation. This section was completed in September 2011. Grass growing on the laneway must be sprayed to avoid damage to the surface.

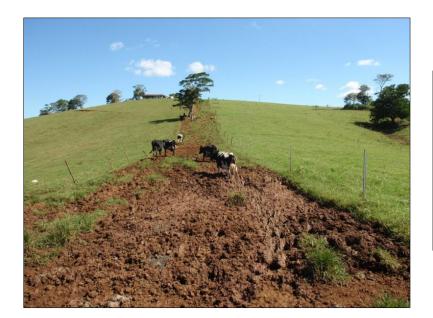
Left: The northern laneway prior to works. Poor drainage causing severe waterlogging. This section of laneway has been abandoned in favour of construction of a new laneway to the east following the contour and reducing the steepness of the laneway.

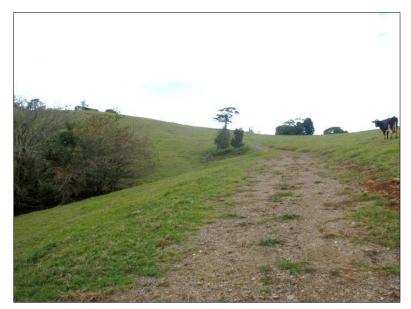
Left: The new section of laneway following the contour and minimising steepness. The northern laneway.

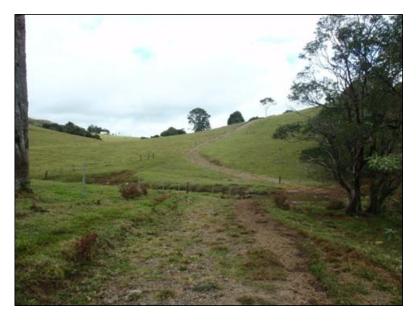
Left: Bottom section of northern laneway. Note Daley Creek in the centre of the photo. Grass needs to be managed on the laneway surface.

The wet summer of 2011-12 caused minor damage to the incomplete laneways – particularly the northern laneway which did not have adequate 'whoa-boys' installed, allowing flows to scour a section at the bottom of a relatively steep slope.

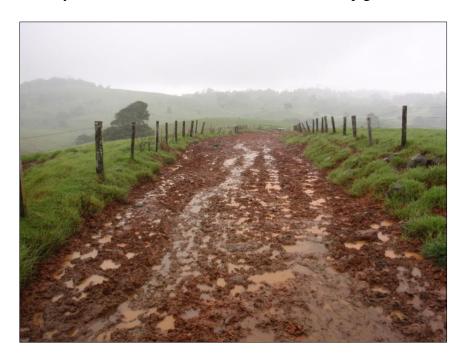
The western laneway services the paddocks to the west of the dairy. Significant erosion over several years has left this laneway severely degraded with a cattle trough undermined and where the laneway meets the concrete dairy apron a sharp and deep drop-off.

Left: The western laneway prior to the project. The laneway has eroded to the point where it traps and holds water resulting in an excessively boggy surface.

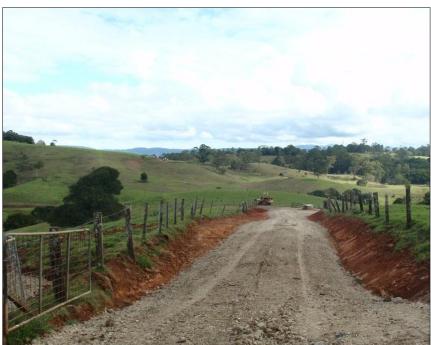
Left: The western laneway profiled and hardening to create a free draining durable surface.

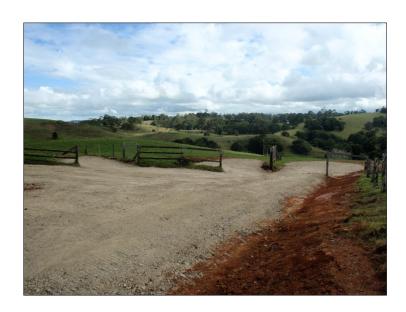
Left: Rehabilitated western laneway where it splits off into paddocks.

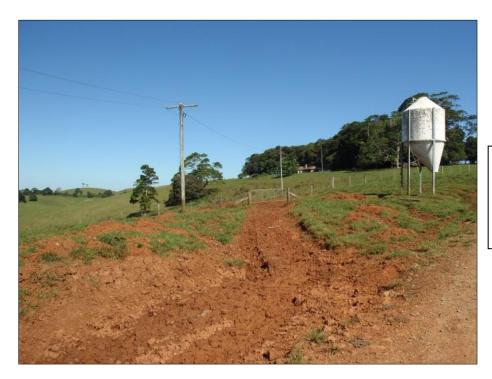
The eastern laneway services the paddocks to the eastern side of the property. This laneway was less formal with livestock traversing a wide path across the slope – leaving many deep ruts.

Left: The eastern laneway from the dairy entry road prior to works. Note the poor drainage.

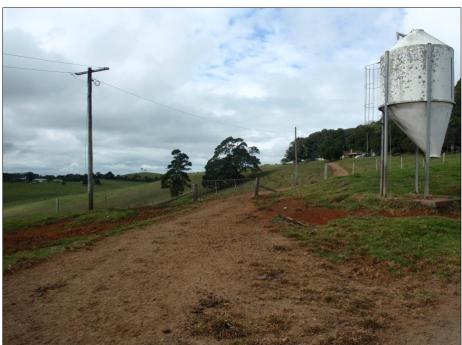
The formalisation of the laneway has significantly reduced 'tracking' – even with the fencing yet to be completed.

Left: Rehabilitated eastern laneway.

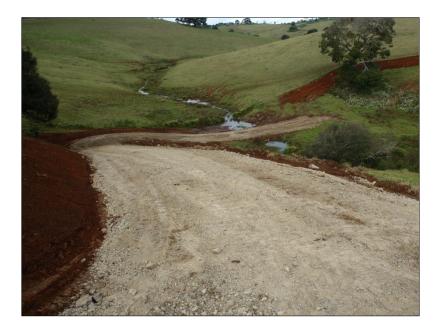
The property has extensive frontage to the Obi Obi Creek with an approximate length of two kilometres. The western laneway crosses the waterway. This crossing was upgraded with two 600 mm pipes and hardened surface. Further profiling of the laneway beyond the crossing was completed to improve access. These works were completed at the landholder's cost.

Left: Rehabilitated crossing over the upper Obi Obi Creek.

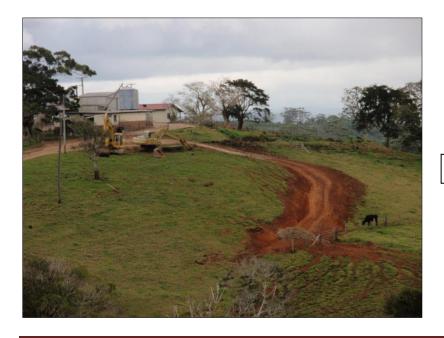
Over the life of the project (planning commenced in January 2011) a short laneway (100 metres) running from the dairy to a paddock to the east (unrelated to the 'Eastern laneway'), became degraded. This laneway was rehabilitated.

Left: New laneway.
