Bridge Creek Rehabilitation Project

Lake Baroon Catchment Care Group

**Prepared by Mark Amos
Catchment Coordinator
LBCCG
Project No. 0910-004**

PROJECT TITLE: Bridge Creek Rehabilitation Project (McLauchlan)

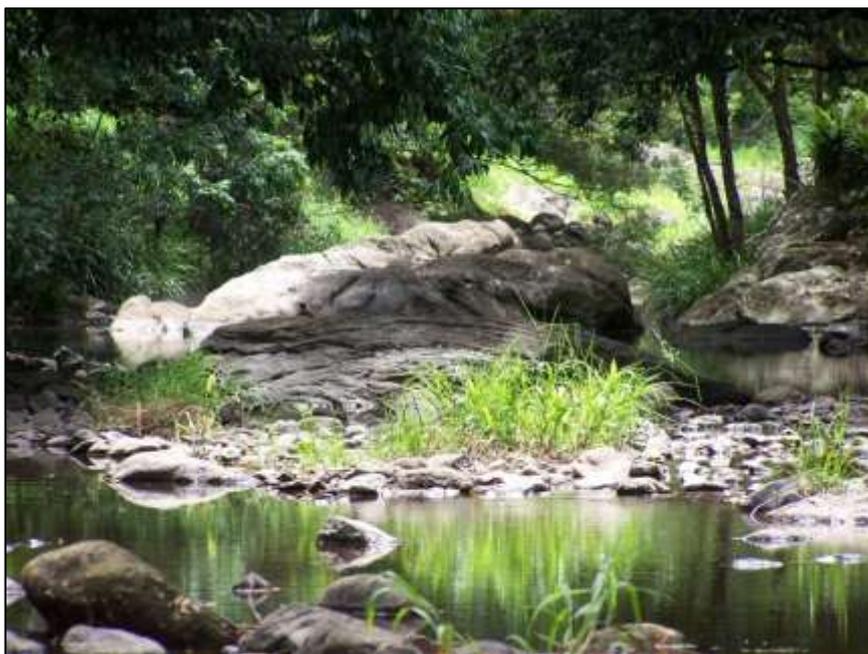
Figure 1: Bridge Creek near the River School on Bridge Creek Road. The waterways generally have good riparian vegetation, with good bed diversity and bank stability. The creek however is threatened by sediment loads entering the waterway through erosion in the catchment.

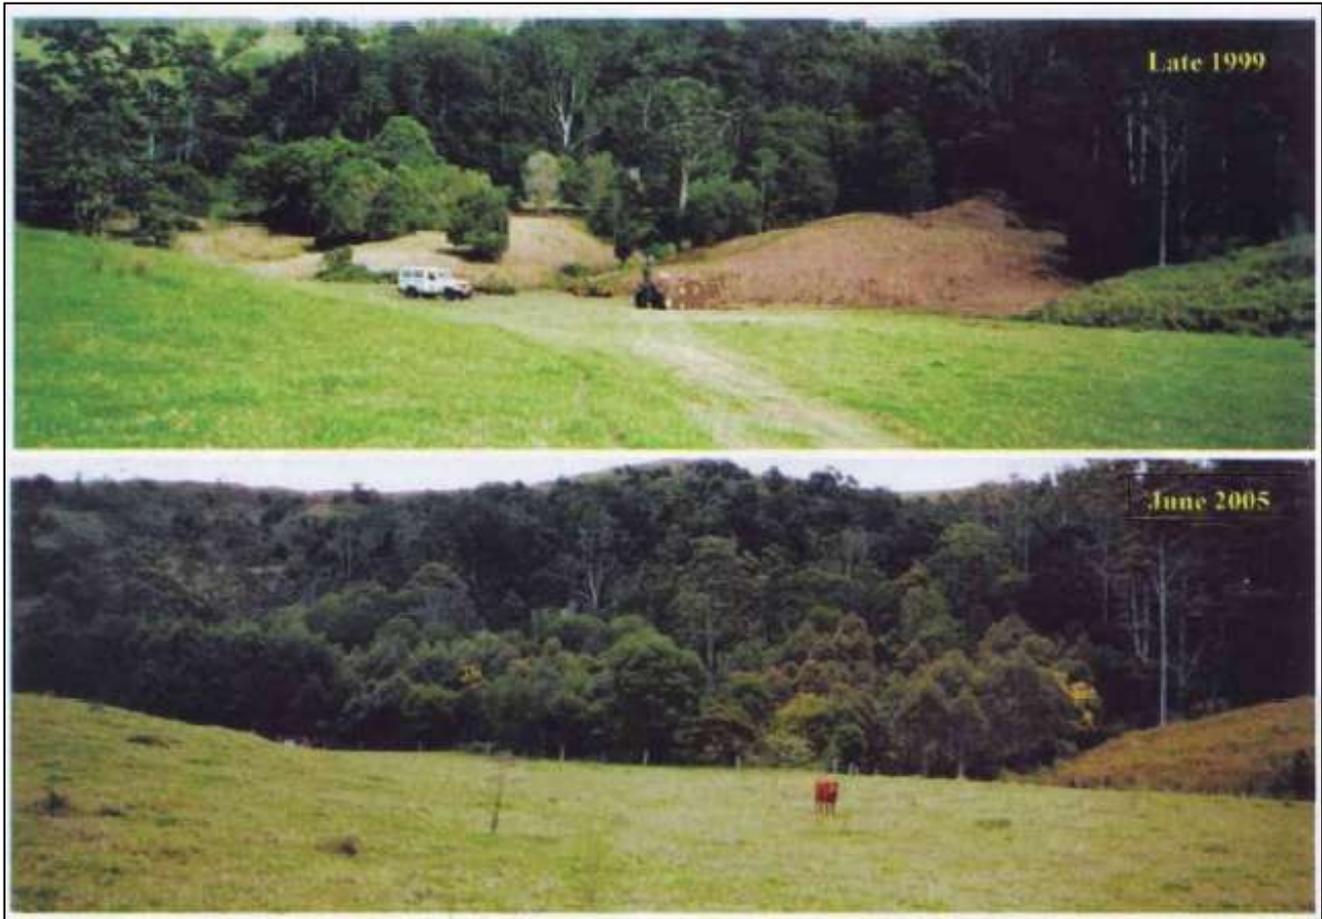
Figure 5: “The Corridors of Green” project on the property, coordinated by Barung Landcare, fenced 220 metres of Bridge Creek and revegetated 3.5 hectares of waterway and steep hill-slope.

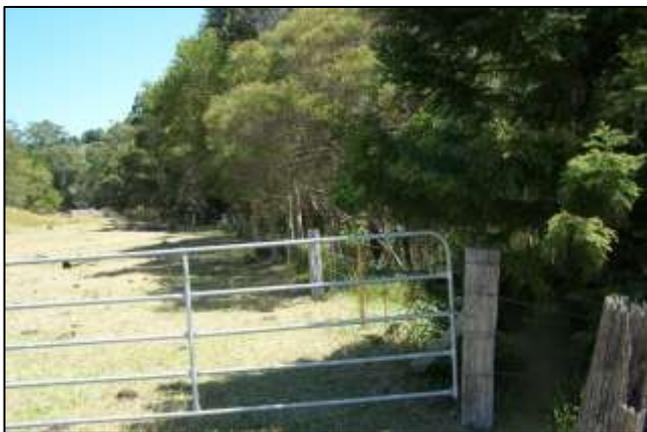
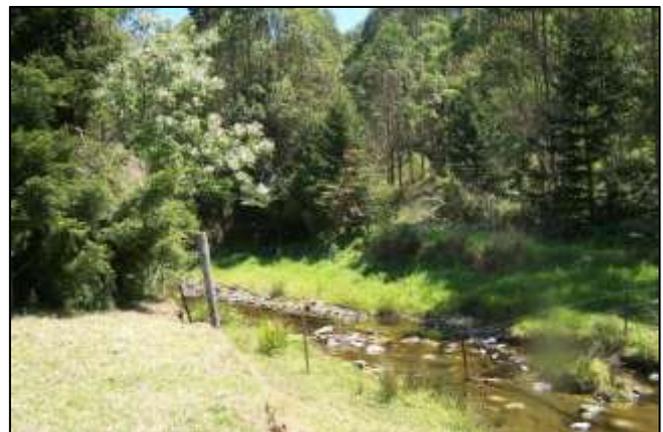
Figures 6 & 7: The COG project in 2009

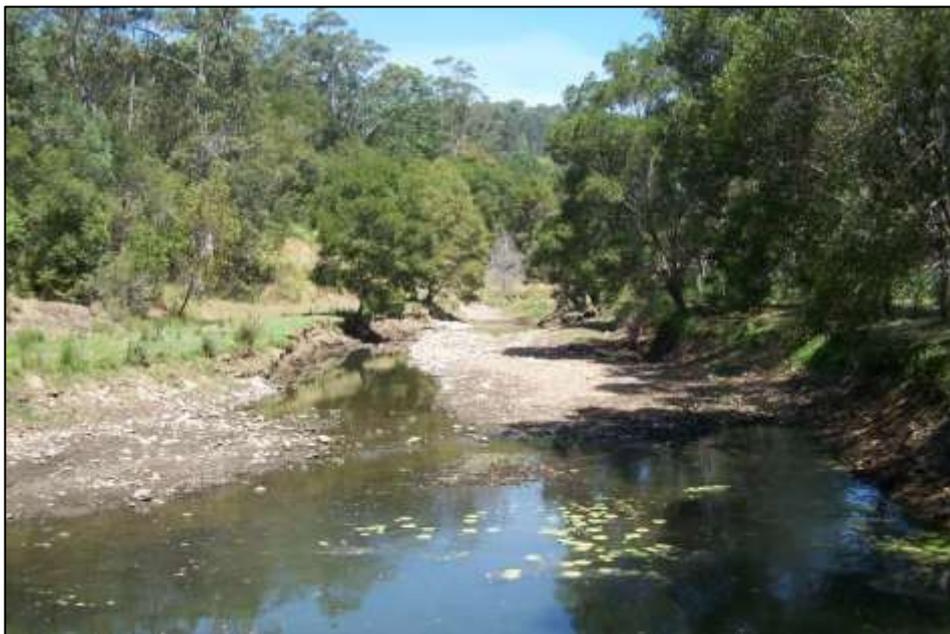
Figure 8: Bridge Creek where it enters Lake Baroon immediately downstream of the McLauchlan property. Note the large amounts of sediment in the bed of the creek; sediment ‘drops’ out as the flow dissipates at this point where it enters the Dam.

The main issue identified by the McLauchlan's was the management difficulties associated with the numerous springs and associated water-logging. Erosion from the steeper areas of the property deposits sediment onto less steep areas and with groundwater springs contributing moisture, results in the formation of water-logged zones. Furthermore during heavy rainfall events loosened sediment, caused by livestock overgrazing, runs off and enters Bridge Creek and ultimately Lake Baroon (see Figure 8).

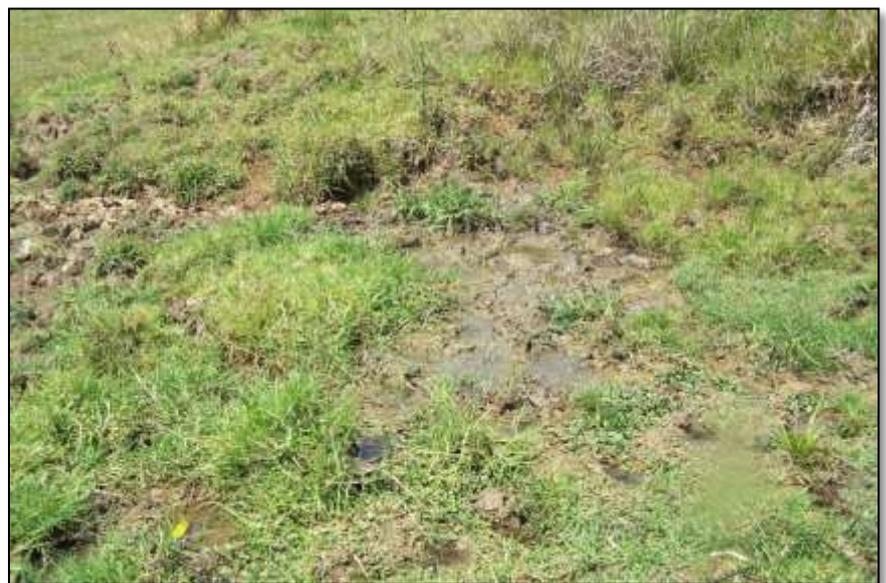
Figure 9: Much of the sediment that reaches Lake Baroon originates from springs on the hill-slopes of the catchment – particularly from the McLauchlan property.

The constant moisture provided by the springs tends to grow more and ‘fresher’ pasture on these sites, resulting in heavier grazing pressure which contributes to a higher concentration of nutrients and greater erosion which is washed into Bridge Creek during heavy rainfall events.

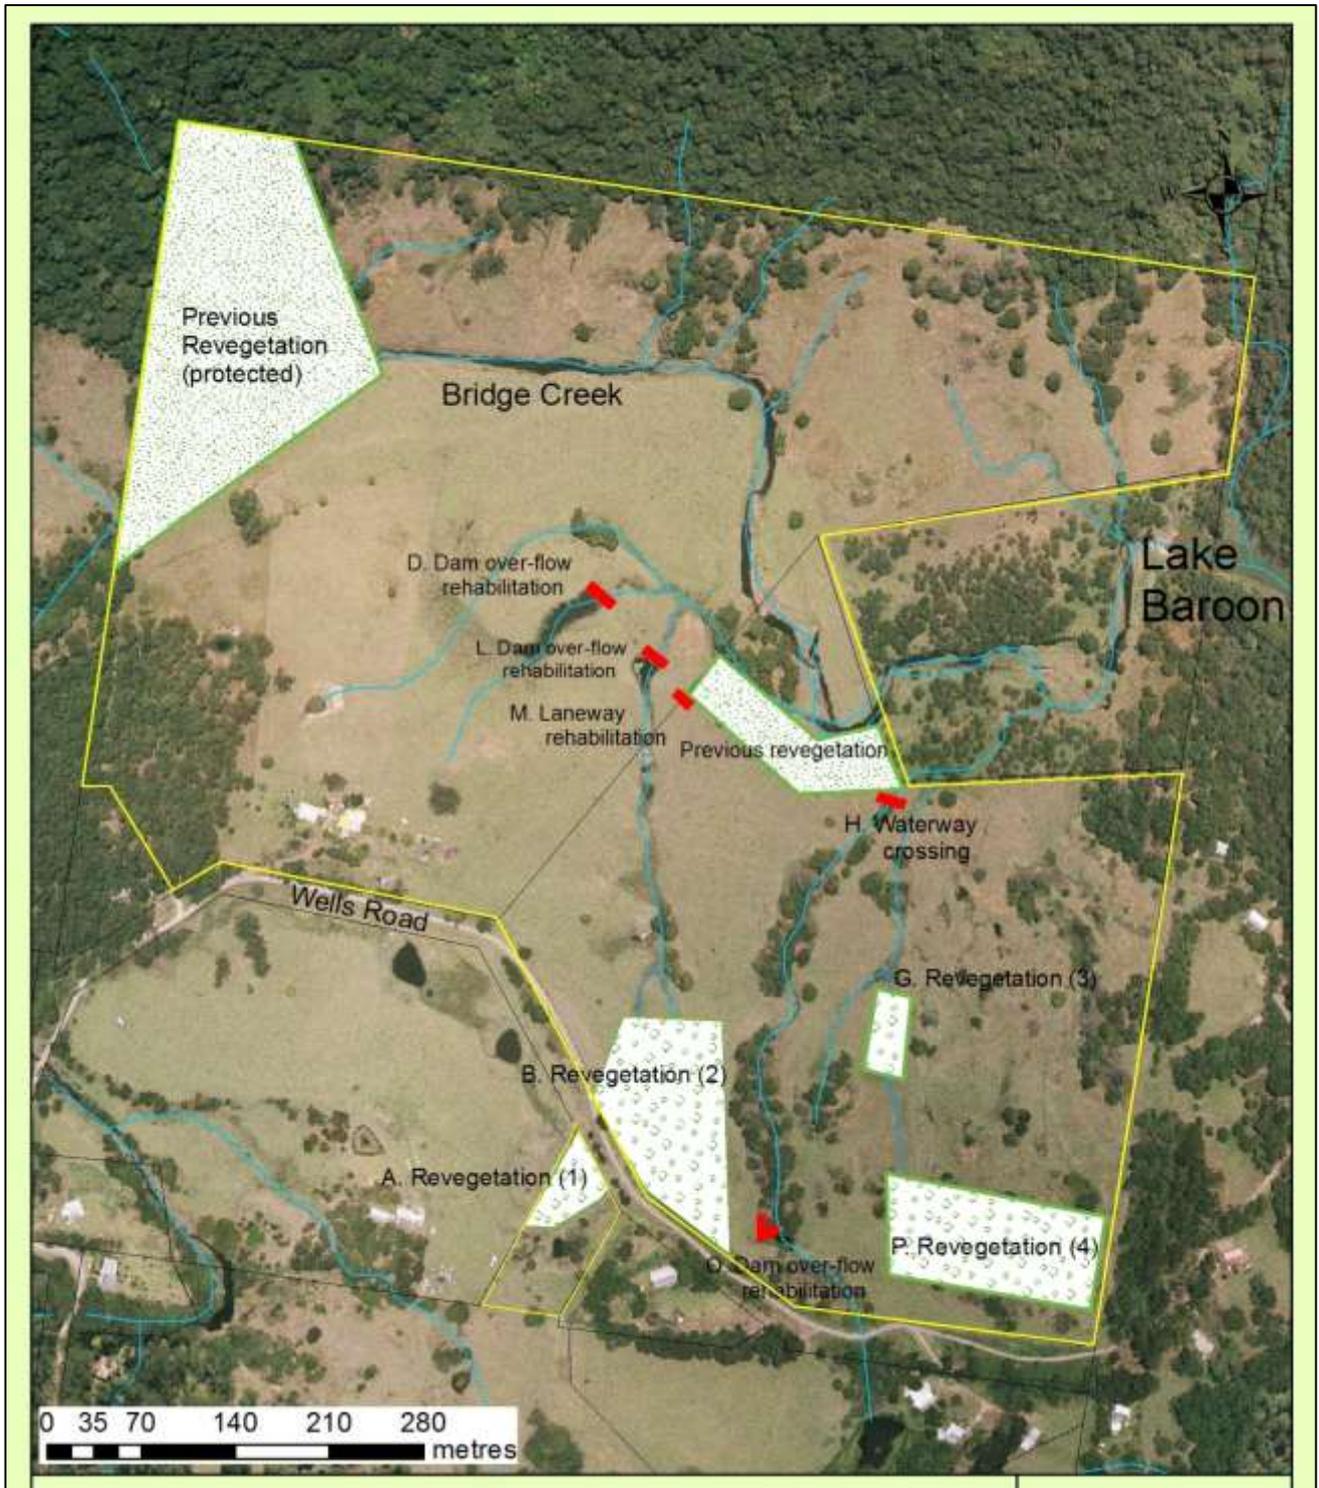
Figure 11: Proposed on-ground works and previous revegetation sites.

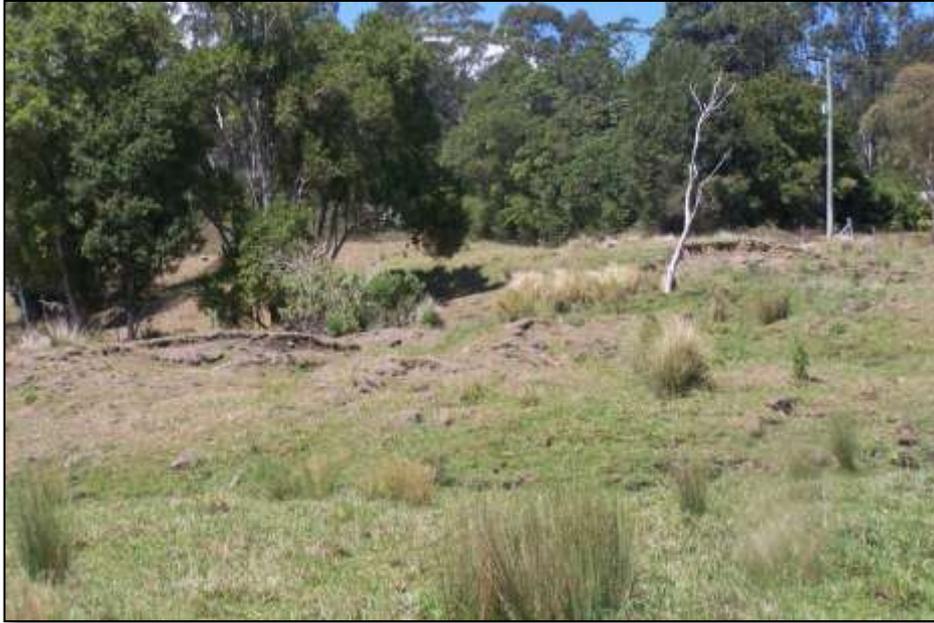
Figure 12: Erosion in the past has resulted in flows from a spring on Well's Road following a new path. Minor earthworks, fencing and re-vegetation will stabilise the area and provide a large (1 hectare) vegetation 'cluster'. Note the lumps and mounds of sediment eroded from higher up-slope.

With minor earthworks; forming a low diversion bank to redirect surface water flows back to the original waterway, and revegetation, the site will be stabilised reducing soil loss and nutrient inputs into Bridge Creek.

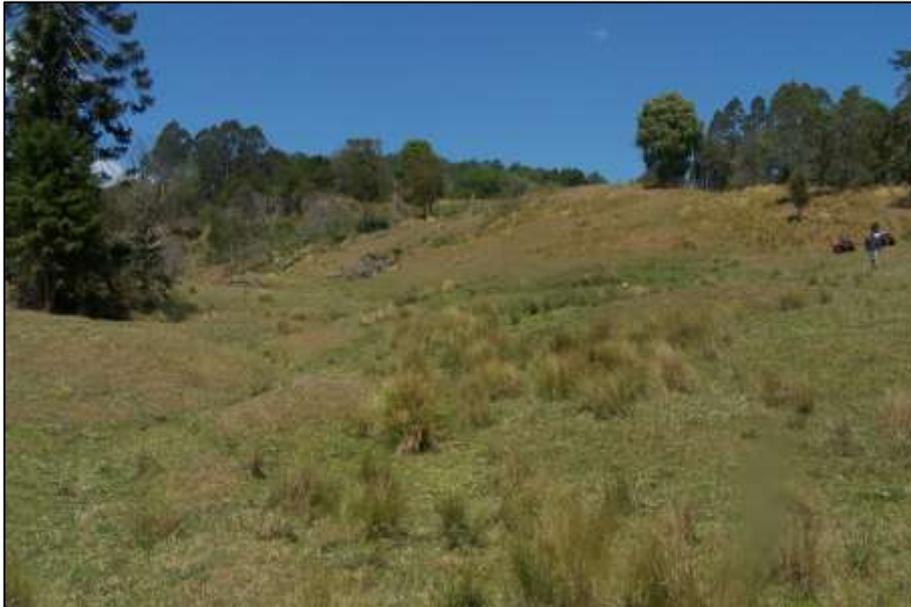
Figure 14: The waterway, although ephemeral, is constantly waterlogged and attracts heavy grazing pressure from livestock. Note the humps and mounds which is material deposited by erosion further up the hill-slope – particularly the area in the background (Revegetation Area 3).

Fencing and revegetation of the site will remove livestock, and stabilise sediments deposited in this area from erosion further up-slope.

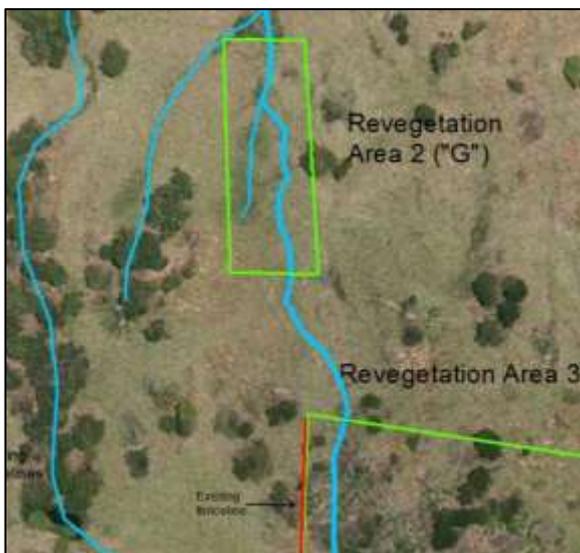
Figure 15: Revegetation Area 2. The site is approximately half a hectare and will require 250 metres of fencing. There is a scattering of native Sedge and Juncus species which would be expected to spread once livestock is removed from the site. Revegetation will consist of 1,000 plants selected for their ability to withstand water-logging.

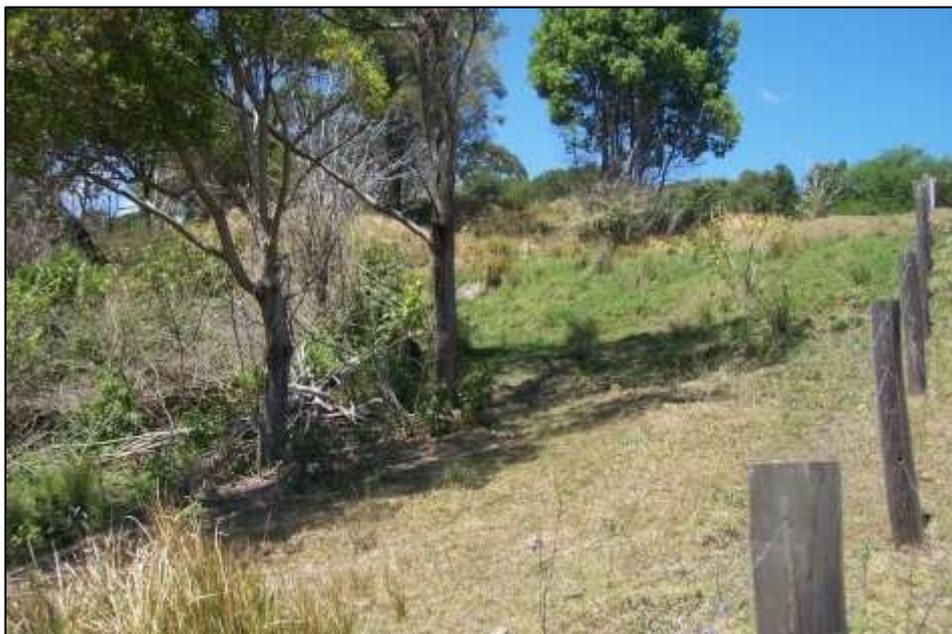
Figure 16: The relatively steep slope has been identified as having a high likelihood of suffering from land slips. The landowner has retained all vegetation possible to maintain stability, but would prefer to replace weedy species with native vegetation. Note the green spring in the centre of the photo.

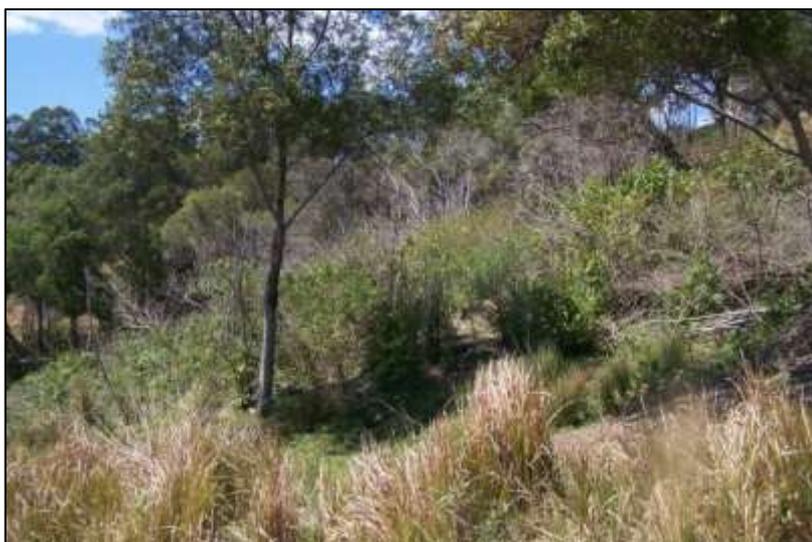
Figure 17: The hill-slope has stabilised with good growth of blady grass and the weedy lantana. Low impact removal of the lantana will minimise soil disturbance and combined with exclusion fencing will allow natural regeneration and recruitment to occur. The site will be enhancement planted in the second year to ensure biodiversity and full slope coverage is achieved in the longer term.

Fencing of the site to exclude livestock, and weed management of lantana will promote natural regeneration of native species which will contribute to the stabilisation of the hill-slope. The blady grass will be encouraged as it provides an exceptional buffer to run-off and stabilises loose soils with extensive root systems. (An exception to the general rule; the landowner encourages blady grass on the property and improves its palatability to livestock by regularly slashing to promote fresh growth.)

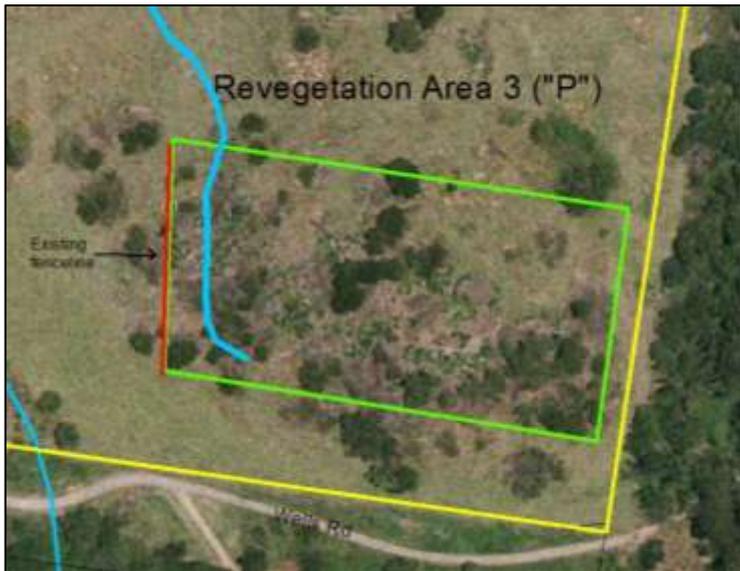
Figure 18: Revegetation Area 3. The site is approximately 1 hectare, but only requires fencing on 3 sides (350m). Note the 'fair' covering of Acacia's, blady grass and lantana. Natural regeneration would be expected to occur once livestock (and lantana) are removed. Enhancement revegetation will ensure diversity and adequate coverage results.

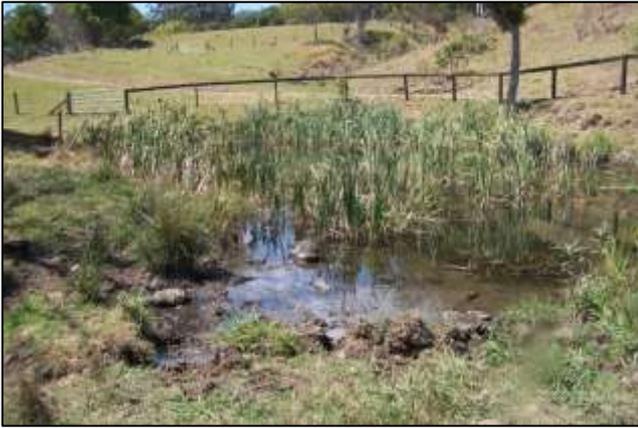
A small spring-fed dam functioning as a wetland and providing useful habitat to aquatic species has a steep overflow which is likely to fail without a ‘formal’ over-flow being installed – including the placement of suitable rock in the gully immediately downstream of the dam.

A crossing will be constructed with a 200mm diameter pipe, a load of road base to stabilise, and large rock placed in the over-flow to halt head-ward erosion.

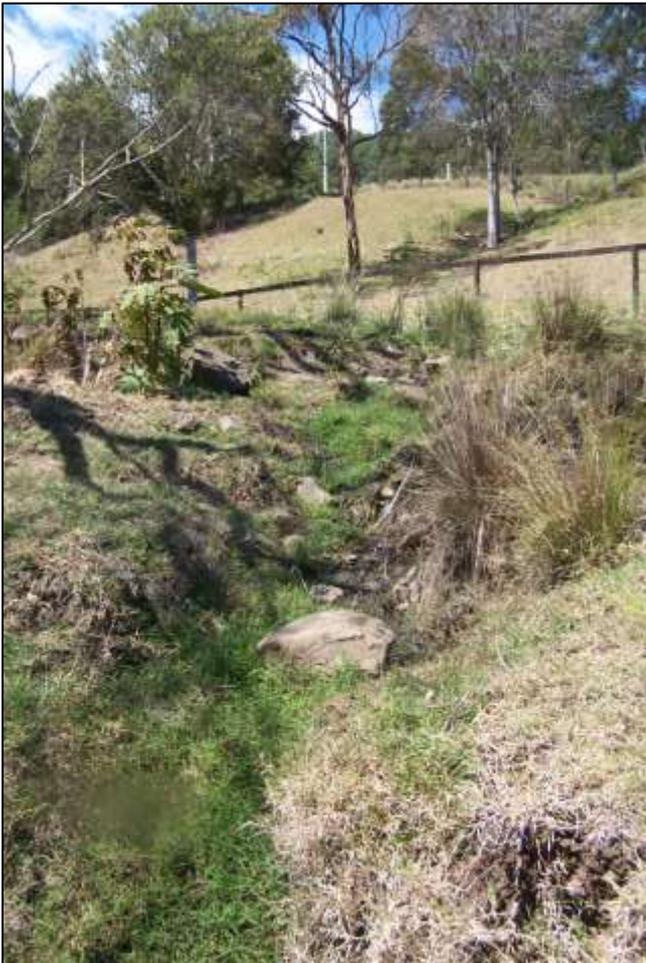
Figure 20: The over-flow to the dam falls away steeply to the gully below. Head-ward erosion is migrating up the slope putting the dam bank at risk. Suitable manufactured rock will form a hard surface for the over-flowing water from the dam to run over minimising scour. Rushes, sedges and pasture grass will further stabilise the over-flow over time.

Large woody debris (LWD) was originally sourced by the landholder to be placed in the over-flow and downstream gully to provide stabilisation, however this material would be better utilised at “C”, (see page 20). Large manufactured rock (300mm diameter) would provide superior stabilisation at this site.

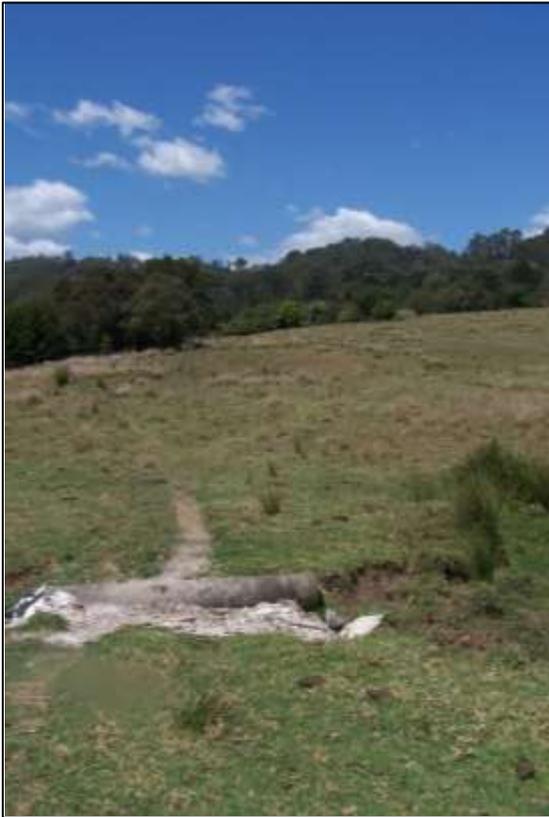
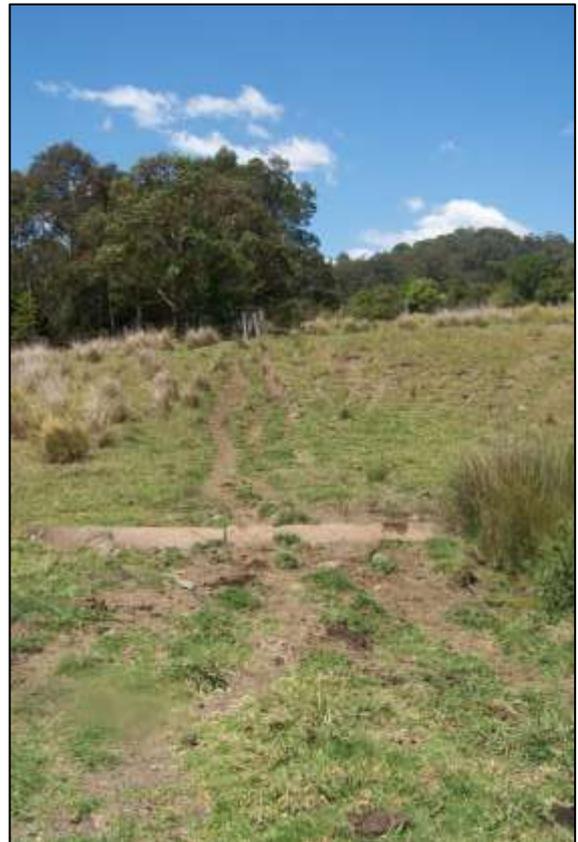
Two existing dam over-flows/waterway crossings on the property suffer from livestock damage. **These crossings require a load of road base and compaction (by excavator) to stabilise, thereby reducing erosion and sedimentation of the waterway.**

Figure 21 & 22: The dam over-flows/crossings require rehabilitation to ensure the dam wall does not fail and erosion is minimised.

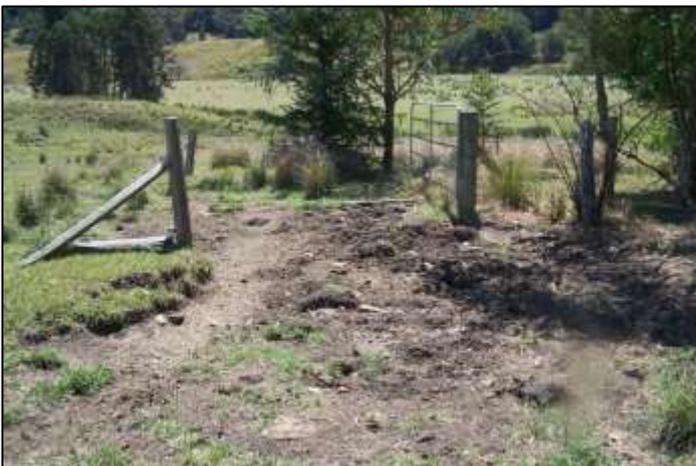
A laneway adjacent to Bridge Creek is eroding from excessive livestock traffic resulting in sediment and nutrient run-off in heavy rainfall events. **A load of road base and compaction will harden the laneway minimising erosion.**

Figure 23: Laneway adjacent to Bridge Creek. A previous revegetation project by Barung Landcare (see Attachment 2) is immediately to the right – a planting on the banks of Bridge Creek.

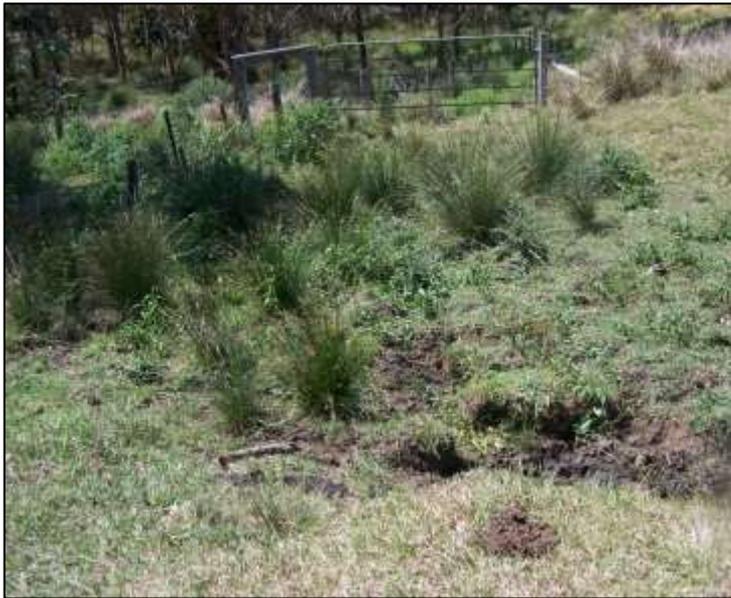
Figure 24: An old waterway crossing on the boundary of Seqwater property. Sediment caused by erosion further up-slope is deposited here creating a boggy waterlogged area. Even during the driest part of the year, livestock cause severe ‘pugging’ and surface water flows cut channels through the gateway resulting in significant erosion.

The gateway is situated on the boundary fence with Seqwater. **By moving the gate back up the fence-line to a more stable position, livestock tracking through the gate will be stopped. The construction of a new waterway crossing opposite the gate will enable access to the north eastern paddocks of the property.**

The crossing will be constructed using a 300mm diameter pipe, a load of road base to harden and stabilise, and property-sourced rock to protect the pipe opening and outlet.

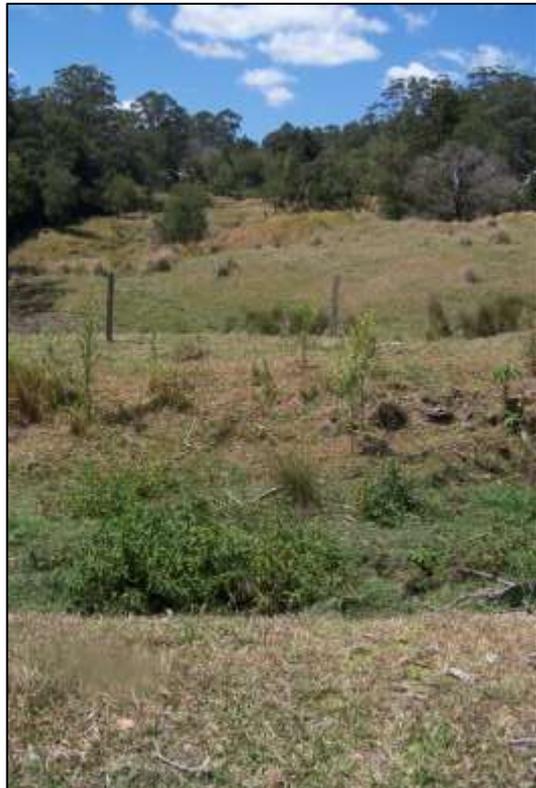
Figure 25: Site for new crossing. A gate will be moved from the left of the picture to the fence in the background to provide access to the north eastern paddocks of the property. A waterway crossing is required to minimise erosion and provide access to the north eastern paddocks on the property.

Note that this particular waterway is ephemeral and a piped crossing will not impact on the movement of aquatic species.

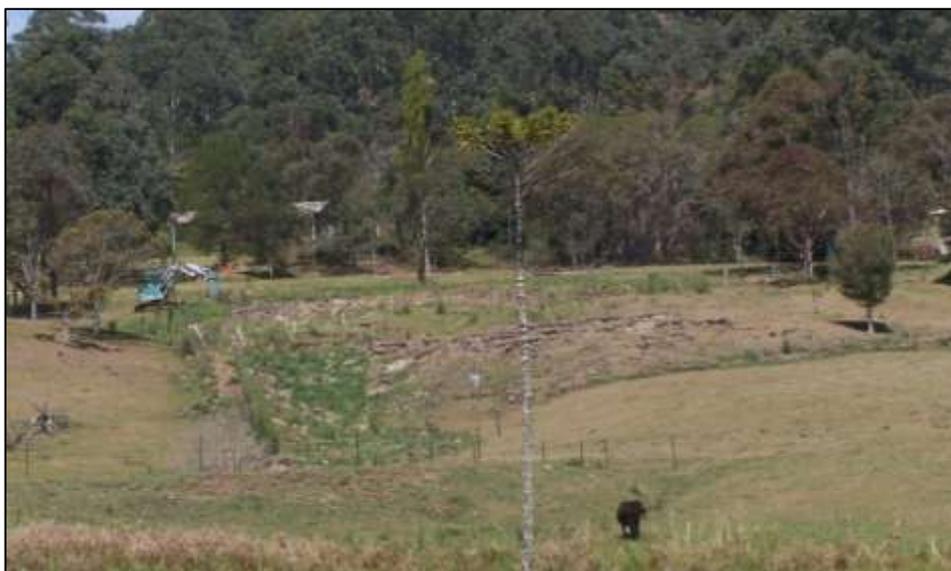
Figure 26: The site to be revegetated is in the background (where the small excavator sits). Note the debris flow (green area in gully) that has entered David Bull's property (LBCCG provided electric fencing and seeding around the area).

The heavy rainfall in early to mid 2009 reactivated an old landslip on Rob McLauchlan's residential property. A small dam constructed at the head of the gully increased ground pore-water pressure and resulted in a slip that caused the failure of the dam bank. A debris slide flowed downstream into the neighbour's property (David Bull's).

All options require the removal of the dam which in isolation should considerably improve stability.

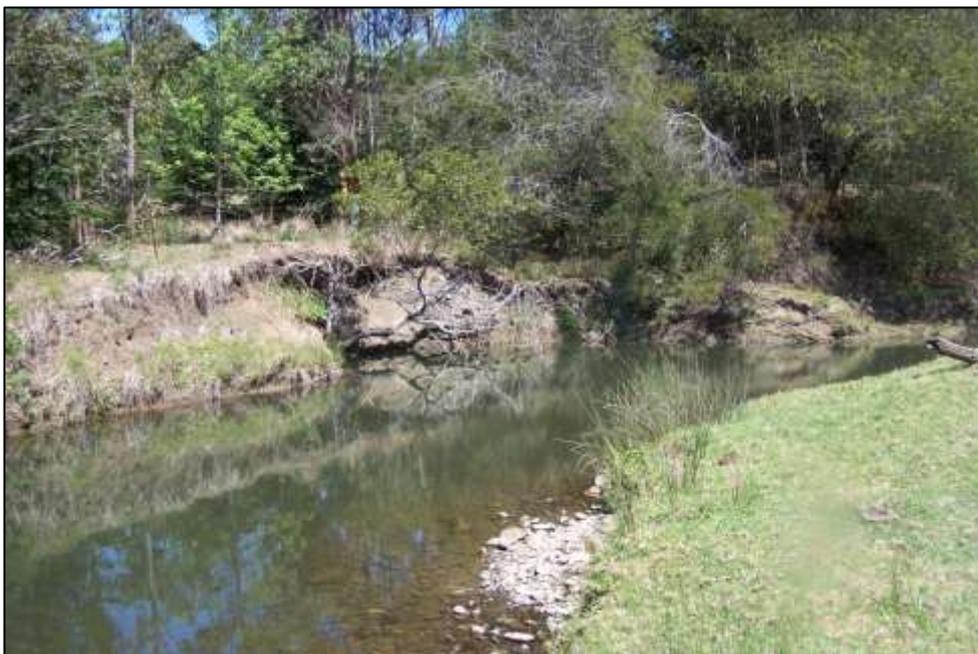
Figure 27: The bend on Bridge Creek before it enters Lake Baroon. Sediment from this erosion is transported to the storage and previous re-vegetation is threatened by continuing erosion.

Immediately before Bridge Creek enters Seqwater owned property, the waterway turns at ninety degrees, resulting in significant bank erosion on the outside of the bend. This erosion is affecting revegetation established under a previous Barung Landcare program (see Attachment 2) and will eventually impact on revegetation on Seqwater land.

Ideally this bend could be reshaped and armoured with large manufactured rock (400mm minus). The site however is difficult to access by large trucks capable of delivering rock. **An alternative method of stabilisation could be by using approximately 30 large tree stumps and trunks salvaged off site (stored on the property).** These could be placed with an excavator (with assistance from Dale Watson – MRCCC) and backfilled with soil so that appropriate vegetation could be planted to provide long term stability.

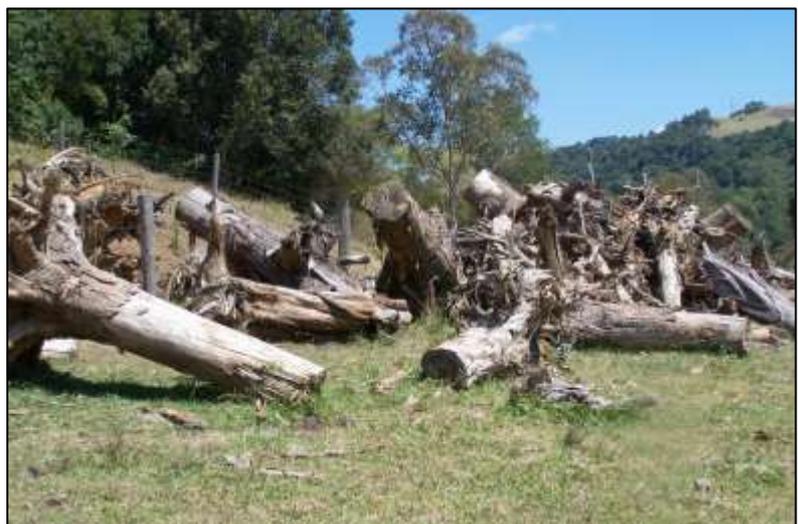
Figure 28: The large woody debris that could be used to rehabilitate the eroding bend on Bridge Creek. This will provide the added benefit of aquatic habitat as this reach of Bridge Creek contains a deep, permanent hole (fish were observed in the hole when visited).

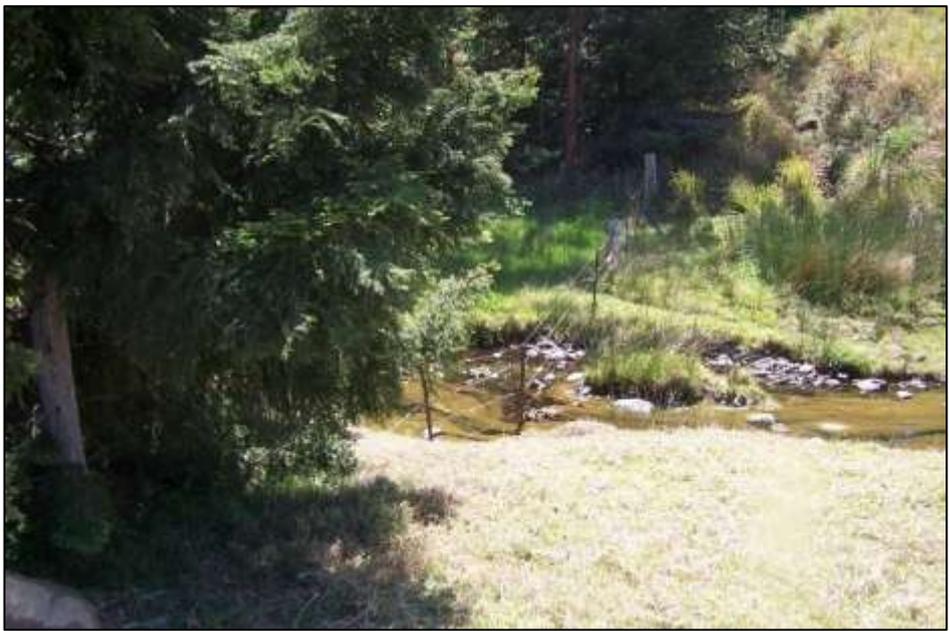
Figure 29: Flood fence on Bridge Creek. The fence is regularly washed away and is difficult to maintain and repair. A suitable low maintenance replacement would serve as a demonstration/test site.

The erection of a suitable flood fence would involve the placement of strainer posts above the high water mark of the waterway, stringing a 10mm cable between the strainer posts and hanging appropriate lengths of chain or steel rods vertically off the cable. The flood fence is electrified using a simple solar powered energiser to discourage livestock from pushing through the chains or bars. The assembly can move, without catching debris in high flows and fall back into position when flows subside.
