Bridge Creek Rehabilitation (McLauchlan) Year 3

PROJECT PLAN

Project No. 1112-004

PROJECT TITLE: Bridge Creek Rehabilitation Project (McLauchlan) Year 3

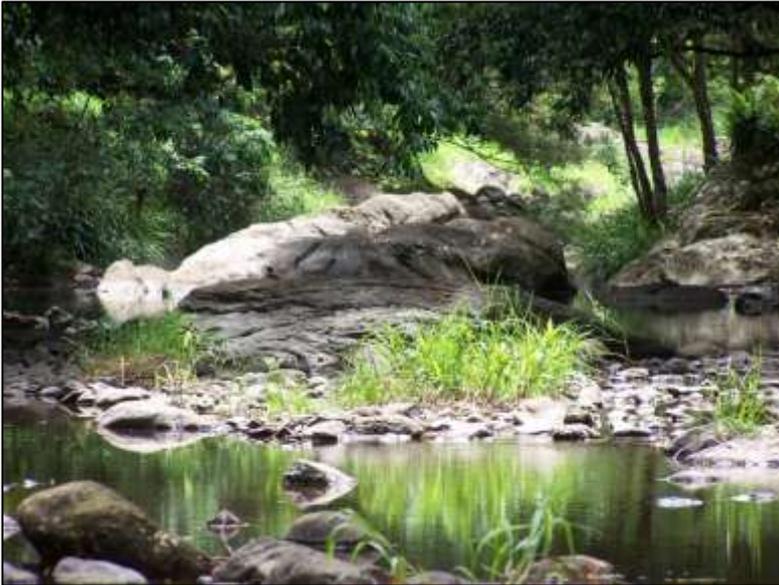
Left: Bridge Creek has good riparian vegetation and displays excellent bed diversity and bank stability. The creek however is threatened by sediment loads entering the waterway through excessive erosion in the catchment – particularly in the headwaters and first and second order streams.

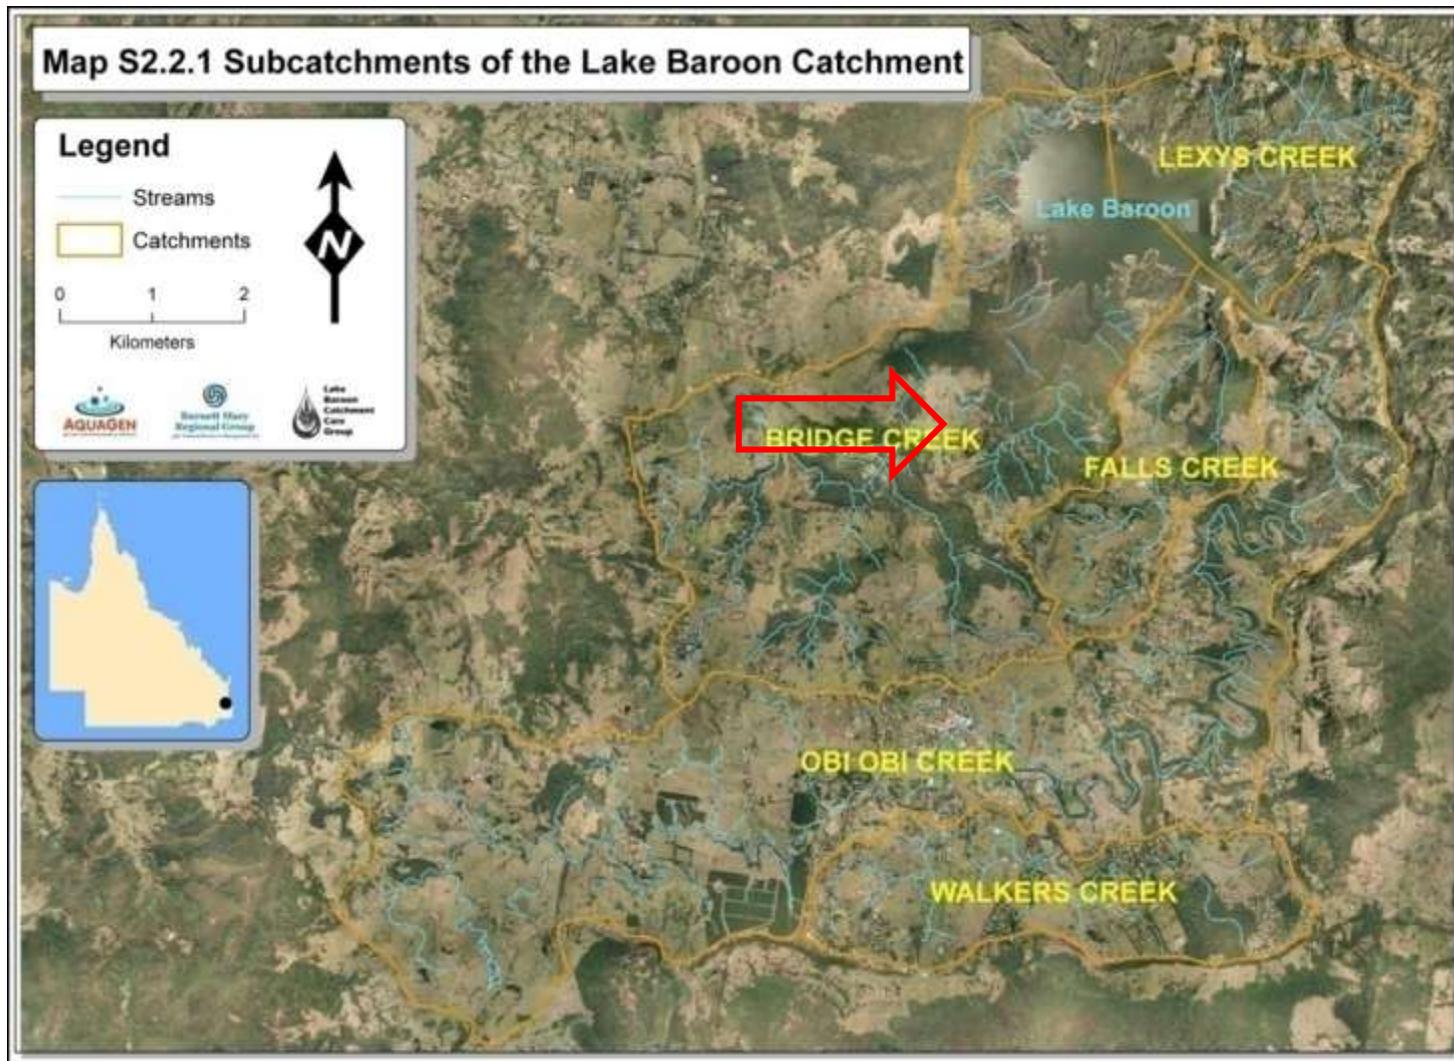
*Above: Bridge Creek forms the western sub-catchment of Lake Baroon.
The McLauchlan property is situated on Bridge Creek immediately before it enters Lake Baroon.*

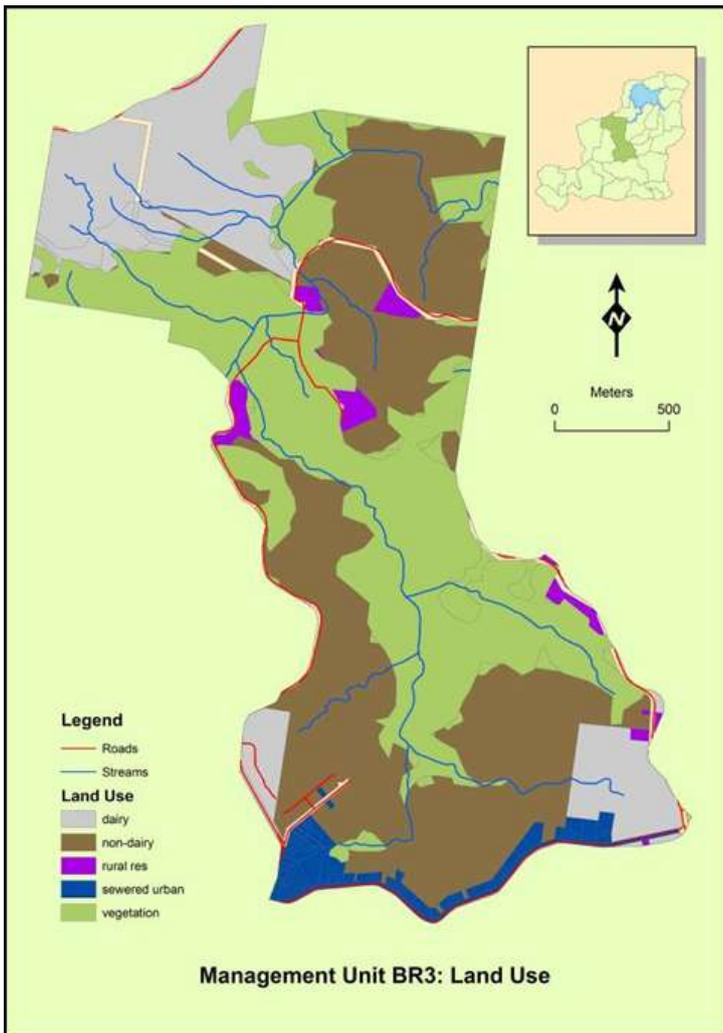
The proposed project is located within Management Unit BR3. This MU is 518 ha in size and has 14 km of significant waterways. Riparian vegetation is present alongside 40% of the waterway length, although much of this is in a degraded condition from environmental weeds.

Above: The Bridge Creek catchment is experiencing a rapid shift from livestock grazing (dairy and beef) to rural residential land use (no dairies remain in the catchment), and several urban developments in the headwaters.

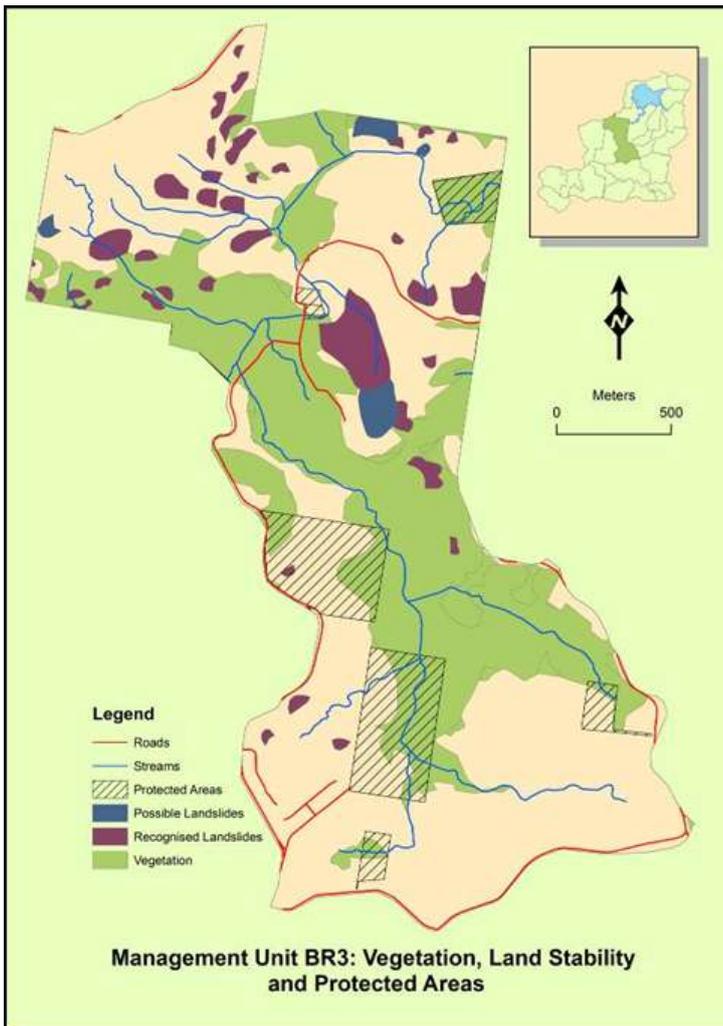
The lower reaches of the Management Unit however, are very prone to slips and mass movement.

Above: The lower part of the MU is particularly unstable (upper part of figure).

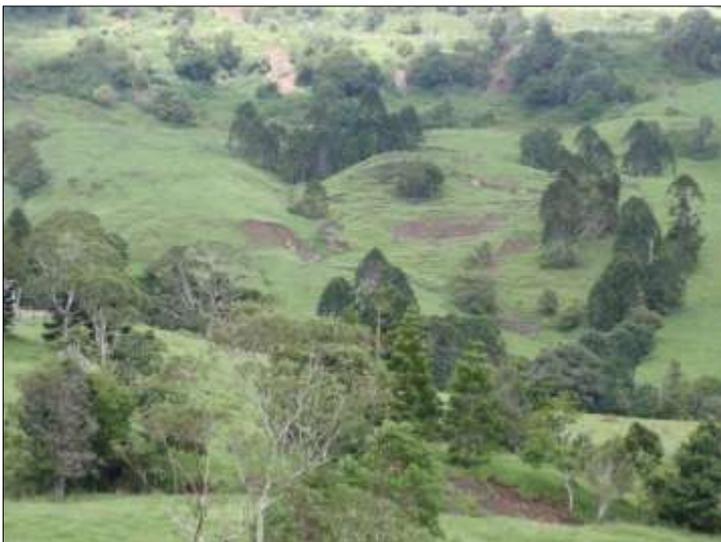
Left: Mass movement in the middle reaches of Bridge Creek

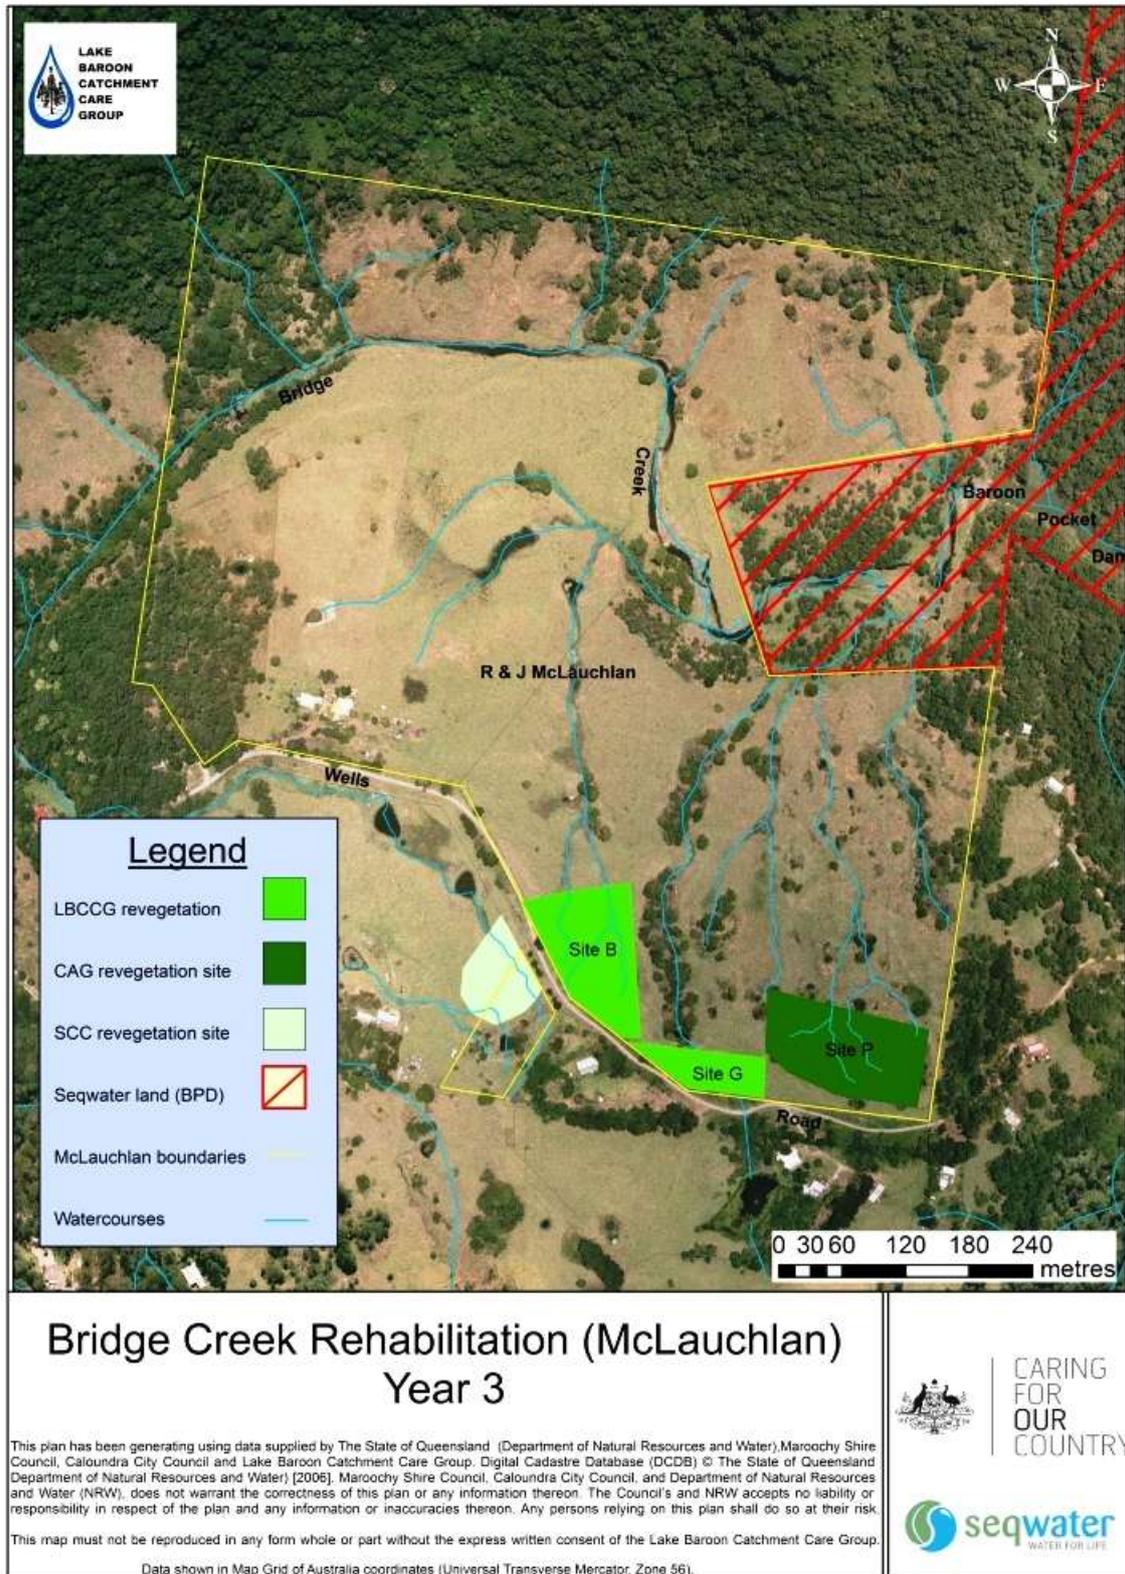
Above: Project Overview – revegetation sites requiring maintenance.

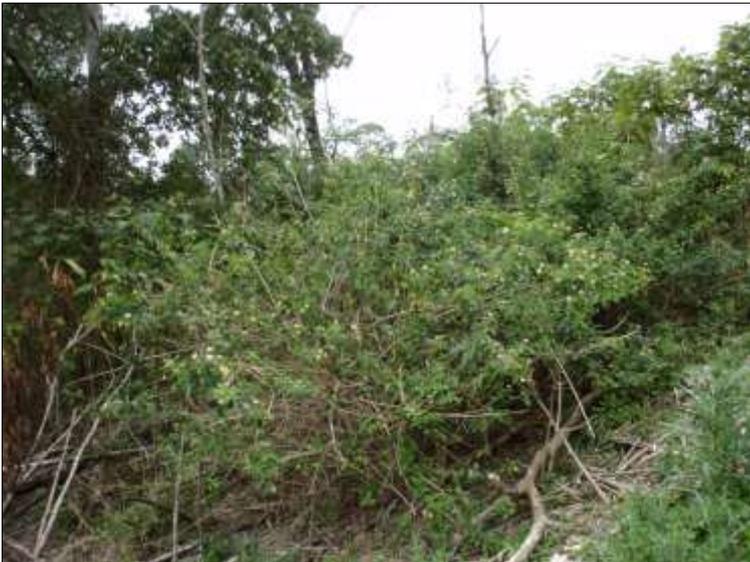
Above: The Community Action Grant site was covered in WONS weeds lantana and blackberry.

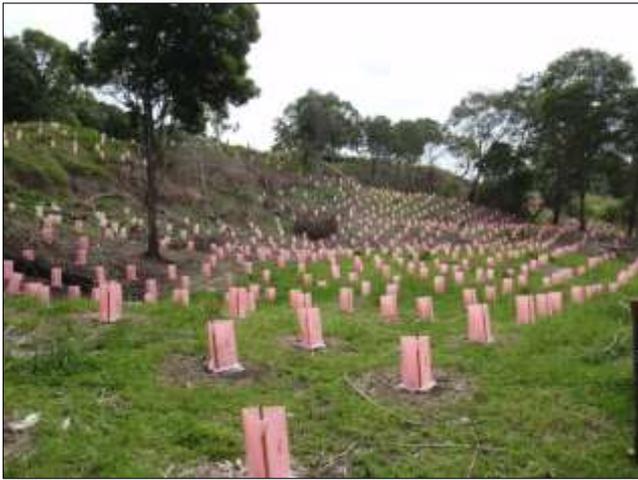
The Community Action Grant site utilised the large (680mm high) ‘Think-Pink’ corflute guards. The land-slip site (a project funded by Sunshine Coast Council and technically not a part of this project) used two litre milk cartons to provide short term protection (from wallabies and herbicide overspray). The final revegetation site utilised the smaller (350mm high) ‘Think-Pink’ guards as the majority of this site was assessed as being drier and weed growth was not expected to be excessive.

Above: 'Think-Pink' tree guards reduce maintenance costs off setting their initial high purchase and installation cost.

It is clear, despite the initial greater expense to purchase and install the 'Think-Pink' guards, that the use of these types of guards is greatly beneficial to the success of the revegetation project. The pink guards increase the visibility of plants – particularly if a maintenance visit is delayed (or missed), allow faster herbicide application around the plant by shielding the stem from overspray and protect the plant from predation. This reduces the overall maintenance cost.

At this stage it is unclear how many times a 'Think-Pink' guard can be used but is expected at least three – which will spread the purchase cost over the multiple uses.

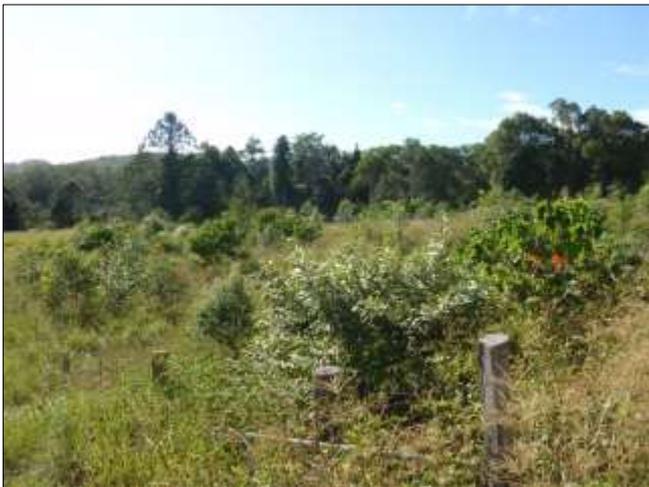
Above: Site B (2,500 plants).

A combination of guarding methods has been used on the various revegetation sites. The largest site (2,500 tube-stock) was initially unguarded, however predation by wallabies prompted retro fitting of plastic sleeve guards on susceptible species.

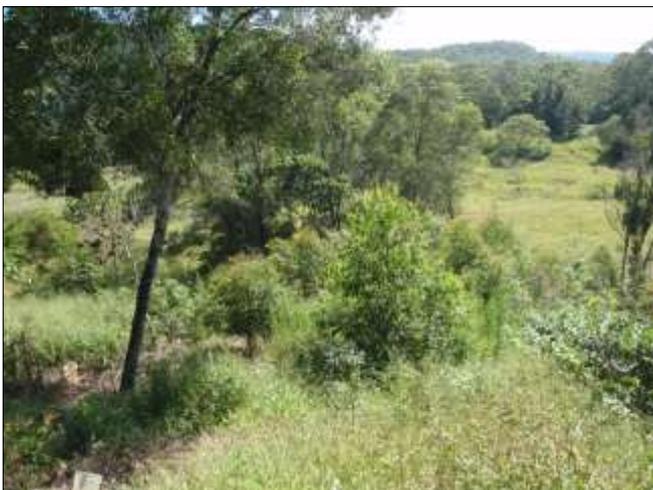
Above: Site P - CAG (1,300 plants).

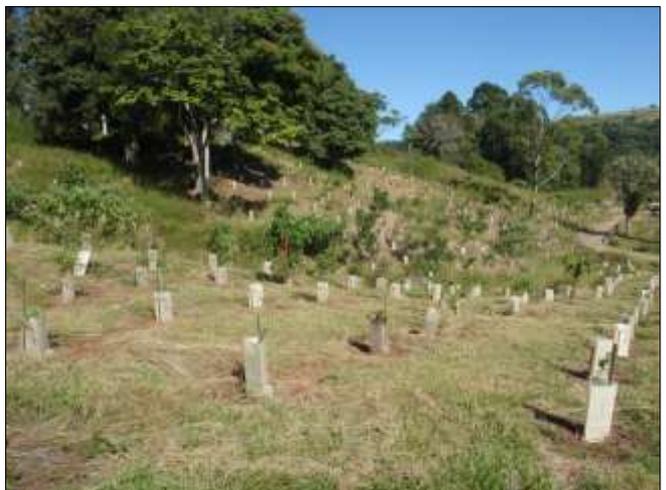
Above: Site P (700 plants).
