Bridge Creek Rehabilitation (Watter)

Lake Baroon Catchment Care Group

**Prepared by Mark Amos
Catchment Coordinator
Lake Baroon Catchment Care Group
Project No. 0910-007**

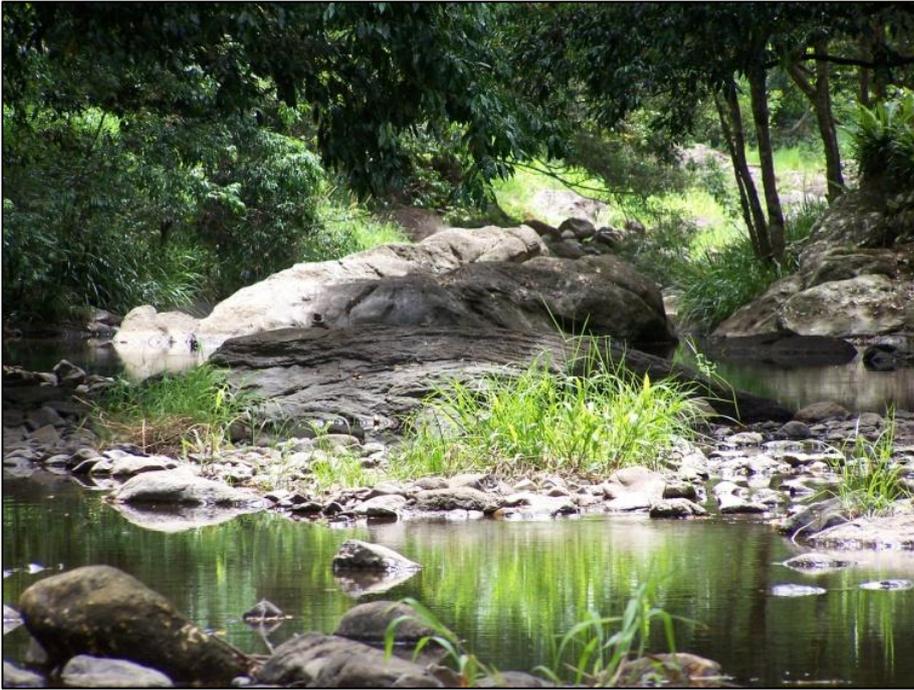
Figure 1: Bridge Creek near the River School. The waterways generally have good riparian vegetation, with excellent bed diversity and bank stability. The creek however is threatened by sediment loads entering the waterway through erosion in the catchment.

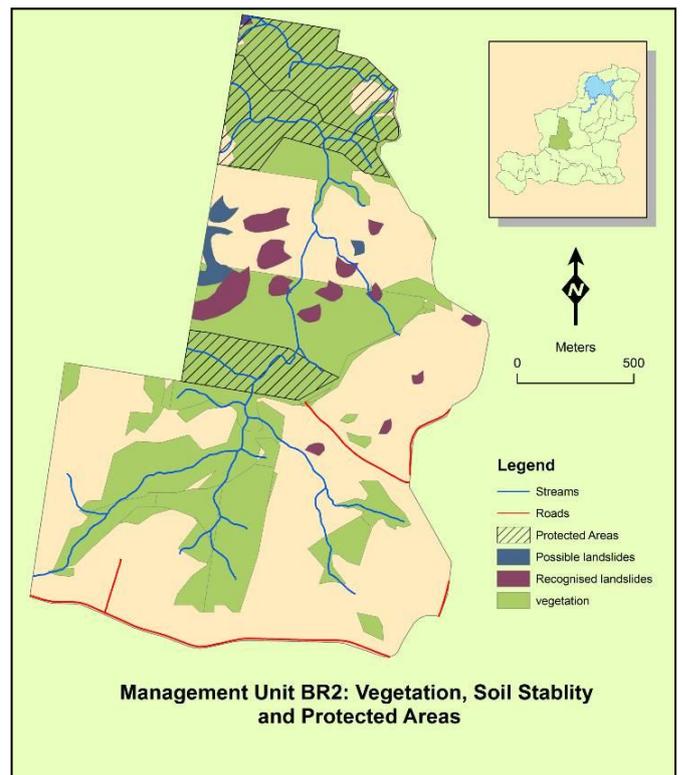
Figure 4: This map shows BR2's instability and likelihood of suffering mass movement (land slides & slips). The proposed project site is now relatively stable due to good property management and can be successfully rehabilitated.

The Bridge Creek catchment is recognised as being prone to mass movement (land slides & slips). This property has had minor landslips in the past, however recent good property management has left the property stable and suitable for revegetation. The geology of the property (and most of the Bridge Creek catchment) however, results in numerous springs on the property that continually provide waterlogged areas which are frequented by livestock which 'pug' the soils and results in the loss of soil during rainfall events.

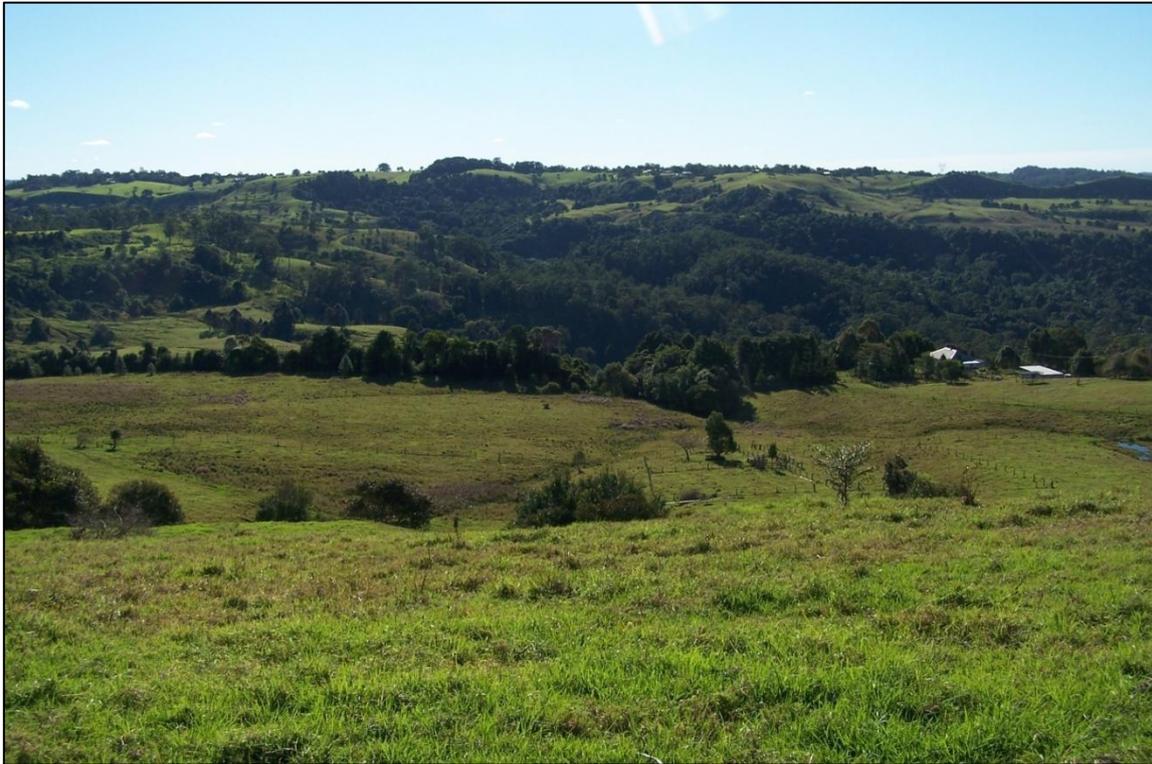
Figure 5: The Watter property from Bridge Creek Road. A steep slope on the eastern side leads to fertile flats on the western side of the property. Three distinct waterways split the property from east to west.

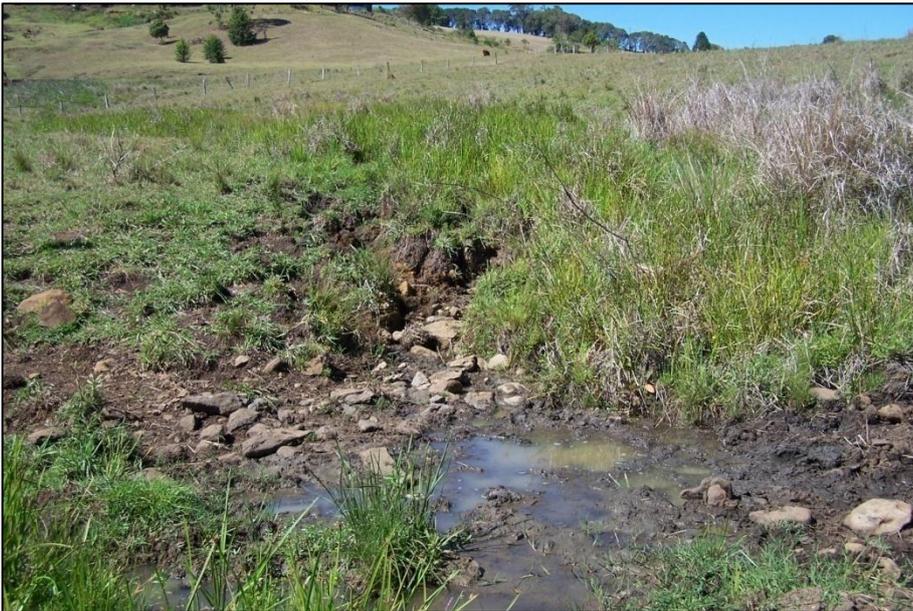
Figure 6: Uncontrolled livestock access to the main waterway on the property has left it degraded and eroding – sediments and nutrients flow downstream to Bridge Creek and ultimately Lake Baroon.

The main waterway on the property has uncontrolled livestock access and combined with the lack of soil binding vegetation, results in bank and bed erosion and the transport of sediment and nutrients from the property to Bridge Creek. Despite this, the waterway still retains isolated pockets of native sedges and aquatic vegetation which, if livestock was excluded, would relatively quickly form an effective filter to trap sediments and nutrients. Revegetation of the banks of the waterway would provide further stabilisation and provide habitat and biodiversity.

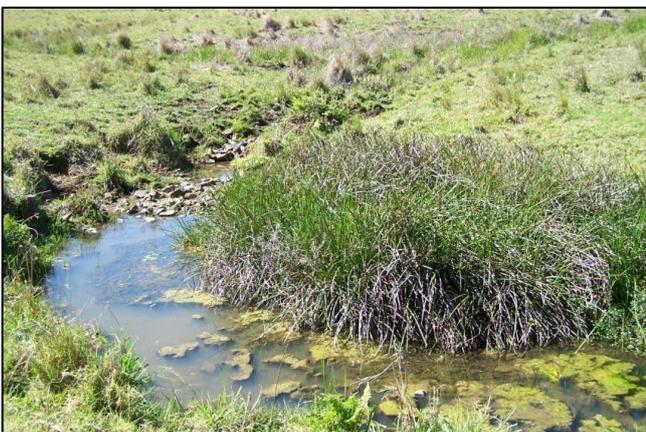
Figure 7: Even during the driest part of the year, the waterway has flows. Despite the degradation to the waterway, native sedges and rushes persist. Fencing of the waterway will exclude livestock; allow the existing vegetation to spread and provide an effective filter and revegetation will buffer overland flows.

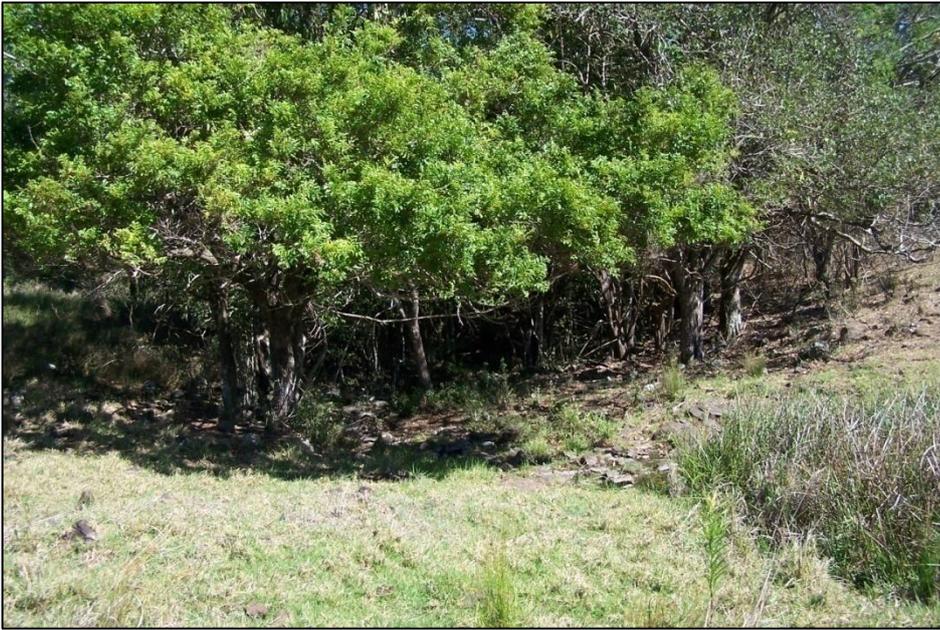
Figure 8: The remnant vegetation at the downstream end of the waterway. Note the bedrock crossing immediately in front of the trees – this crossing will be retained as it is very stable.

A bedrock crossing will be retained at the downstream end, immediately before the waterway enters the remnant. Planting of the waterway will be carried out over a period of three years to ensure the landholders can effectively manage maintenance.

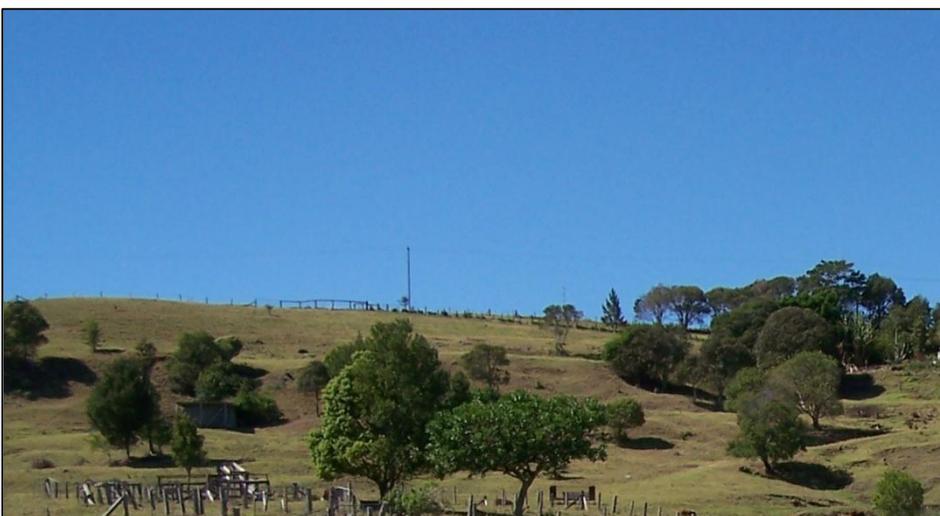
Figure 9: The slope in the centre of the photo can be clearly seen as a brown area, indicating the poor pasture condition caused by excessive hill slope erosion and thin topsoil. Eroded material is washed into the waterways of the property.

A steep slope on the eastern side of the property has unrestricted livestock access and has become a livestock ‘camp’ due to the presence of scattered native and non-native trees. Pasture coverage is poor due to the heavy grazing pressure by livestock and the thinness of topsoil resulting from continual hill-slope erosion. Sediment (and nutrients) from this area ‘flow’ off this hill-slope during rainfall events, entering waterways on the property, resulting in sediment ‘slugs’ forming, which further contributes to the water logging of the waterways.

Fencing would enable pasture to re-establish, forming a protective covering, minimising erosion and nutrient transfer. Furthermore natural regeneration by native tree species (currently regeneration is not allowed to establish due to grazing pressure) will be encouraged, which can be augmented by enhancement planting if necessary, once regeneration rates are known.

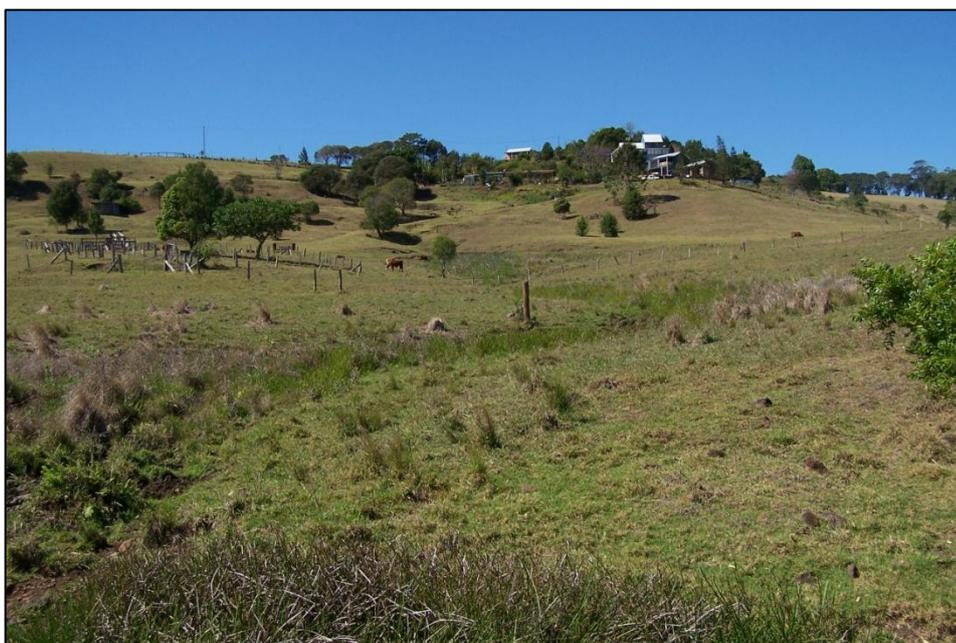
Figure 11: The main waterway on the property and Revegetation Area 1. Fencing to exclude livestock will run either side of the waterway and be revegetated with appropriate species. Note the sedges growing in the waterway.

The main waterway on the property will be fenced to exclude livestock and revegetated over a three year period with appropriate species to provide a vegetative filter/buffer from paddock run-off, stabilise the bed and banks and retain existing sediment on site. Included at the downstream end of the fencing will be a small area of remnant vegetation.

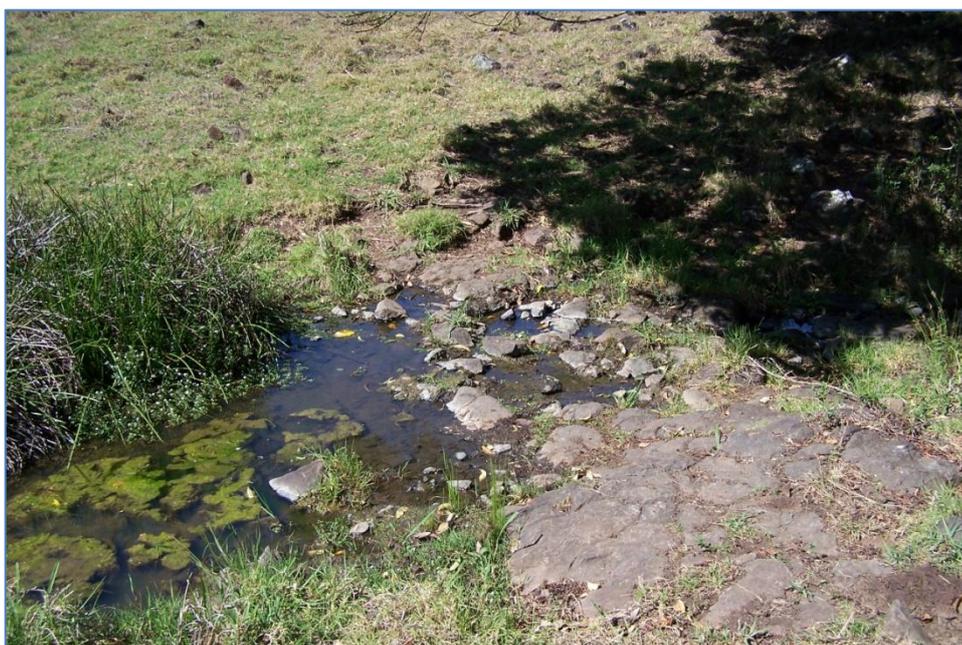
Figure 12: Bedrock crossing that will be retained for access to the northern side of the property. Note the effectiveness of the rock bar at halting previous head-ward erosion.

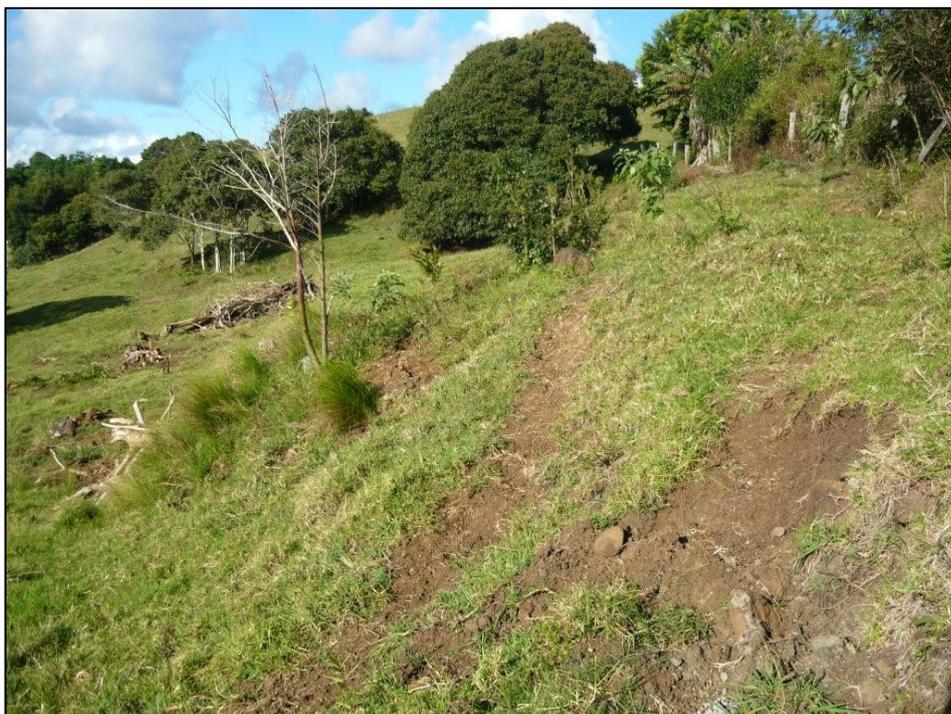
Figure 13: The steep hill-slope requiring fencing to exclude livestock and allow pasture to re-establish and stabilise. Revegetation of the slope can be completed once the level of natural regeneration is determined.

Fencing to exclude livestock will allow existing pasture to recover and provide stabilisation of a steep eroding hill-slope. Water quality downstream is impacted by sediment and nutrient run-off from the slope. The area has scattered native (*Mallotus* sp.) and exotic trees (Privet and Coral) which improve stability but also attract livestock seeking shade and shelter, thus contributing to further erosion.

Natural regeneration is expected to occur (currently any regeneration is affected by livestock) and will be enhanced with revegetation in the second and third years of the project. This is to allow stabilisation by pasture initially before any revegetation attempts.
