**LAKE
BAROON
CATCHMENT
CARE
GROUP**

Ruddle Dairies Laneway Rehabilitation

PROJECT PLAN

Project No. 1112-006

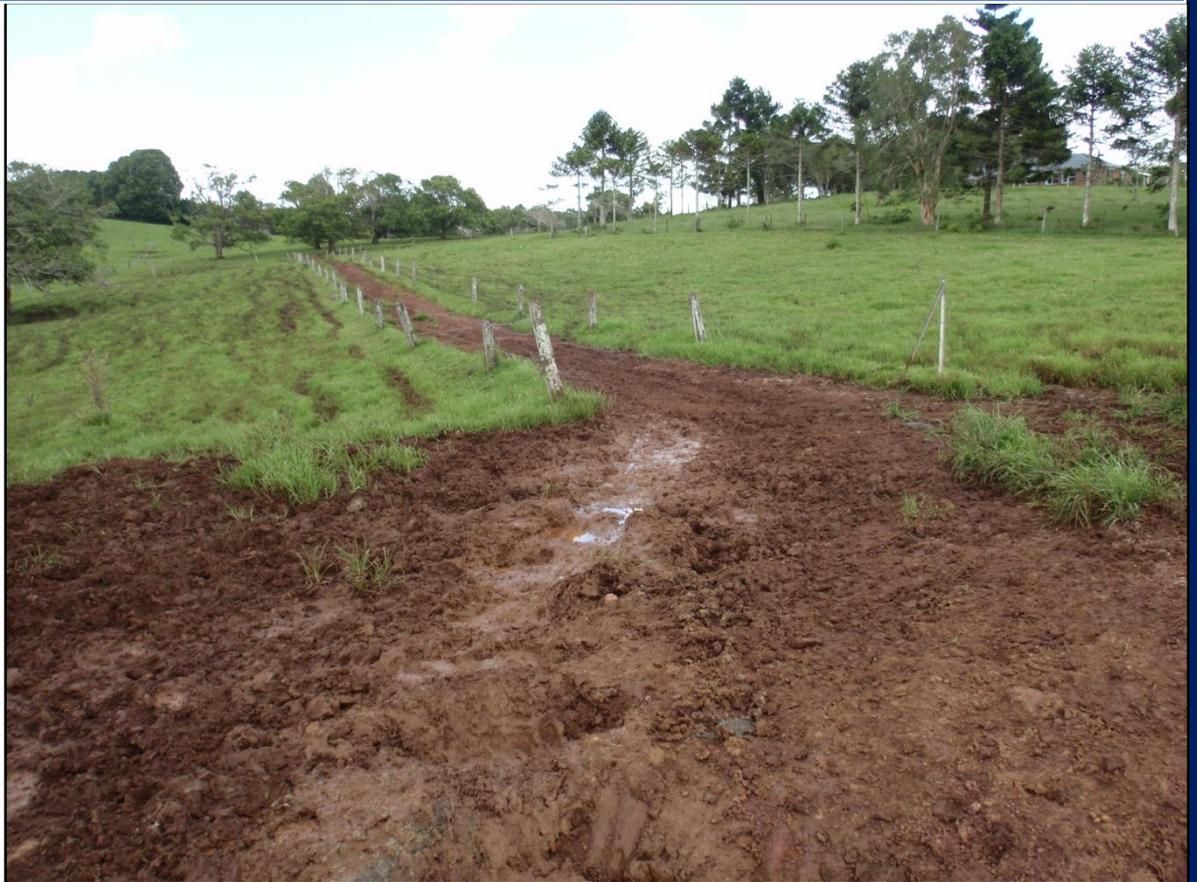
Cover photo: Eastern laneway on Ruddle Dairies.

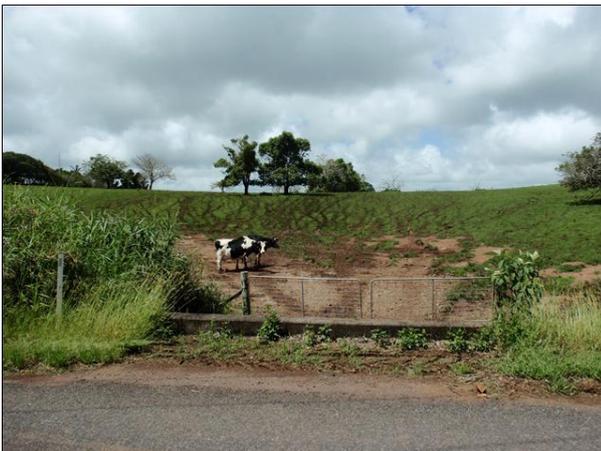
Left: The lack of a formal laneway results in multiple tracks forming and erosion over a wide area.

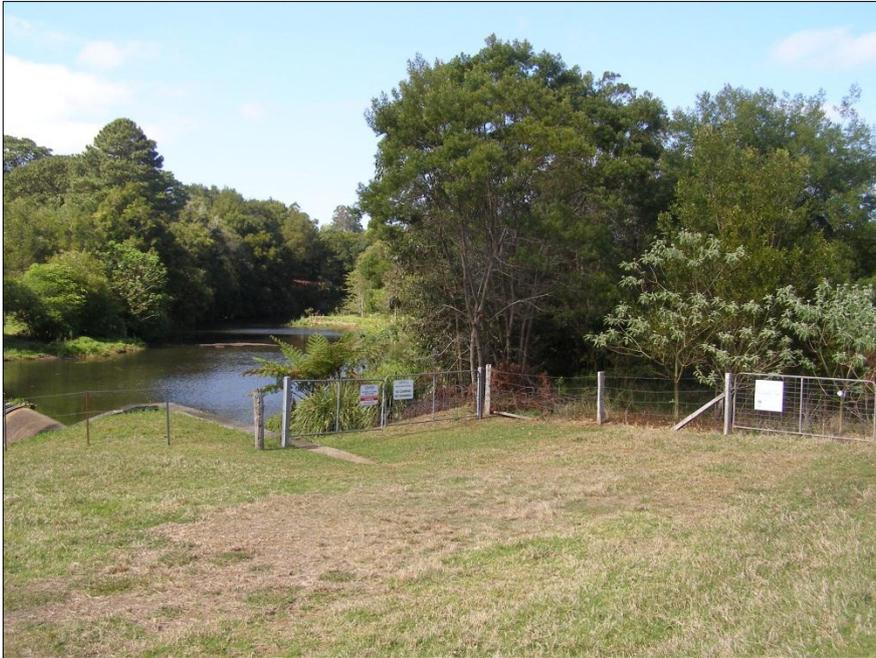
Left: Obi Obi Creek is the largest sub-catchment of Lake Baroon. Maleny's water supply comes from two weirs on the waterway – the proposed project is in the headwaters of the waterway; upstream of King's Lane Weir. This reach of Obi Obi Creek is threatened by sediment and nutrient loads entering the waterway through erosion in the catchment.

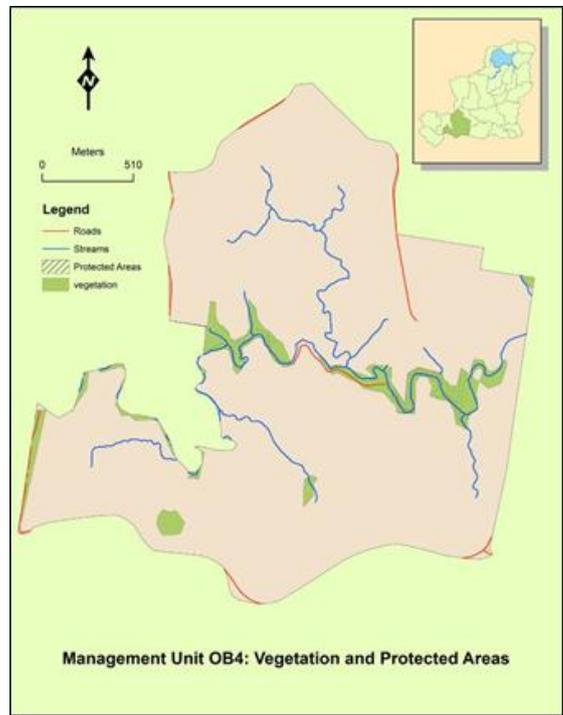
Above: The MU is geologically stable; however the lack of riparian vegetation contributes to the high nutrient inputs to the catchment’s waterways.

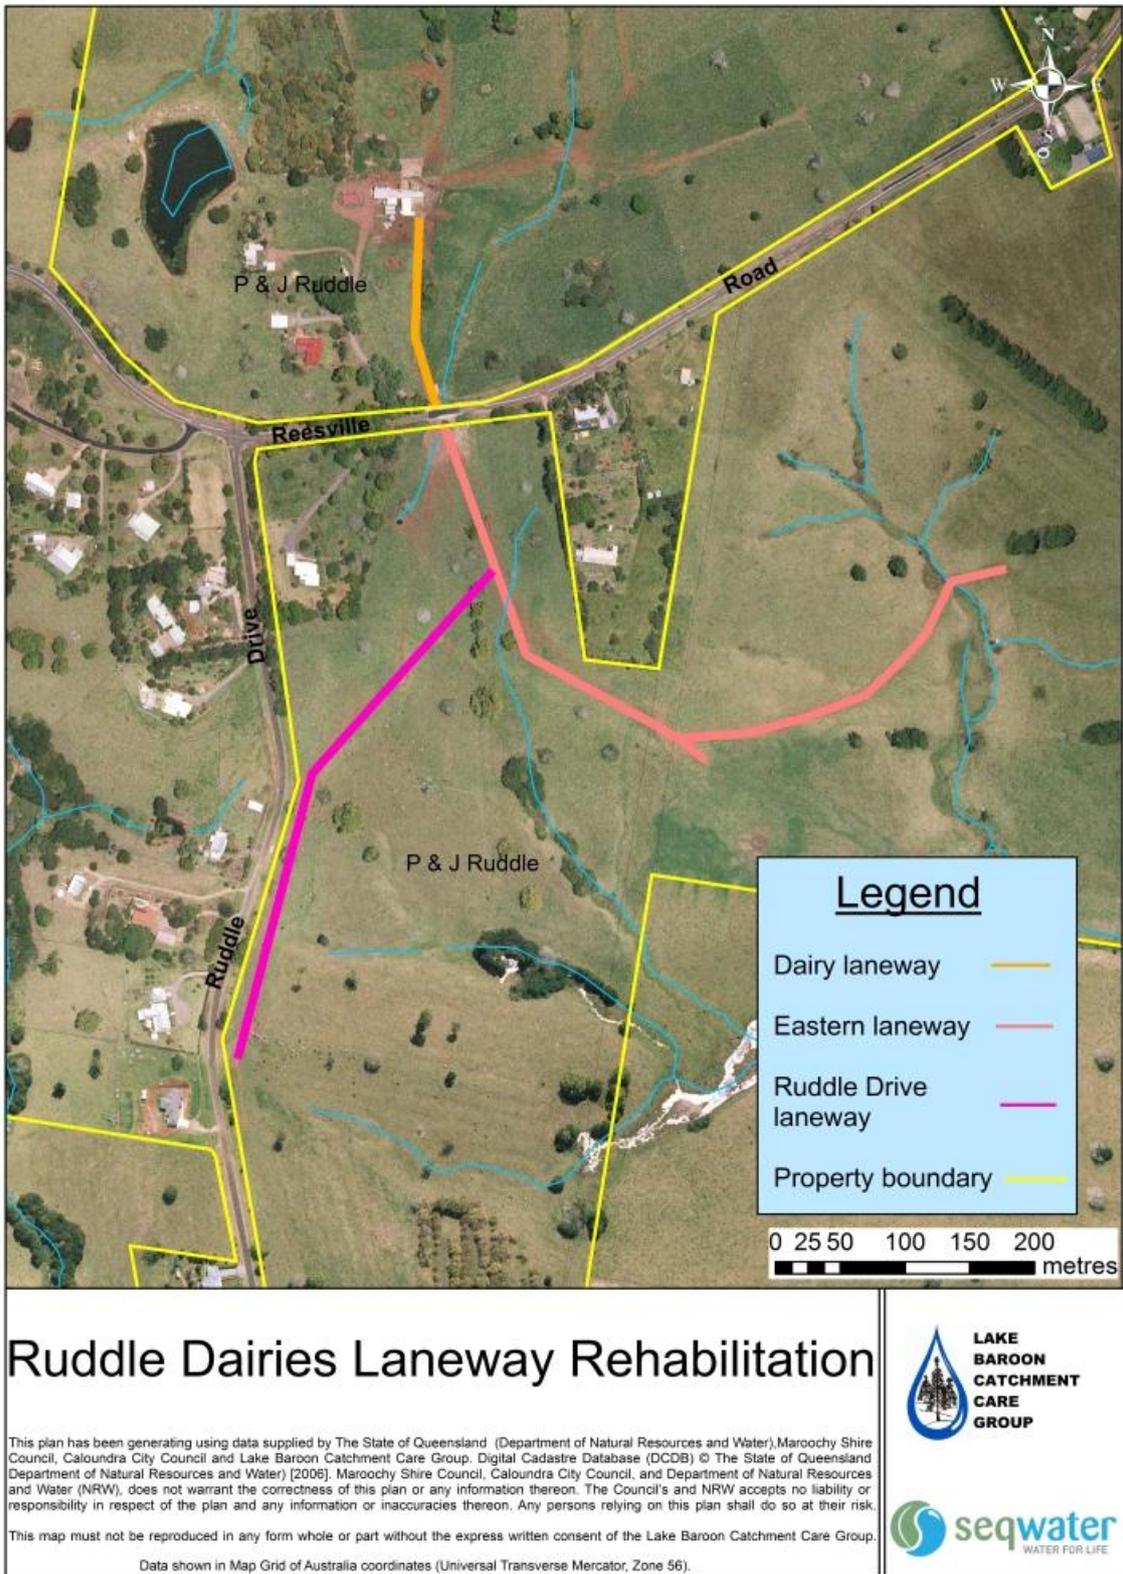
Above: Project Overview - proposed on-ground works.

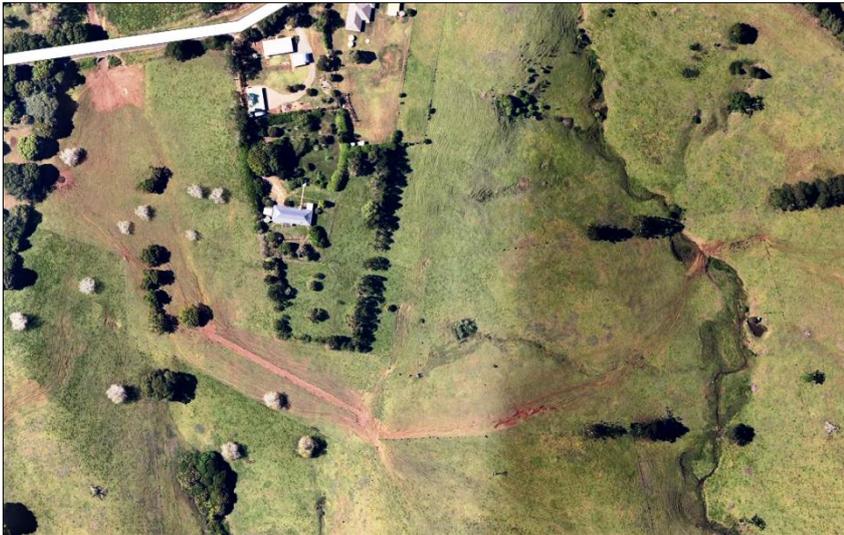
Left: The eastern laneway can be clearly seen in this 2010 aerial photo.

The eastern laneway runs from Reesville Road servicing the south eastern paddocks of the property.

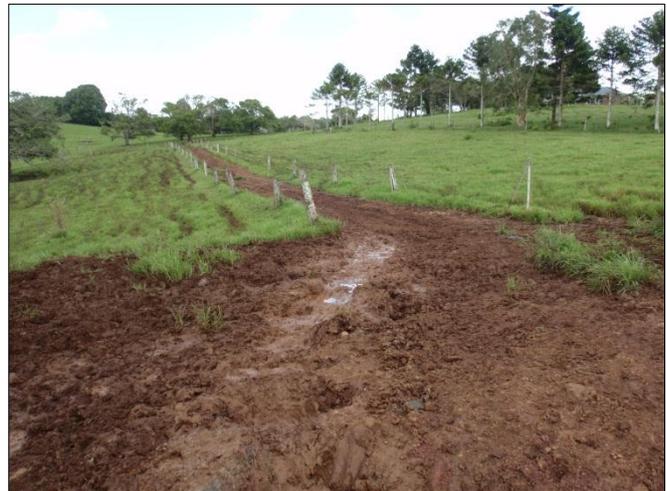
The laneway is severely degraded despite attempts in the past to harden a short section with coarse rock – which has left the laneway very uneven and hard on livestock hooves. As a consequence the laneway does not effectively shed water resulting in deep muddy holes and livestock reluctance to use it. A wider, unhardened laneway adjacent is used when the main laneway is un-trafficable resulting in significant erosion of topsoil.

Above: The eastern laneway suffers from poor drainage.

The laneway requires significant re-shaping to improve run-off and the placement of pipes to divert paddock flows safely onto pasture that can filter sediments and manures.

Road-base and compaction will harden the laneway reducing erosion and resultant sediment and nutrient run-off.

This laneway will be constructed to a width of four metres to allow sufficient passage for the large herd.

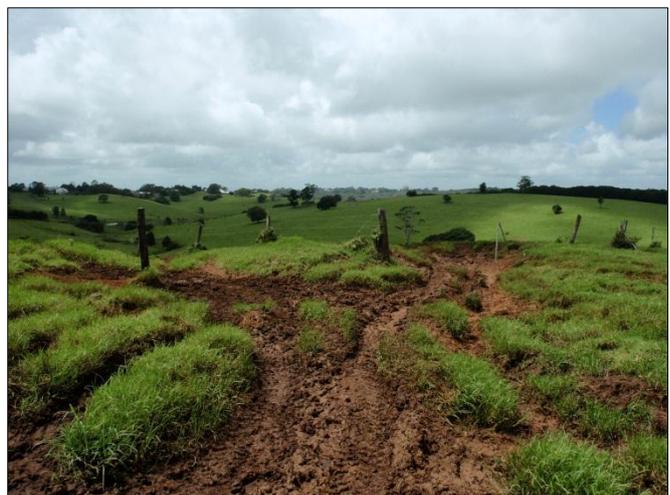
Right: A poorly drained gateway mid-way along the eastern laneway.

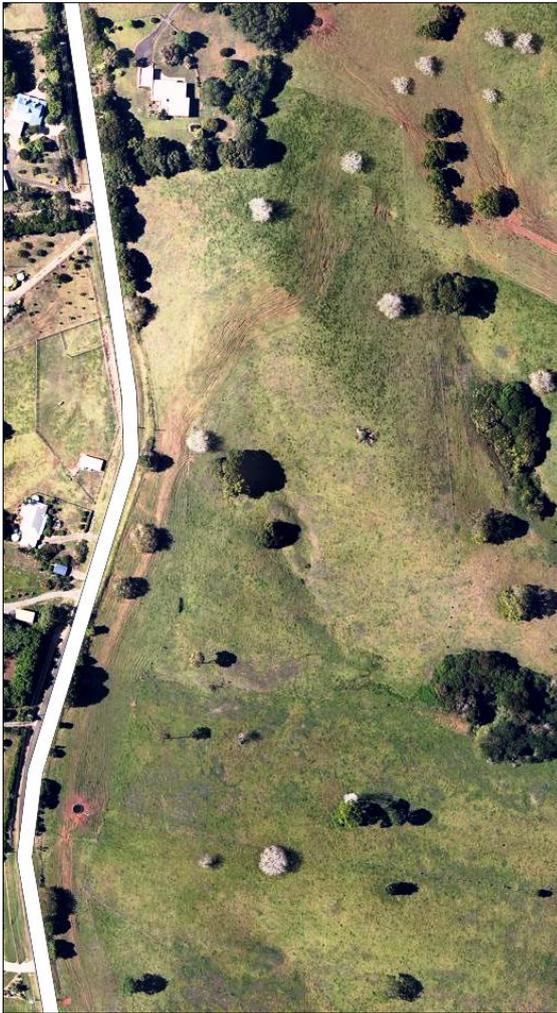
The Ruddle Drive laneway branches from the eastern laneway and runs parallel to Ruddle Drive servicing the southern paddocks on the property.

Left: The Ruddle Drive laneway can be clearly seen in this 2010 aerial photo.

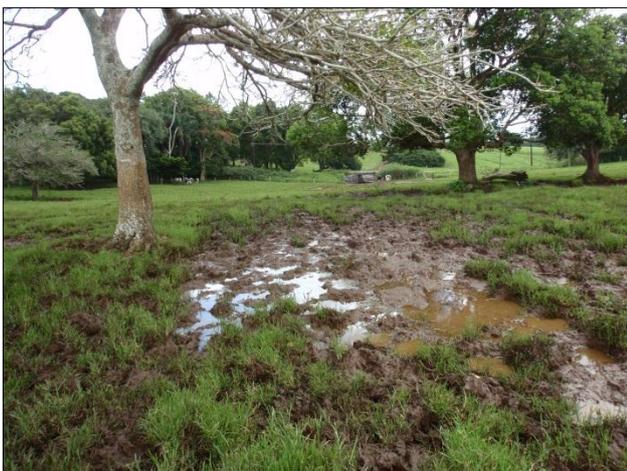
The laneway has been partially hardened in the past and therefore will cost less to rehabilitate. The laneway requires re-profiling to improve drainage and a skin of road-base to eliminate channelling and reduce erosion.

Above: The Ruddle Drive laneway in places suffers from very poor drainage.

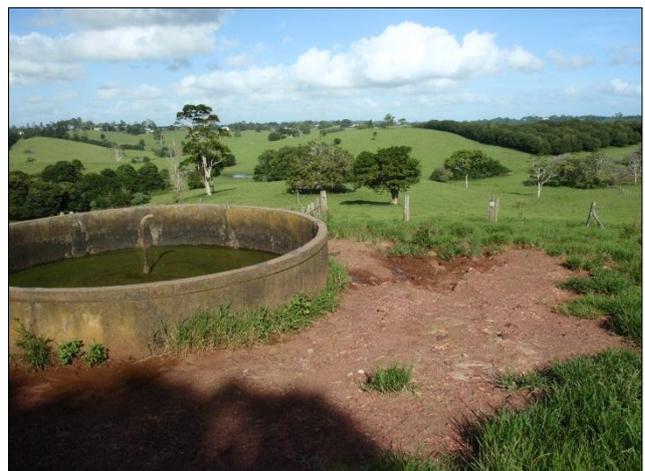
A water trough near the end of the laneway requires several loads of road-base to reduce erosion.

Above: The stock trough near the end of the laneway requires road-base placed to reduce erosion.

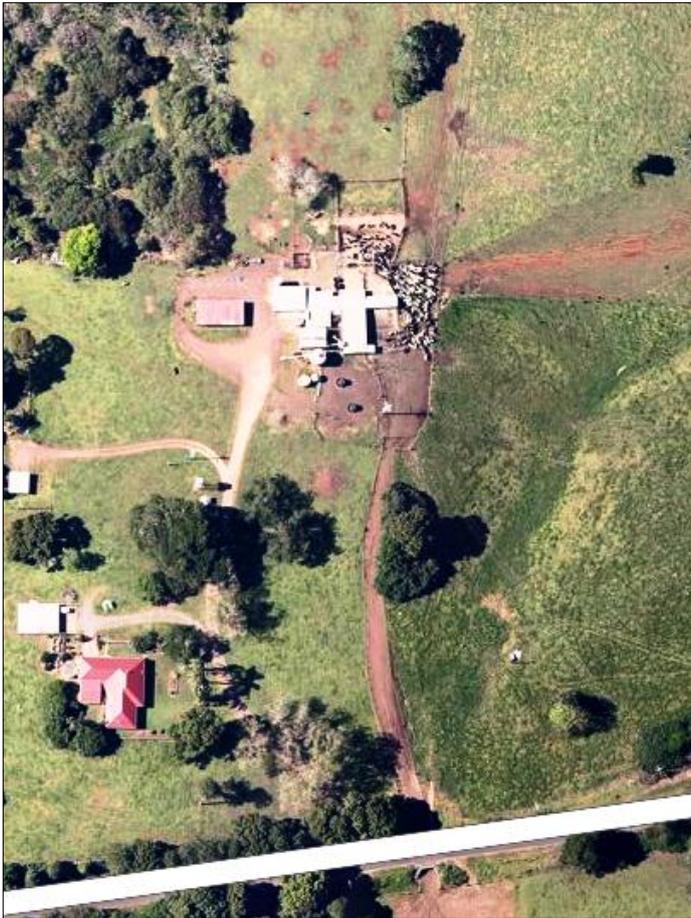
Above: The dairy laneway can be clearly seen in this 2010 aerial photo.

The dairy laneway links the property on the southern side of Reesville Road to the dairy.

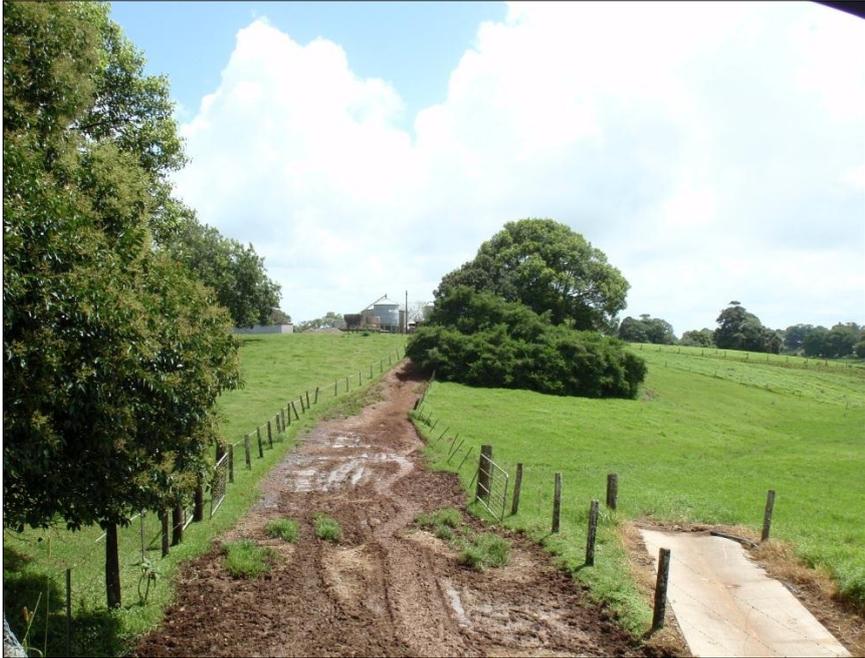
Left: The dairy laneway

This laneway receives the heaviest traffic and therefore requires significant and regular rehabilitation and maintenance.

Road-base and compaction will harden the laneway reducing erosion and resultant sediment and nutrient run-off.
