Bridge Creek Rehabilitation

FINAL REPORT

Caring For Our Country Community Action Grants 2009-10

PROJECT NUMBER: **CAG09-00259** (LBCCG 0910-004) **DATE:** **August 2011**

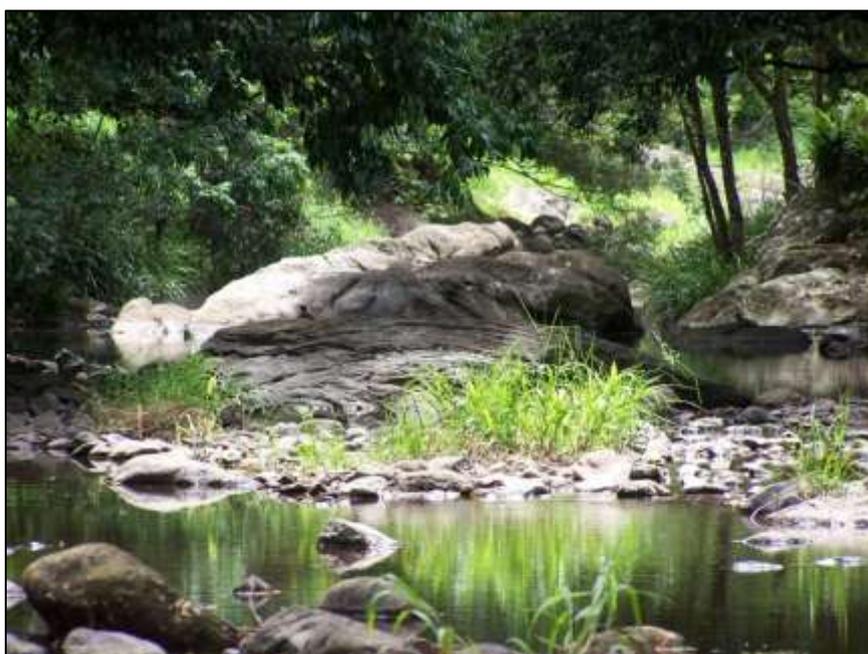
Figure 1: Bridge Creek near the River School on Bridge Creek Road. The waterways generally have good riparian vegetation, with good bed diversity and bank stability. The creek however is threatened by sediment loads entering the waterway through erosion in the catchment. Lake Baroon, the main potable water supply for the Sunshine Coast is less than 500 metres downstream from the project site.

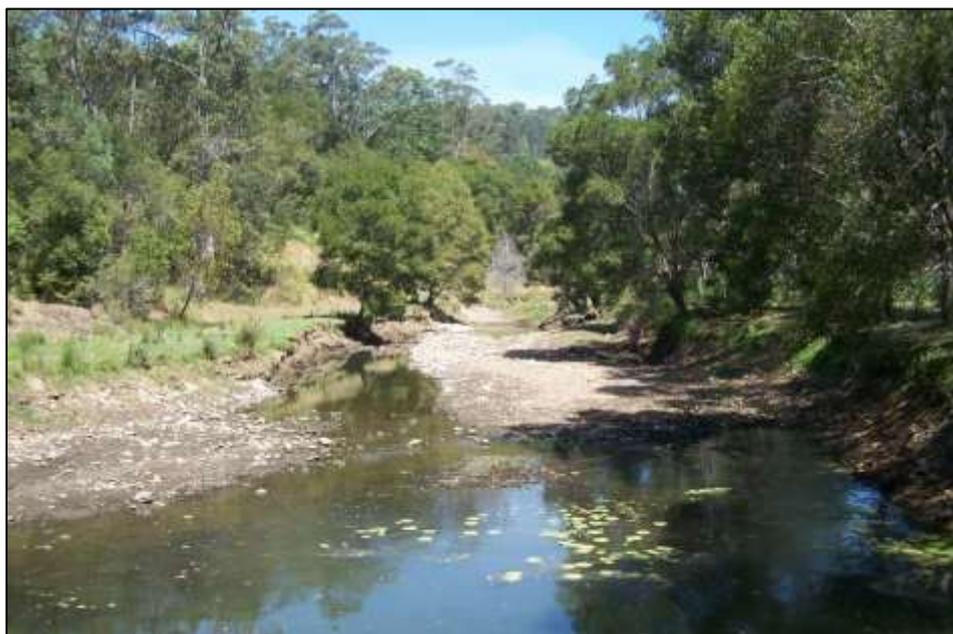
Left: Bridge Creek where it enters Lake Baroon immediately downstream of the McLauchlan property. Note the large amounts of sediment in the bed of the creek; sediment 'drops' out as the flow dissipates at this point where it enters the Dam.

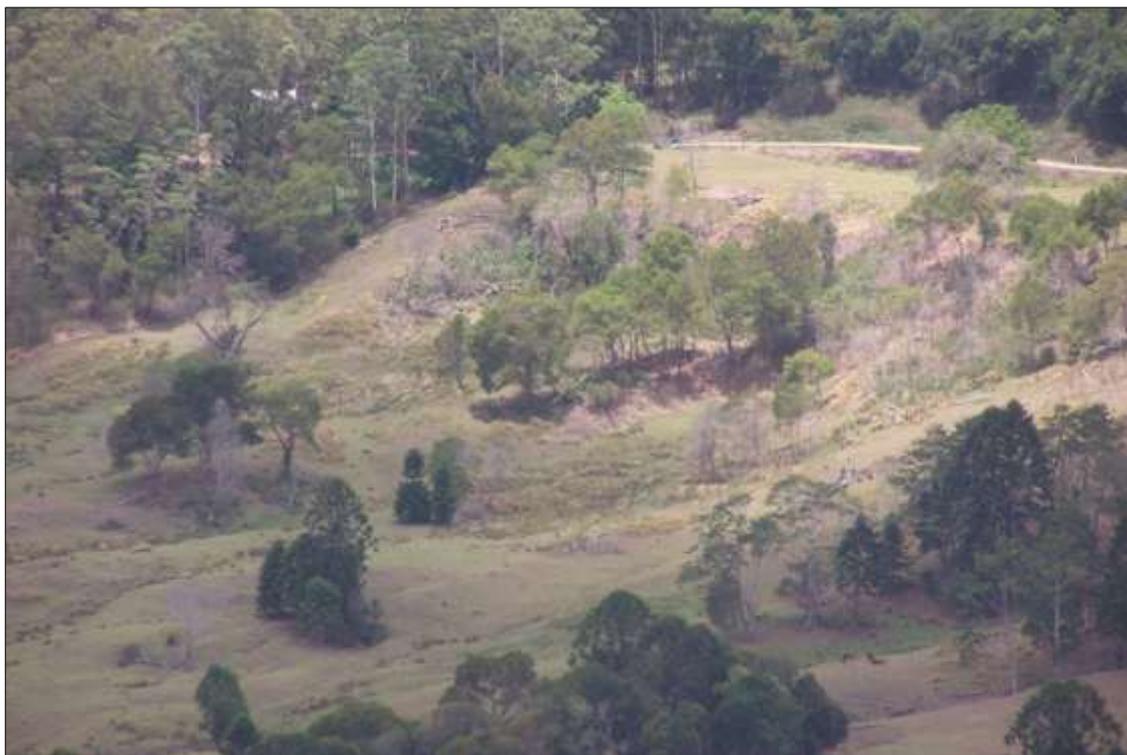
Above: The project site from Tesch Road, Witta (December 2009- pre-work).

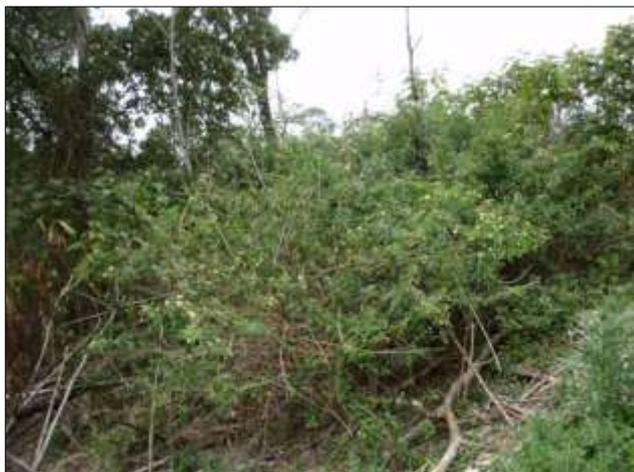
WoNS Lantana

Initial weed management involved spraying by the landholder to control the lantana and other environmental weeds. Spraying killed approximately fifty percent of the infestation.

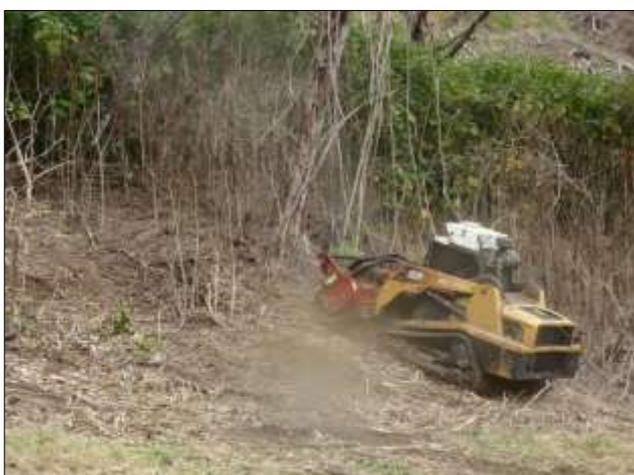
Skid-steer mounted mulcher clearing site

A skid-steer mulcher was used to mulch the standing weeds resulting in a fine mulch layer spread evenly over the site. This method was fast, effective and cost-effective.

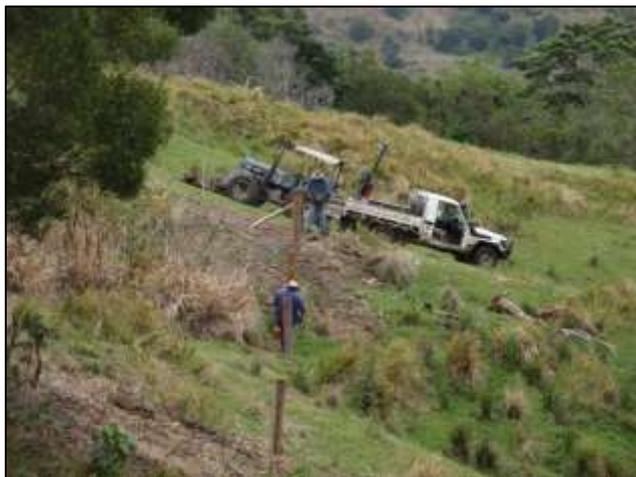
Site fencing in progress (August 2010)

Fencing was completed by a local contractor (Langdale Fencing) measuring approximately 350 metres with two access gates. Despite difficult access (steep slopes and active spring) fencing was completed within budget.

As the property runs beef cattle, the fencing consists of four strand barb with timber split posts and steel posts. This type of fencing is standard for the area.

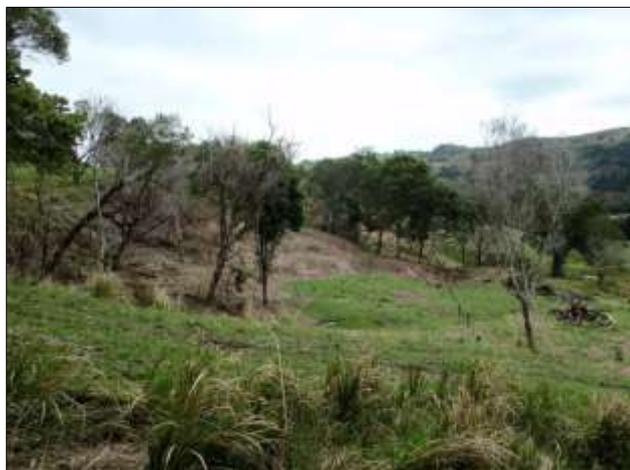
Fencing completed (August 2010)

The fencing was designed to have few changes of direction as possible to ensure a strong and cost-effective fence.

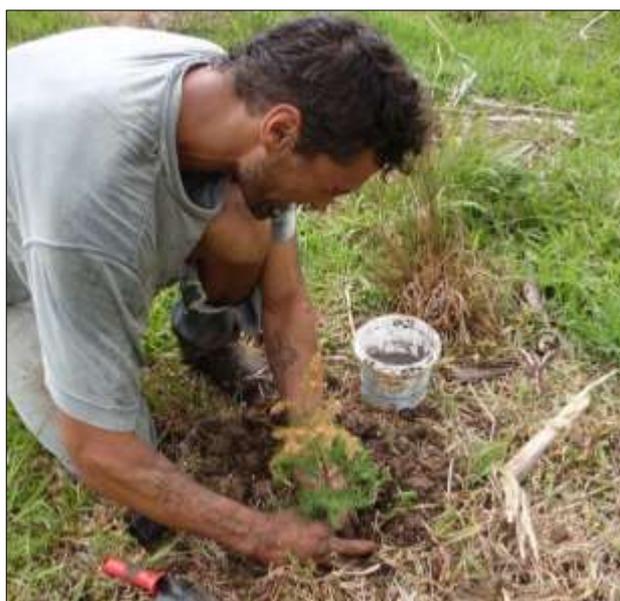
Revegetation (October 2010)

Site preparation was dictated by the fact that the site is historically unstable and prone to erosion. Therefore one metre rings were sprayed approximately two metres apart retaining as much pasture groundcover as possible. This spacing results in 1,000 plants per 4,000 m² – usually providing a shade canopy in approximately two to three years.

Planting was completed by Barung Landcare with locally sourced tube-stock. Think-pink tree guards and jute weed mats were used to protect seedlings until established. The corflute guards provide a highly visible guard from chemical overspray, weeds, frost and predation from hares and wallabies.

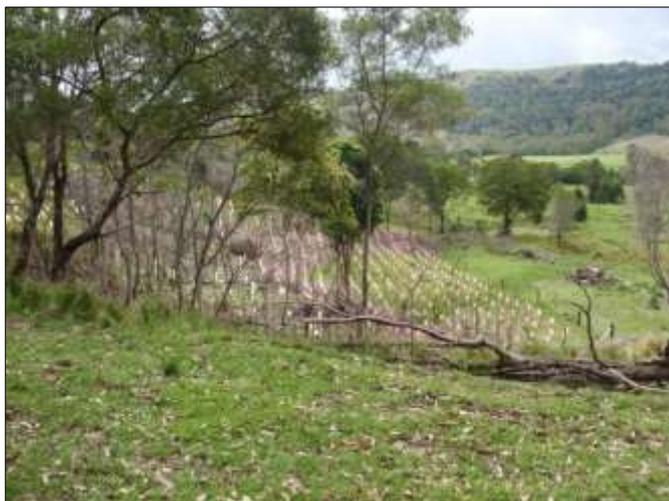
Revegetation completed (October 2010)

Initially 1,000 tube-stock were planned however 1,300 tube-stock were planted. This was due to the site being slightly larger than expected, trees planted closer to established trees than necessary and spacings closer than designed.

Despite the soils on the site having been highly disturbed in the past from land slips and waterlogging, plant establishment has been excellent. The pioneer species (particularly Brown Kurrajong, Eucalypt species and Green Wattle) have attained heights of over one metre with few losses.

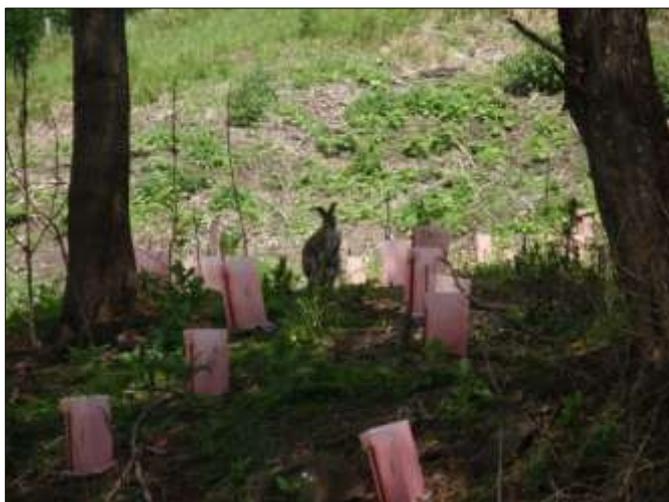
Wallaby predation (September 2010)

To compromise plant survival and growth has been the prevalence of wallabies – particularly when the grass was allowed to provide dense cover and the wallabies would remain on site day and night. Fortunately the guards have protected the establishing trees and the wallabies have merely pruned them.

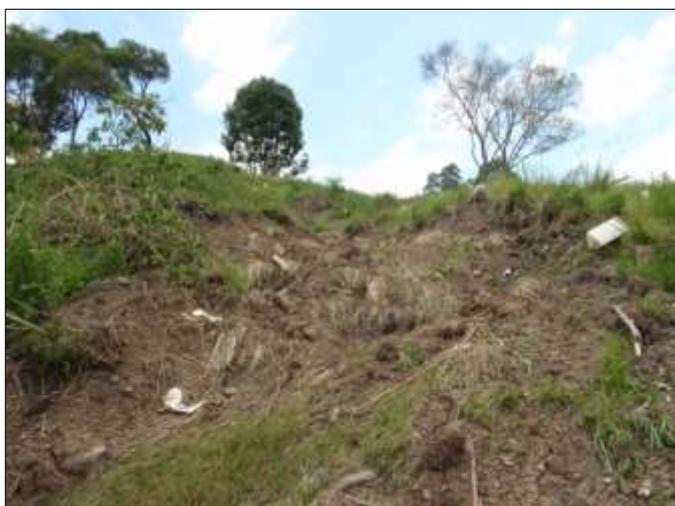
Flooding damage (January 2011)

The project site suffered significant damage during the floods experienced in January 2011. Approximately 900 millimetres of rain fell over a three day period.

The spring area at the western end of the site slipped with a debris flow moving downhill washing out approximately 40 trees and damaging around 40 metres of fencing. With access to the site to repair the fencing impossible due to the extremely wet conditions, temporary electric fencing was installed to cover the damaged area. This work was completed by National Green Jobs Corps participants who also collected the tree guards that had been damaged by the debris flow.

At the eastern end of the site water flow from Wells Road washed out a further 40 metres of fencing (cutting a one metre deep gully), including a gate, and approximately 25 trees.

The resultant sediment was deposited on the revegetated flat engulfing a further 100 trees – although many of these plants were not immediately washed away or killed, they succumbed to suffocation.

Fencing repairs and re-planting of tube-stock that were killed by the January floods will be completed in September 2011 by the Lake Baroon Catchment Care Group and the landowner. There are plans to extend the area and continue revegetation in an effort to increase the size of the site and stabilise further areas.
