**LAKE
BAROON
CATCHMENT
CARE
GROUP**

Bridge Creek Rehabilitation (Watter) Year 4

PROJECT PLAN

Project No. 1213-007
(0910-007)
(1011-007)
(1112-007)

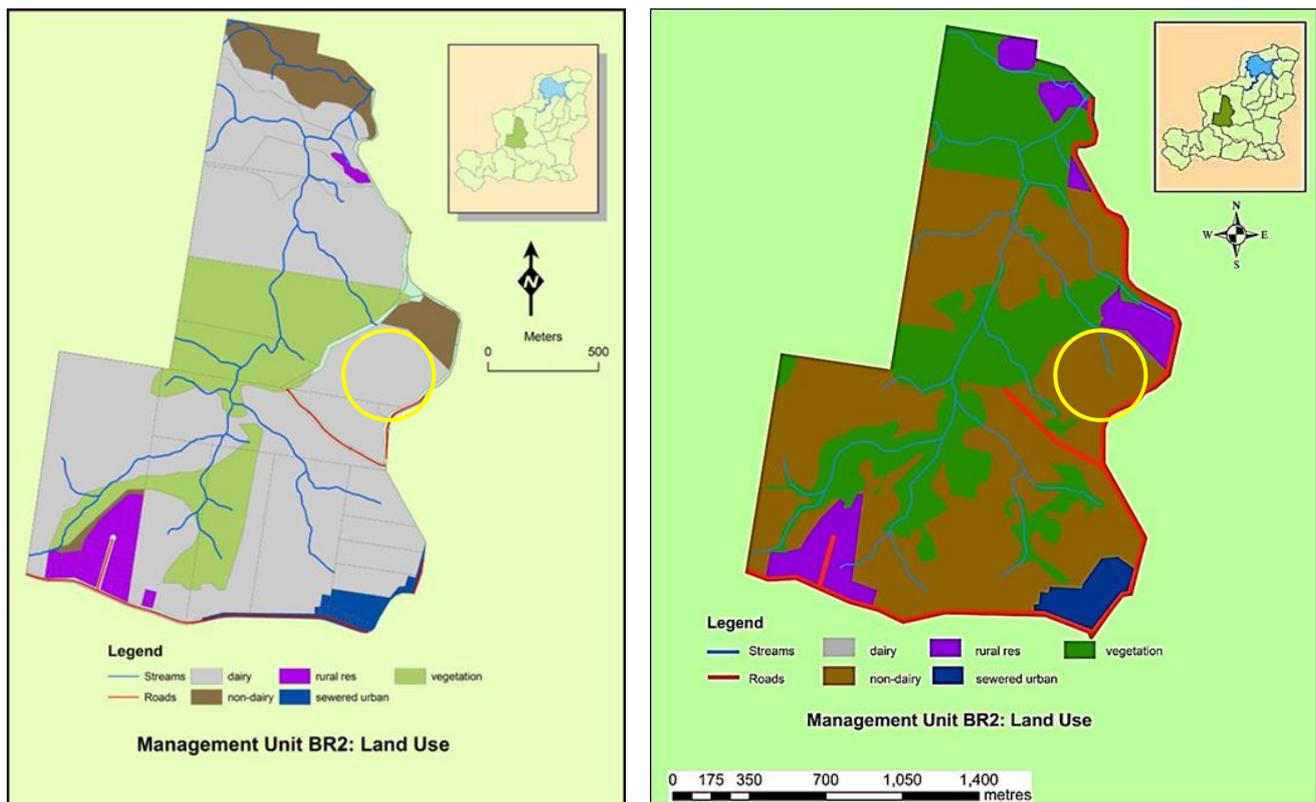
Above: Mapping from 2007 (left) and 2013 (right) highlighting the dramatic changes in land use. In 2013 there are no dairies (or dairy grazing) remaining in the upper Bridge Creek catchment. There has been further urban development in Maleny, and the rural residential growth in the catchment has led to an increase in vegetation. Beef grazing remains the primary land use in the catchment. Project site location highlighted in yellow.

In the early 2000s land use changed dramatically (declining agricultural returns and particularly dairy deregulation), with the loss of all dairy grazing (replaced partially by less intensive beef grazing) and sharp increase in rural residential properties. Vegetation (a large percentage weed species) is returning to once largely cleared properties.

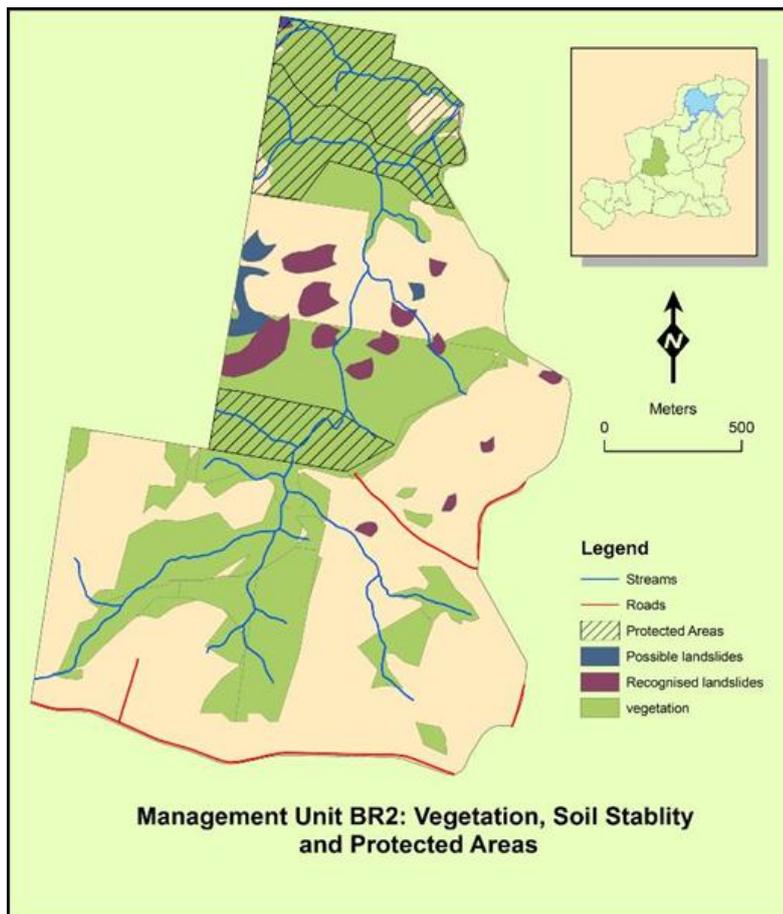
The catchment is characterised by its steep slopes, lack of vegetation in the headwaters, and the inability of the soil to absorb nutrients and moisture.

The middle reaches of the Management Unit have areas prone to slips and mass movement – the most obvious occurring on the Cork property which is immediately downstream of the Watter property.

Left: The Watter property is situated in the middle right of the figure.

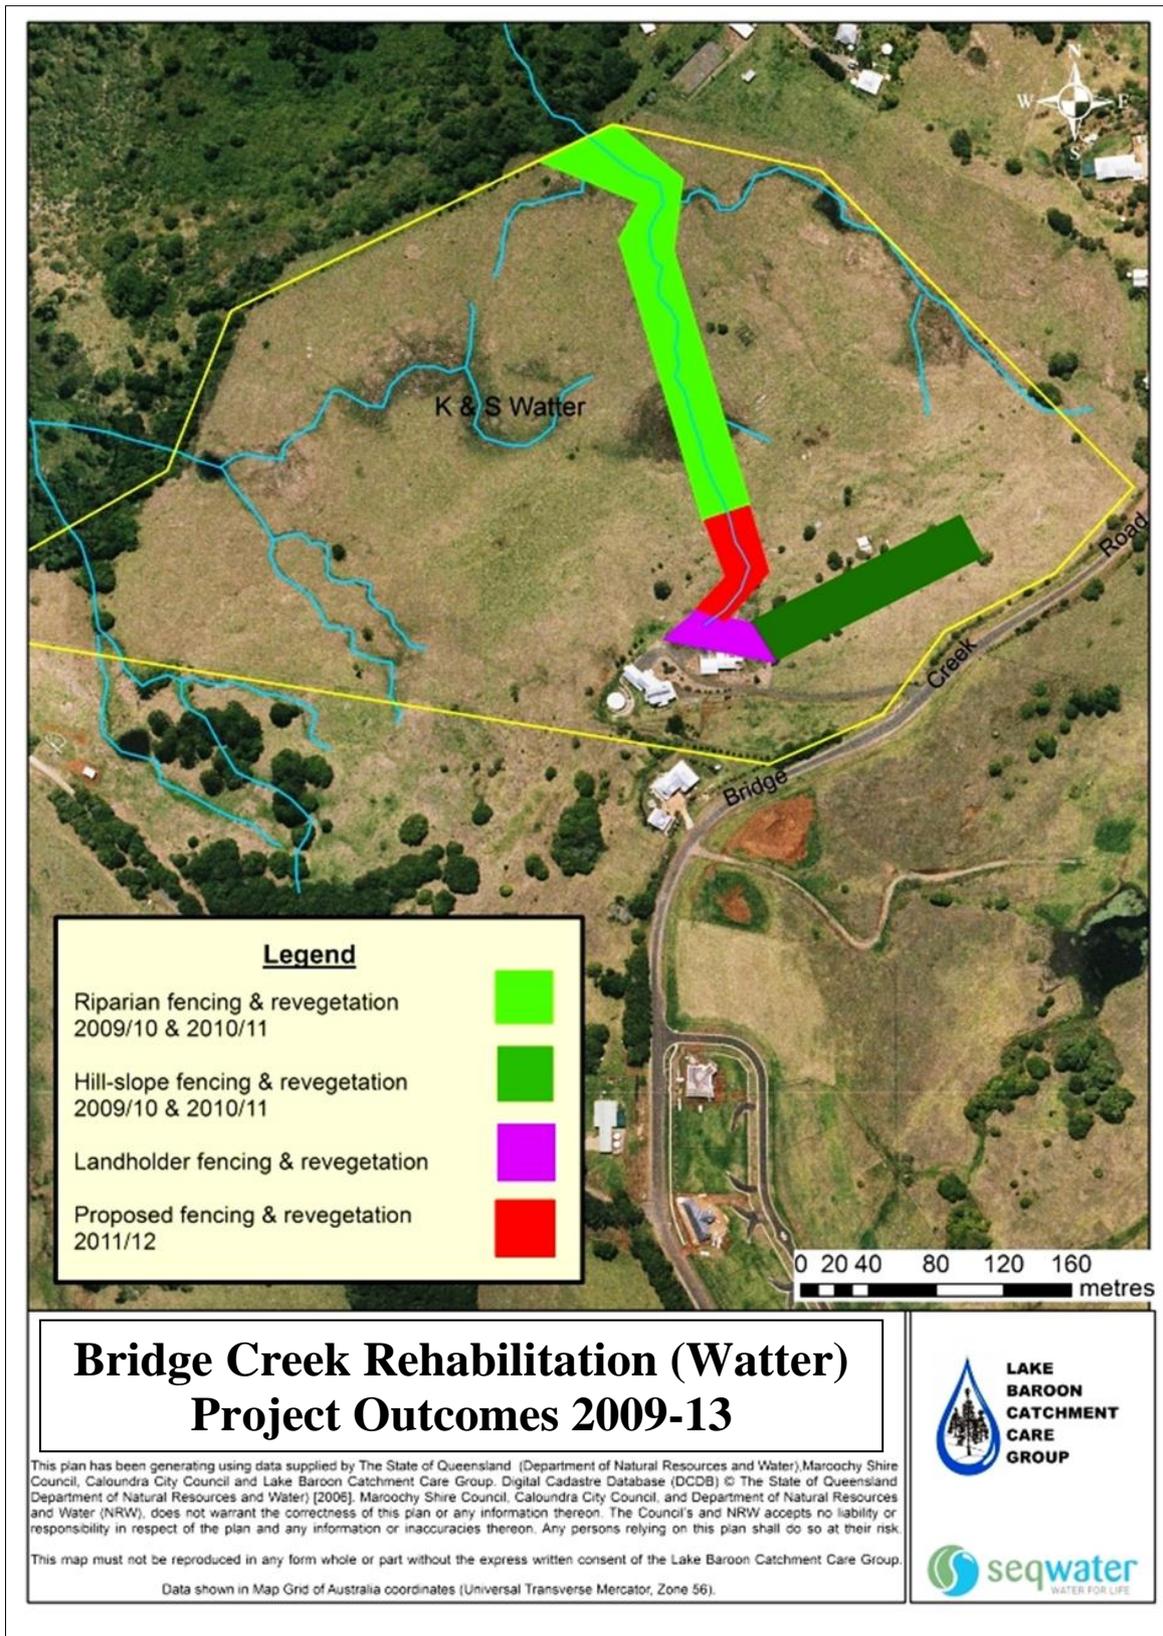
Above: Project Overview - proposed on-ground works.

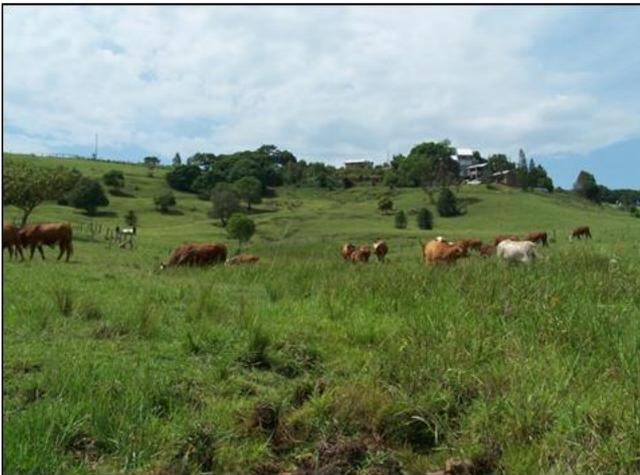
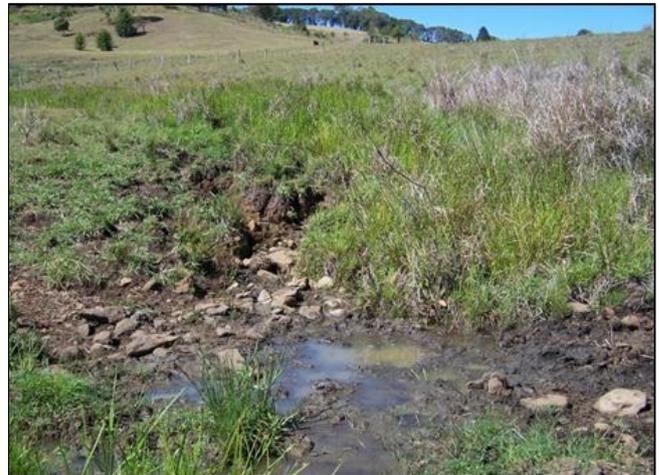
Above: The project is designed to remove livestock access from a first order stream and re-establish a vegetative buffer to reduce erosion and filter agricultural pollutants.

The project (at least up until recently) has performed quite well although plant establishment in Site 1 (the main watercourse on the property) has been difficult. Species selection on Site 1 has proved to be reasonably poor – mainly due to the wet conditions experienced since planting and was compromised further by poor placement of species during planting (Barung Landcare). Ultimately losses have been higher than normal and growth rates far slower than ideal. Replanting has been completed by the landholders at their own expense.

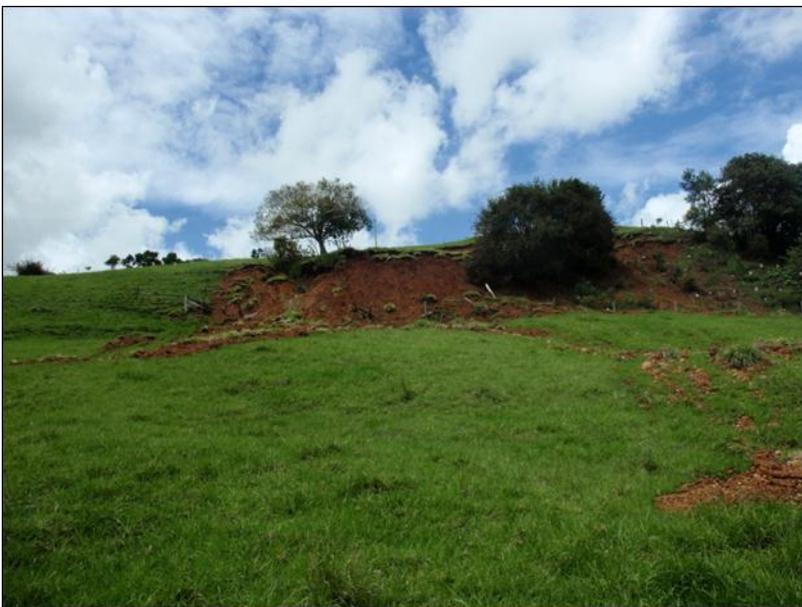
The Australia Day weekend rainfall event saw approximately 830 millimetres of rain fall over a four day period. Combined with the exceptional dry period experienced in the preceding six months resulted in numerous land slips throughout the Lake Baroon catchment. Many previously stable slips were reactivated – with one occurring at the eastern end of the hill-slope revegetation site (Site 2).

The slip has damaged approximately 200 metres of fencing and 150 trees. The landholders have committed to the salvaging of fencing, earthworks to re-profile the landslip and revegetation to ensure the investment by LBCCG and Seqwater is maintained. LBCCG will assist in the repairs by providing surplus revegetation materials and support where possible.

Left: The landslip on the Watter property has damaged fencing and trees.

The landholders have engaged an experienced, local earthmover to profile the site and improve drainage.

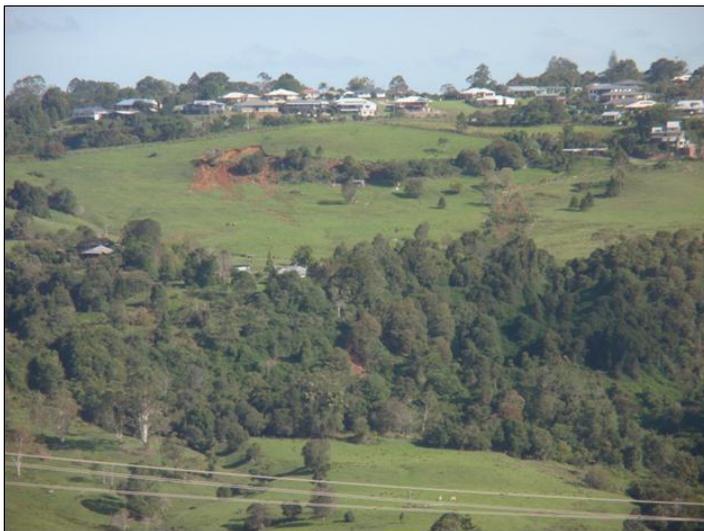
Catchment soil stability mapping had previously identified the property as having two small areas prone to land slip although the hill-slope at the beginning of the project was thought to be stable. The hill-slope grew little pasture and was criss-crossed with cattle tracks which resulted in sediments being washed down hill in rainfall events and entering the waterways.

It is suspected that the nearby Bridge Creek Road drainage was directing flows onto an area already compromised by deep cracking (a result of the previous dry soil conditions). This has been remedied by Sunshine Coast Council.

Left: The Watter landslip from Tesch Road Witta.

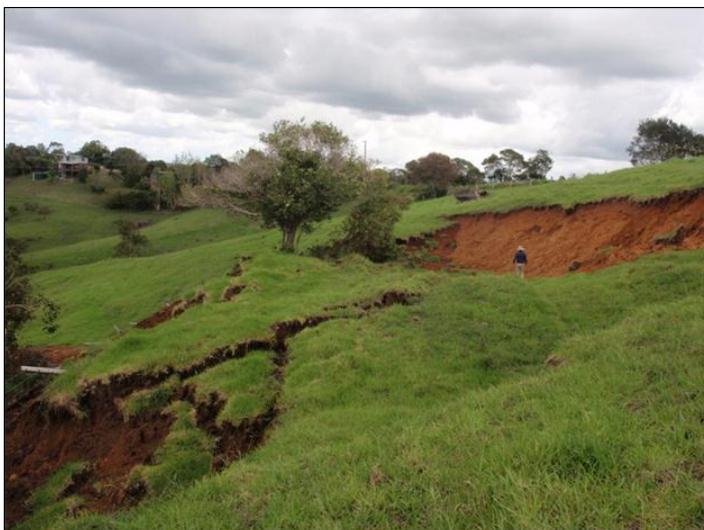
Left: The top of the slip.

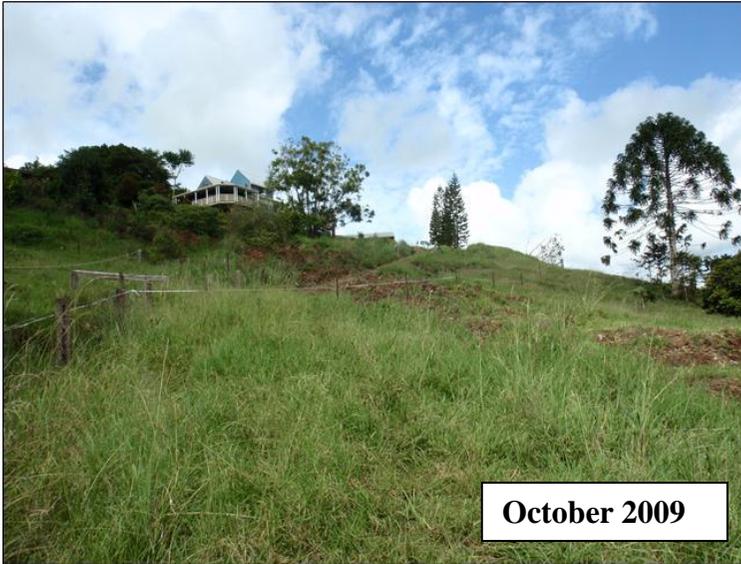
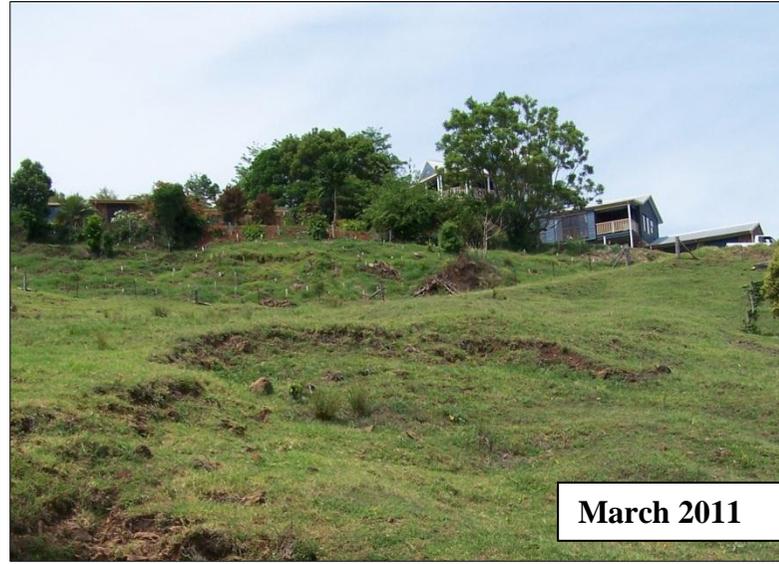
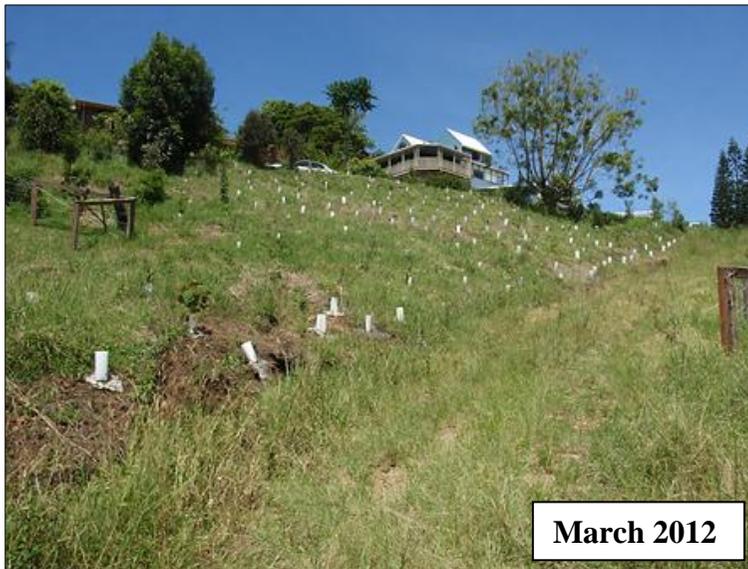
3.4 EXTRA ACTIVITIES

Surplus funds were utilised for extra fencing and revegetation to link Site 1 and 2. A landslip immediately below the house was repaired and revegetated at landholders cost.
