**LAKE
BAROON
CATCHMENT
CARE
GROUP**

Bridge Creek Riparian Remnant Fencing

PROJECT PLAN

Project No. 1112-003

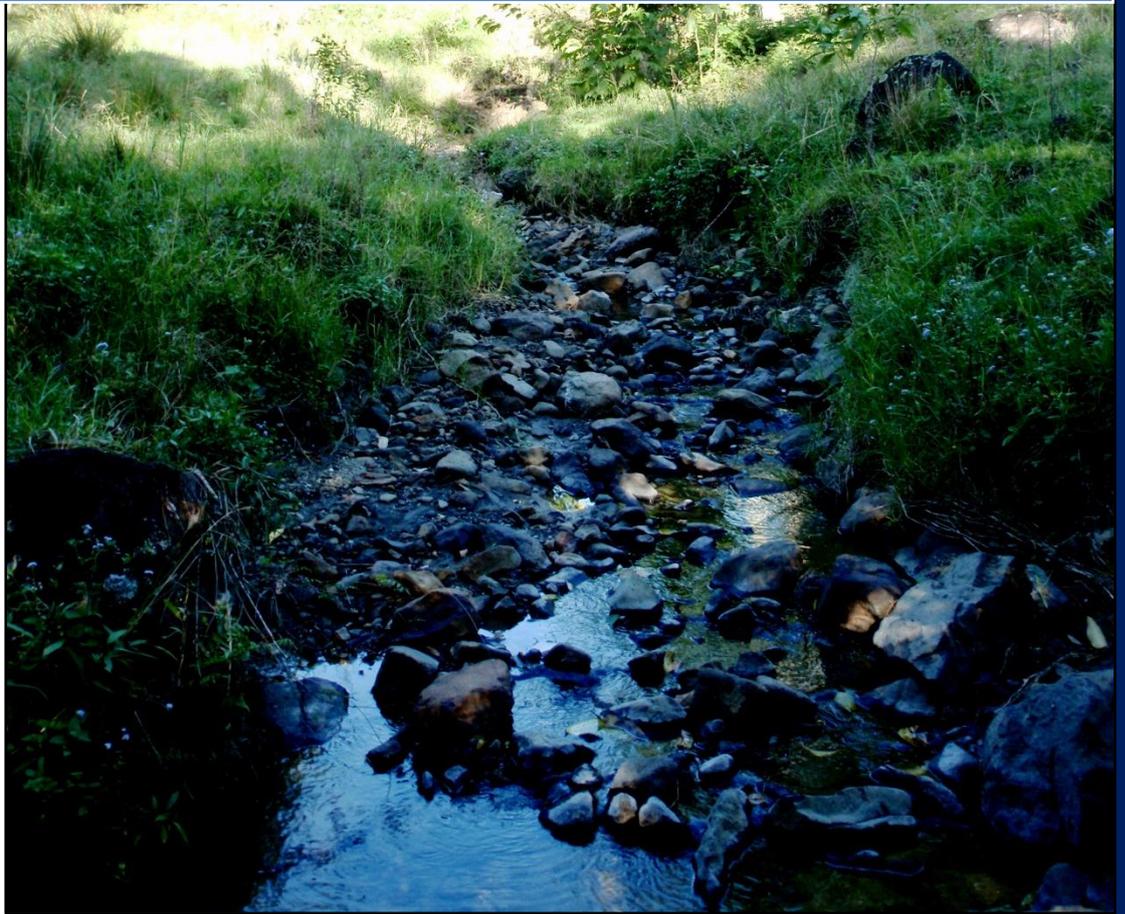
Cover photo: Small eroding stream on Cork property.

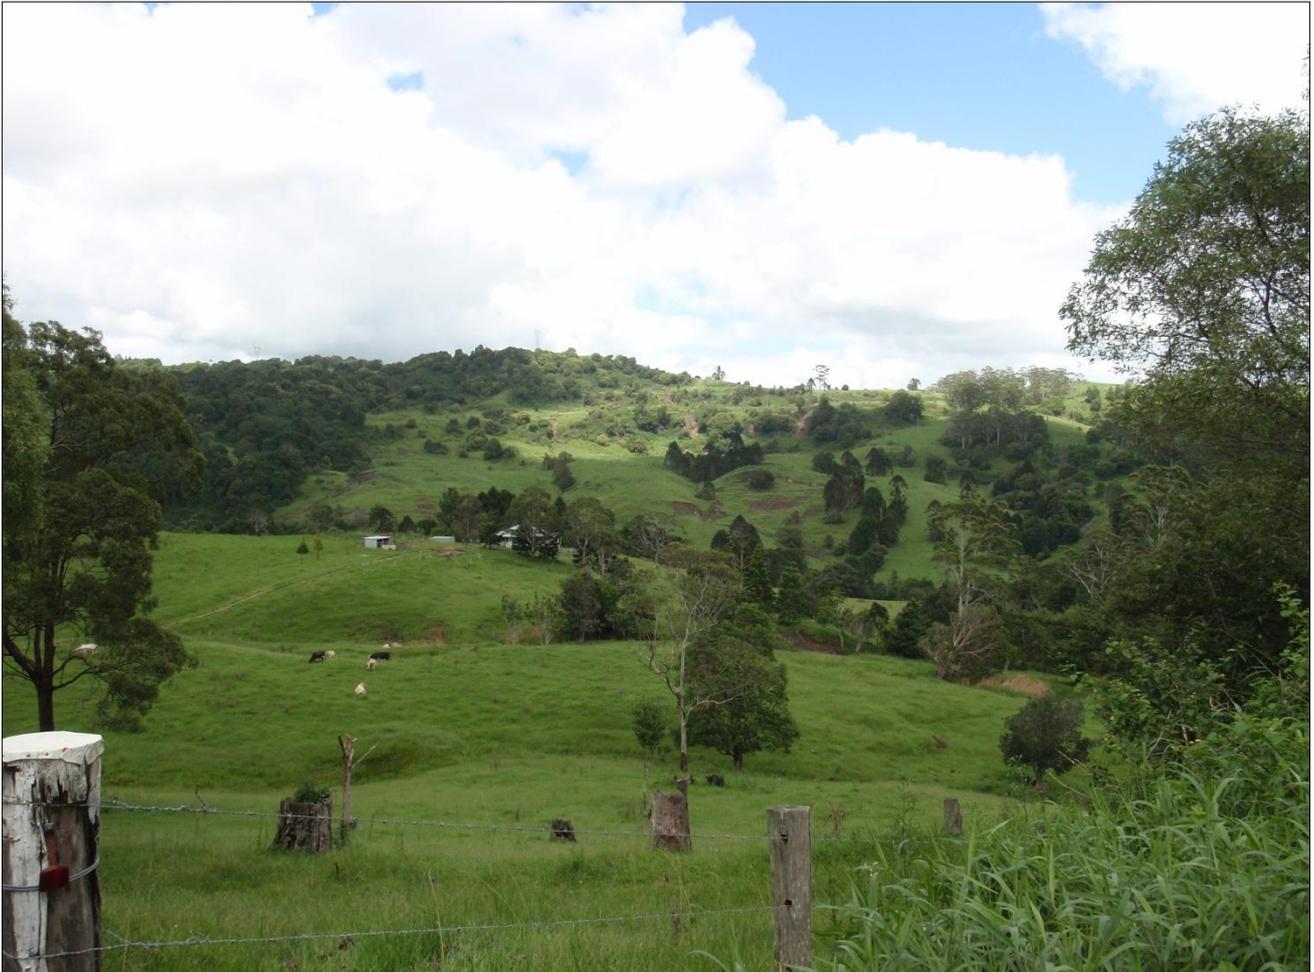
Above: The Cork property from Bridge Creek Road. Note the areas of significant erosion and patches of remnant vegetation.

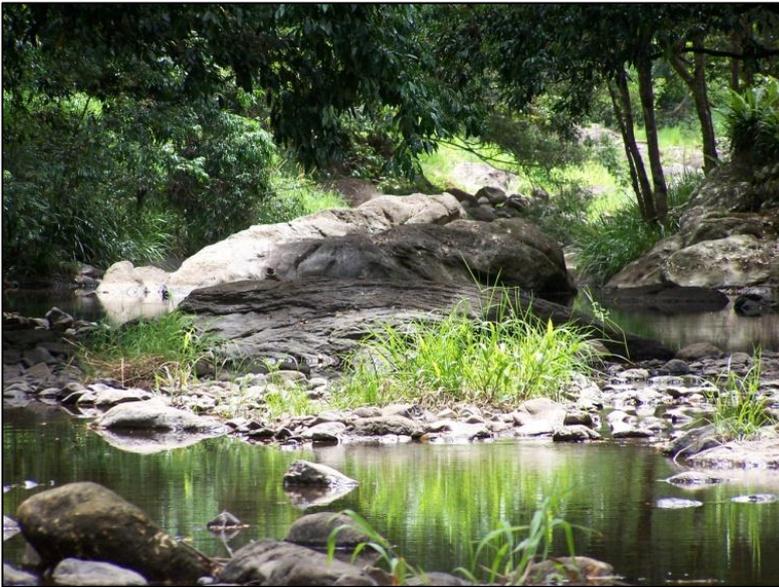
Left: Bridge Creek has good riparian vegetation and displays excellent bed diversity and bank stability. The creek however is threatened by sediment loads entering the waterway through excessive erosion in the catchment – particularly in the headwaters.

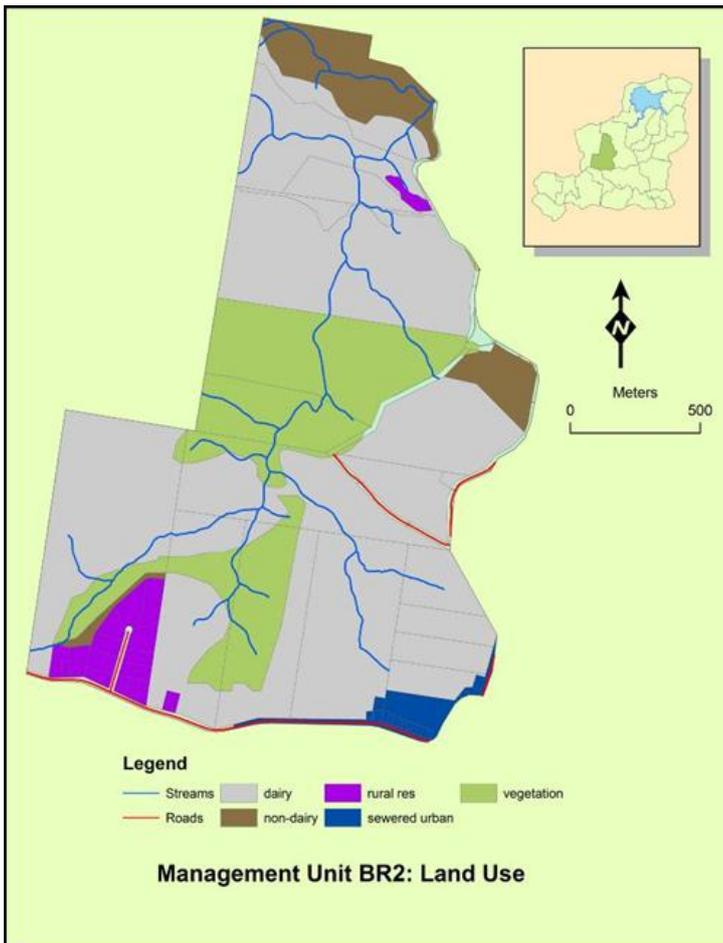
Above: The Bridge Creek catchment is experiencing a rapid shift from livestock grazing (dairy and beef) to rural residential land use (no dairies remain in the catchment), and several urban developments in the headwaters.

The proposed project is located within Management Unit BR2. This MU is 323 ha in size and has 98 km of significant waterways. Riparian vegetation is present alongside 85% of the waterway length, although much of this is in a degraded condition from environmental weeds.

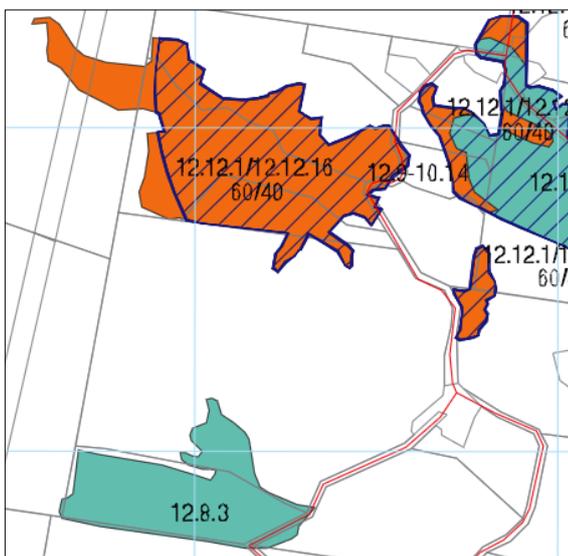
Left: Remnant vegetation on the Cork property. The orange shaded area is RE 12.12.1 Simple notophyll vine forest (Biodiversity Status – Of Concern). This area is also considered Essential Habitat under the Vegetation Management Act. The green area at the bottom of the figure is RE 12.8.3 Complex notophyll vine forest.

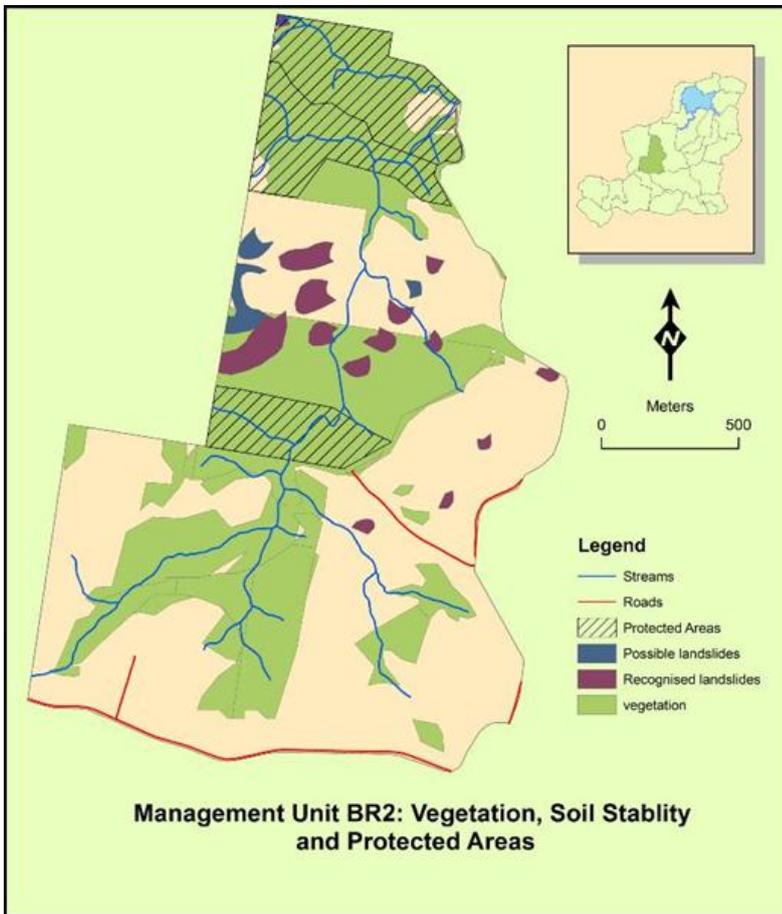
Left: The Cork property is situated in the lower middle of the figure.

The catchment is characterised by its steep slopes, lack of vegetation in the headwaters, and the inability of the soil to absorb nutrients and moisture.

Despite this the upper reaches are relatively stable with nutrient inputs relatively moderate.

The middle reaches of the Management Unit have areas prone to slips and mass movement – the most obvious occurring on the Cork property.

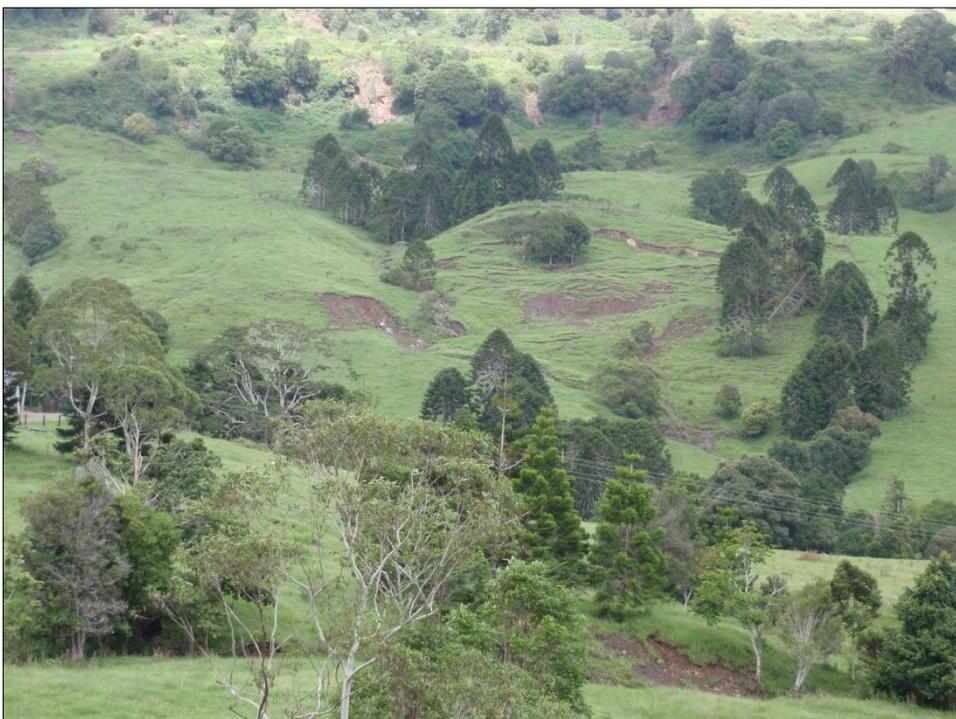
Left: Serious land slips on the Cork property.

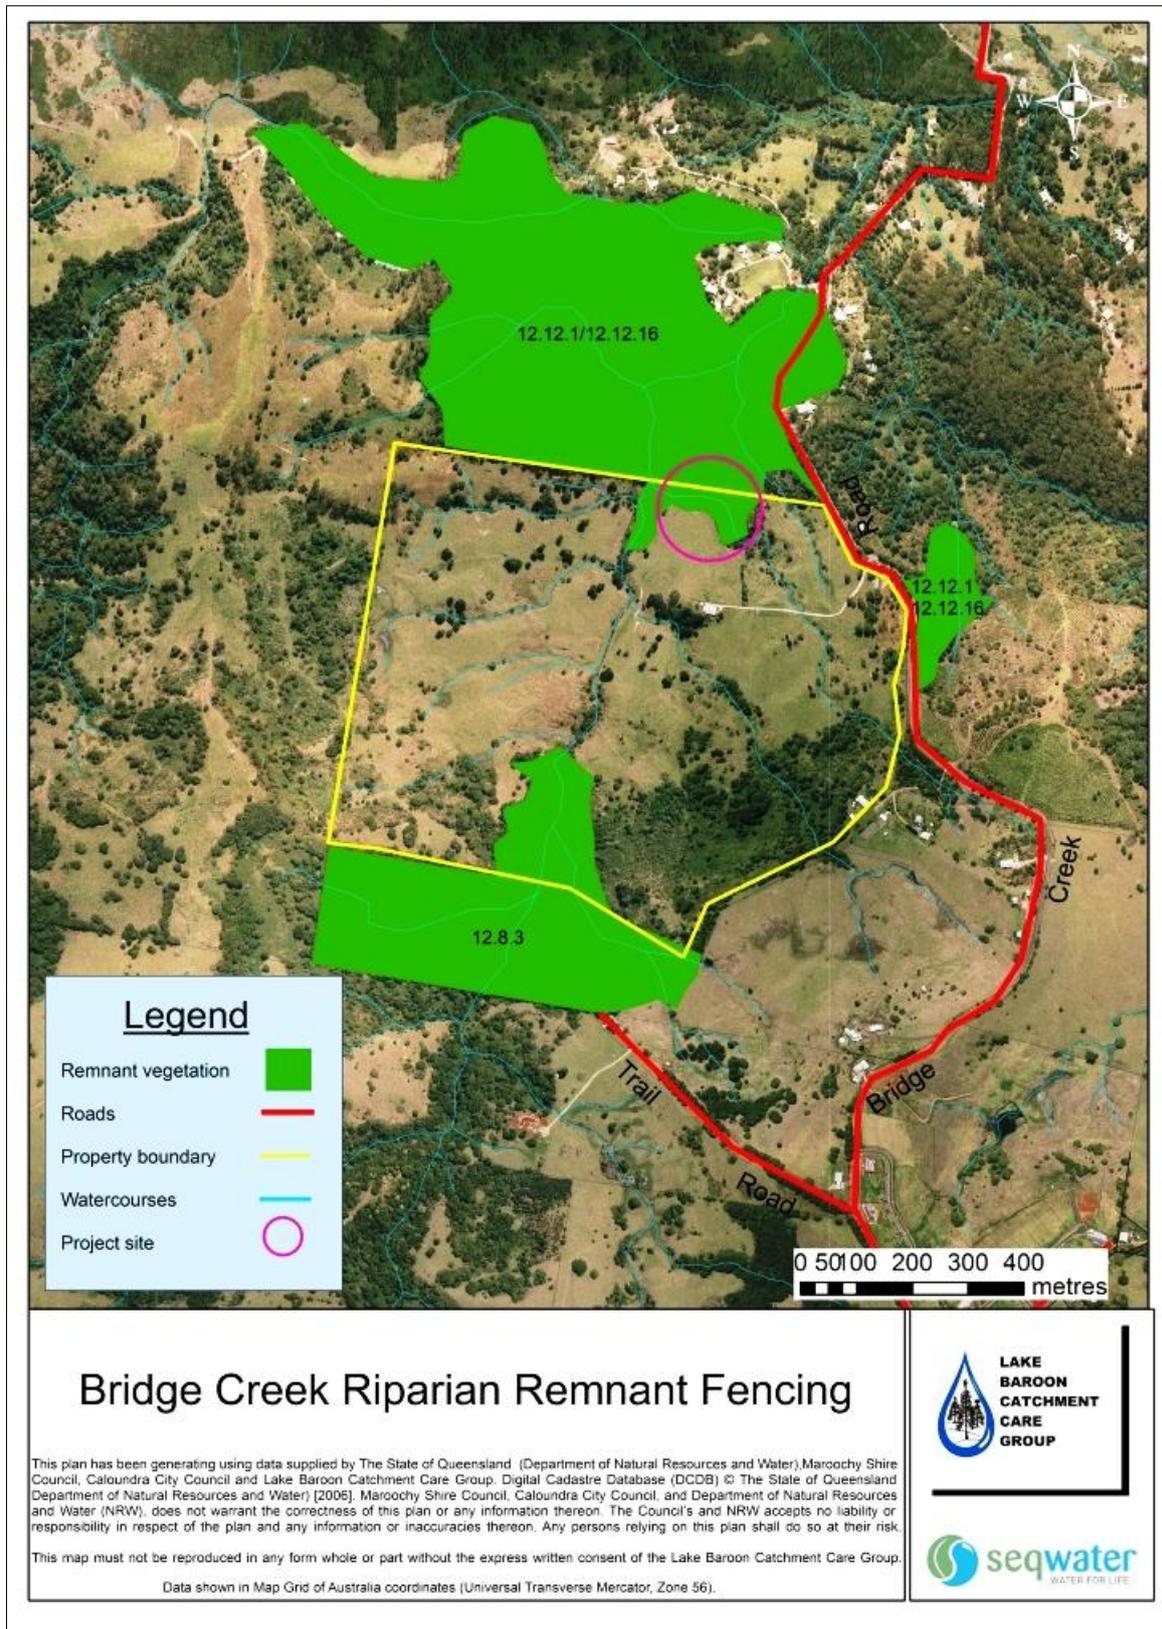
Above: Property Overview.

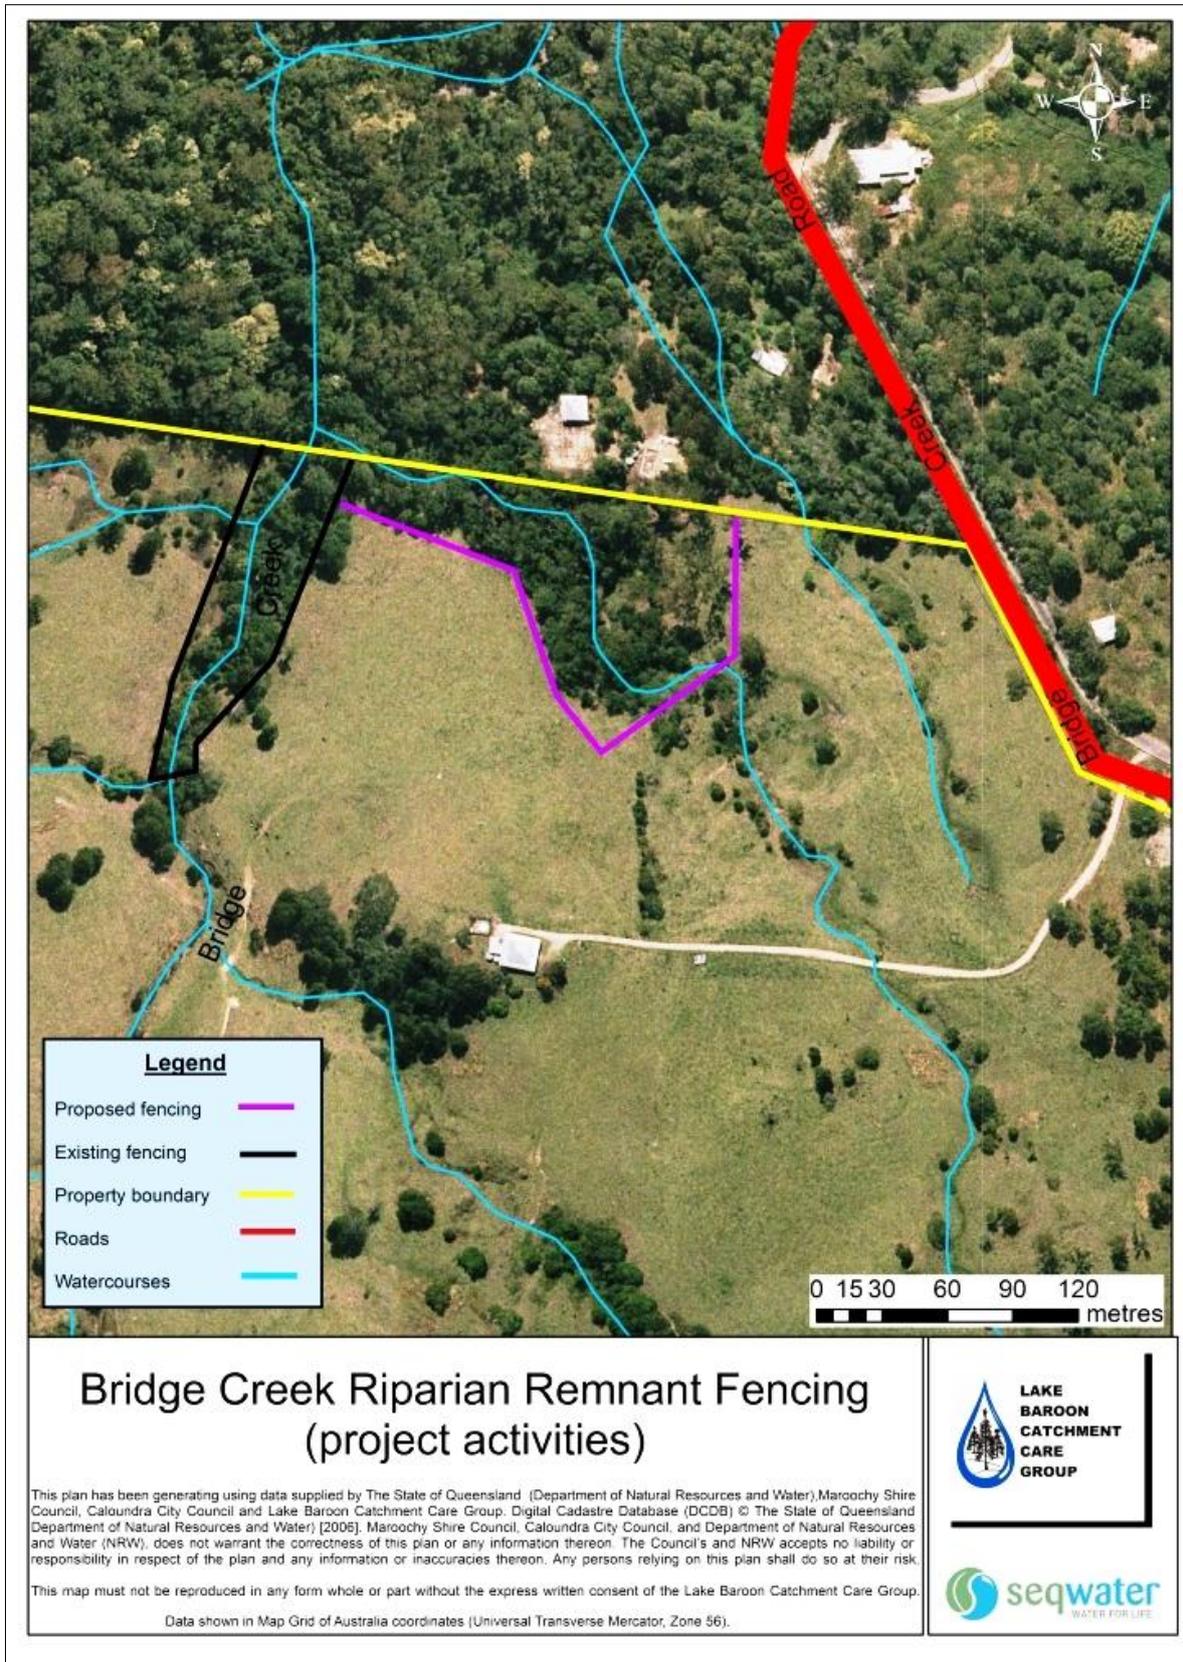
Above: Project Overview - proposed on-ground works.

An area of ‘Of Concern’ remnant vegetation and area classed as ‘Essential Habitat’ under the EPBC will be permanently fenced from livestock. Approximately 300 metres of waterway will be included inside the fence and also includes a waterlogged, unstable area of pasture.

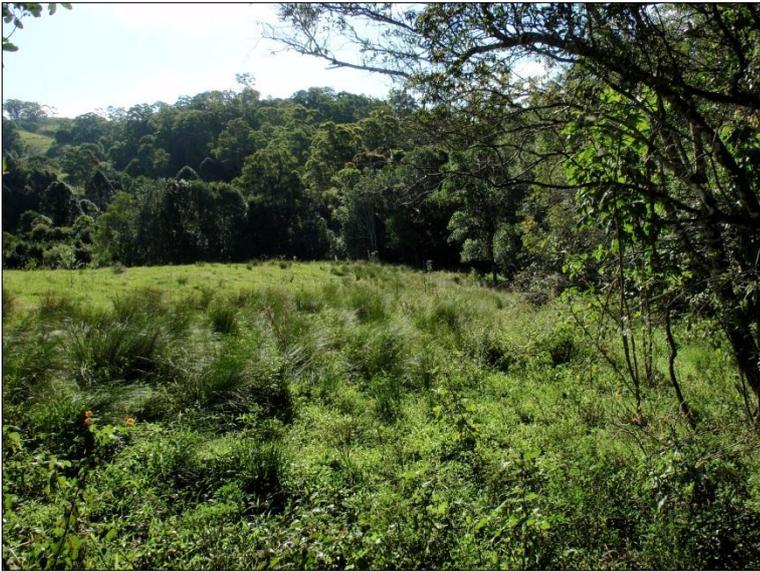
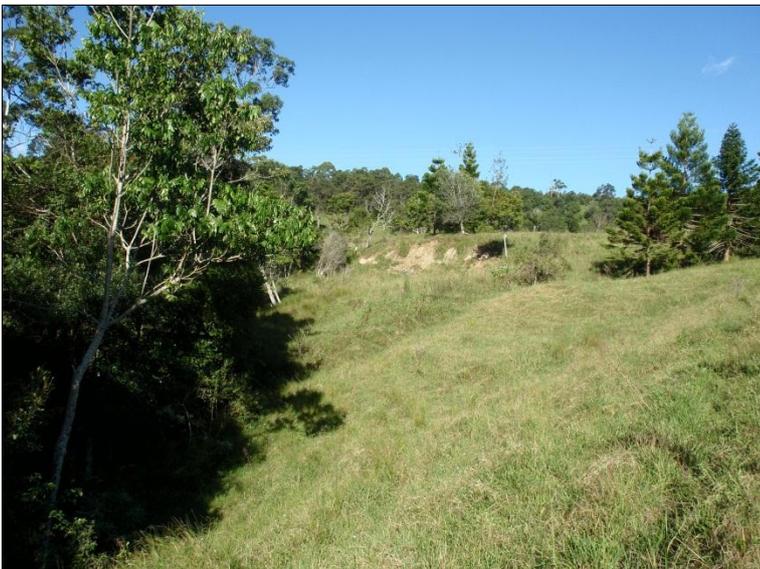
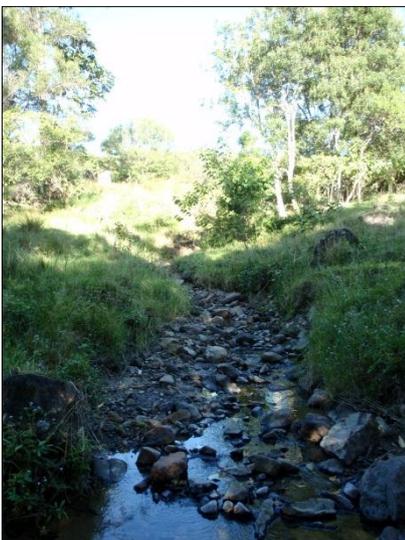
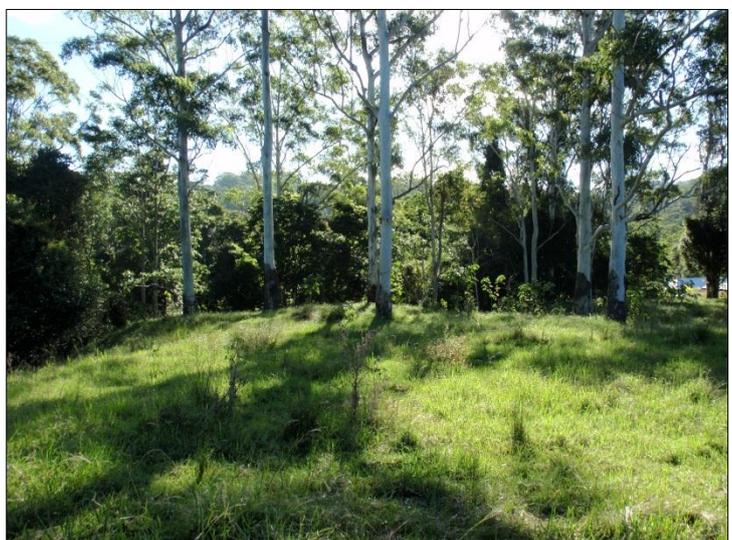
*Top: Remnant vegetation.
Left: The Cork property is unstable with erosion commonplace.
Bottom left: Waterway flowing off the property and through remnant vegetation.
Bottom right: Remnant vegetation.*

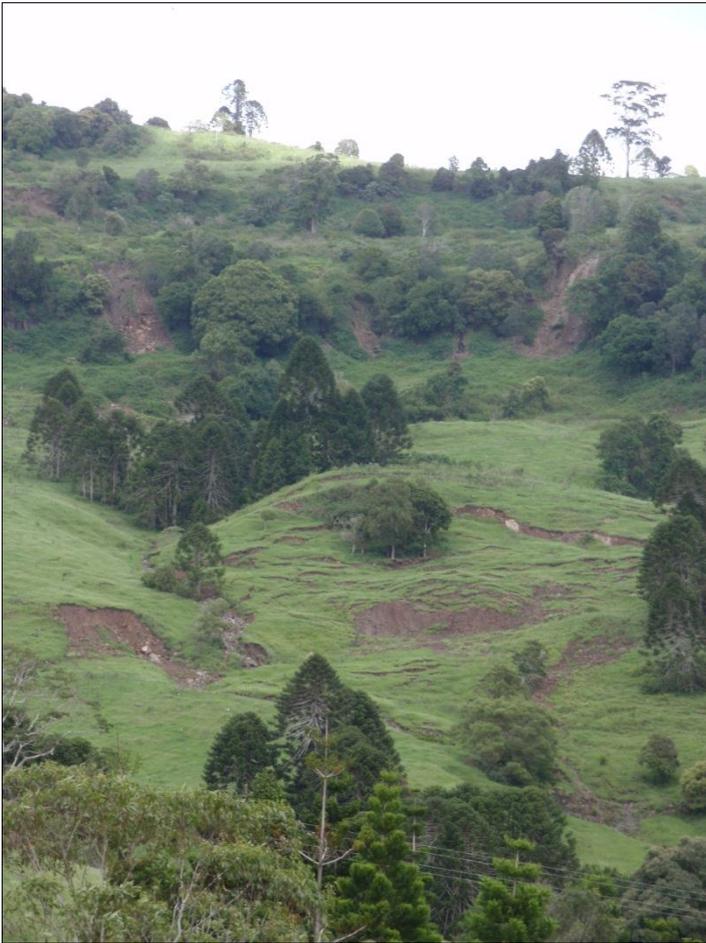
Above: Land slips on the Cork property following the wet summer of 2010/11.

Mass movement in the Lake Baroon catchment has come under increasing notice by Seqwater representatives and staff – primarily because of the risk to dam safety and water quality.

Col (and Stacey) Cork are interested in commencing activities to remediate the land slips on their property and the small remnant fencing project is an excellent way of building trust.
