“Bridge Creek Landslip Remediation”

Final Report & Acquittal (Sunshine Coast Council Minor Grant)

(July 2011)

PROJECT TITLE: Bridge Creek Landslip Remediation (LBCCG Project No. 1011-010)

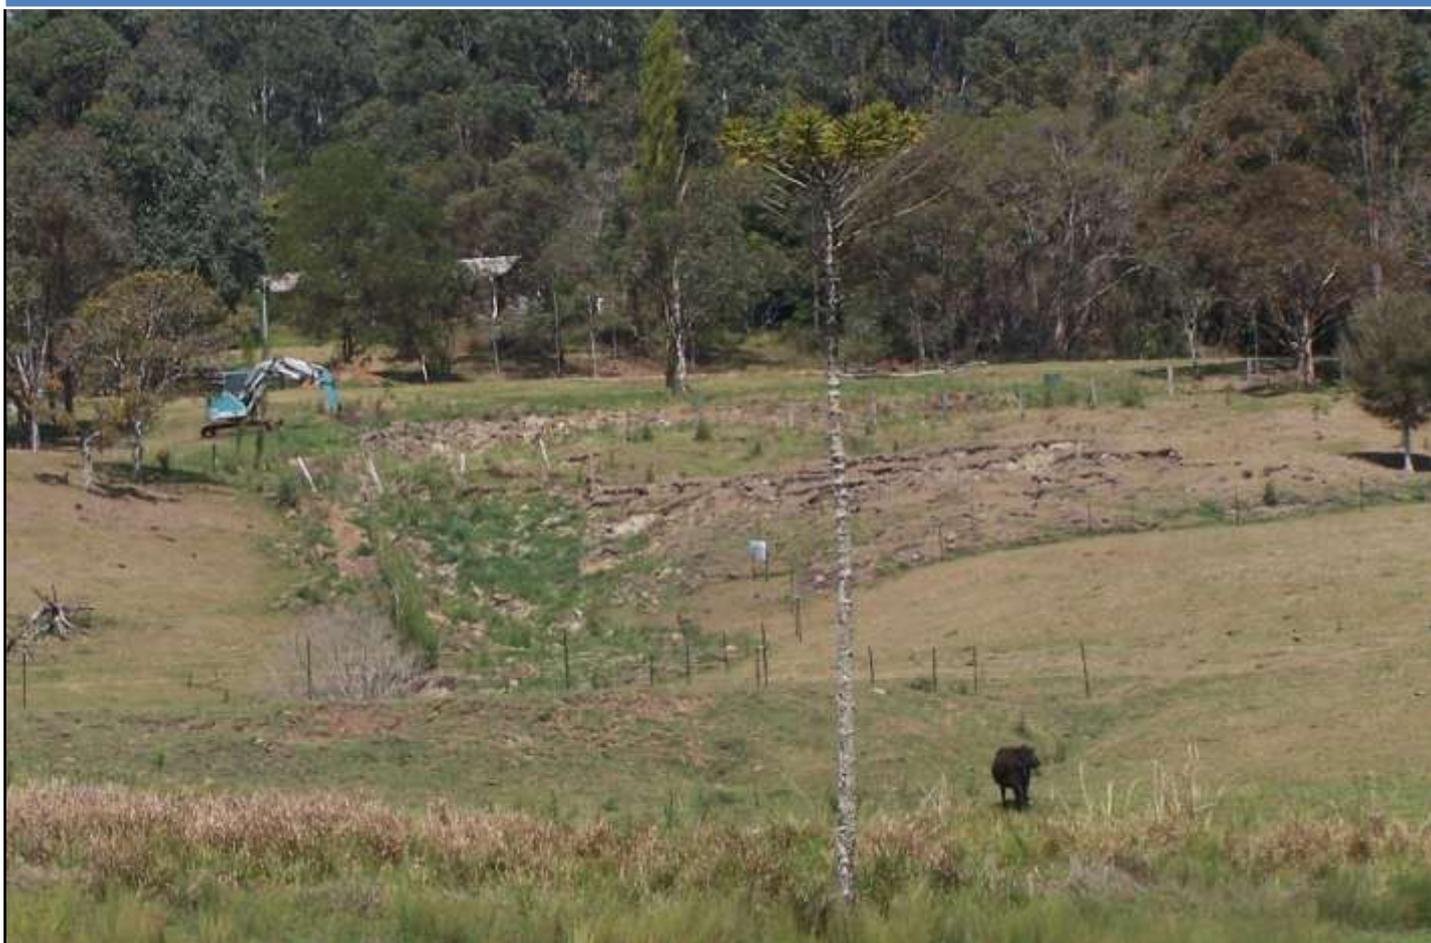
Cover photo: *The land slip on Wells Road, Maleny in August 2009 before remediation commenced.*

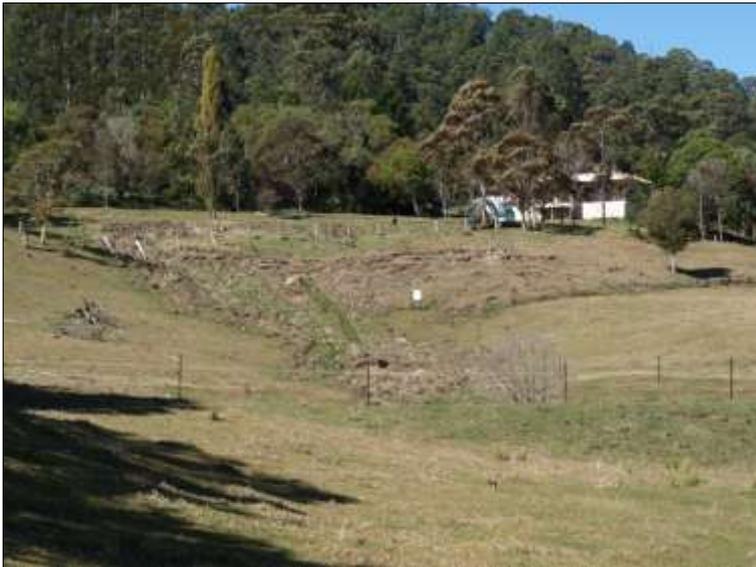
5.1 Fencing & Seeding

Although the hill-slope has been somewhat unstable for the past twenty years, this latest and most visually dramatic slip occurred in late summer 2009. With landholders contacted and an action plan agreed on the first stage was to restrict stock access so the existing grass cover was protected. Further rye grass seeding was required to stabilise bare areas.

Completed July 2009

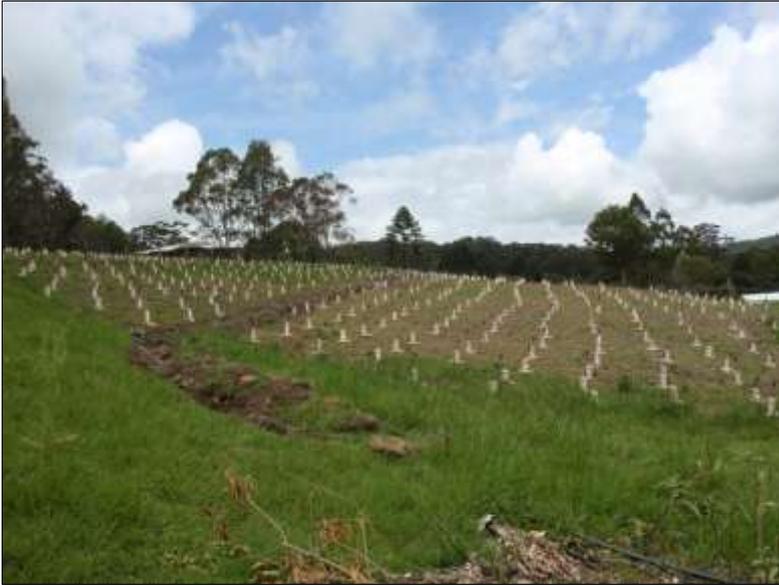
5.7 Revegetation Stage One

Conditions were poor with regular rainfall making the site very muddy and slippery. Planting holes were drilled using a 75mm post hole auger that could be used in the rocky conditions.

Once the seeded grass had established a National Green Jobs Corps team planted Stage One. This was the area disturbed by drainage and profiling works.

Completed November 2010
